Position of Parts in Instrument Panel <From Aug. 2009 Production>

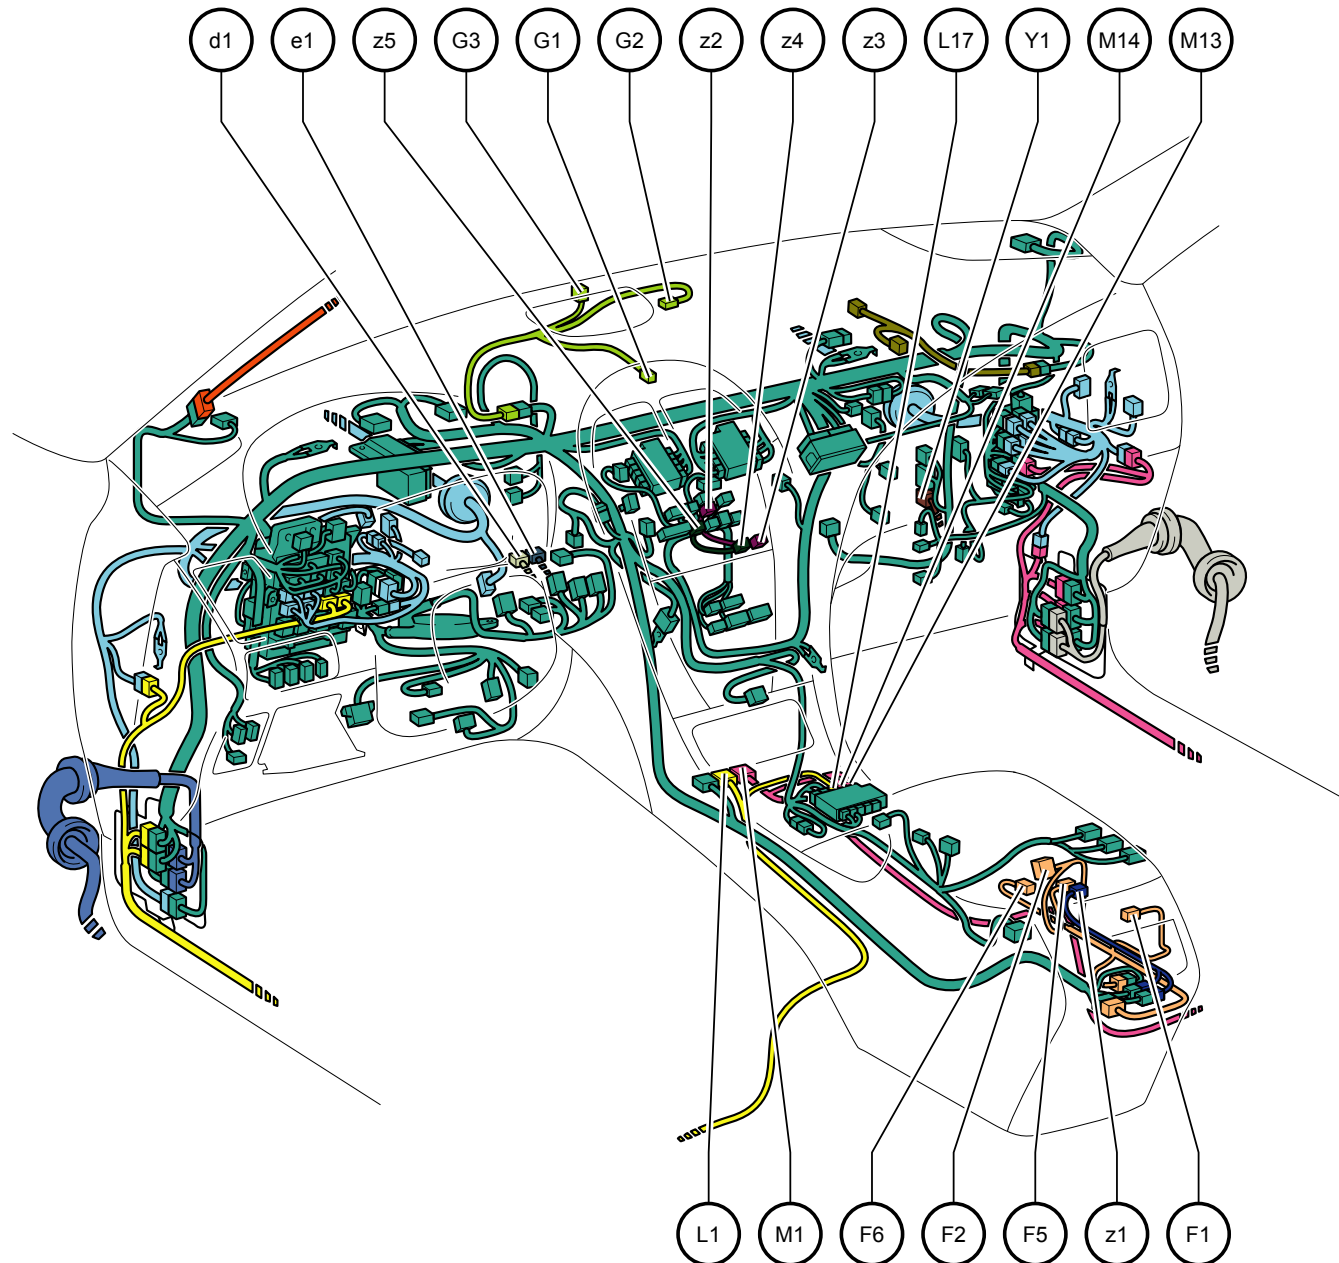
- F 1 Console Box Lamp
- F 2 Power Outlet Socket
- F 5 Stereo Jack Adapter
- F 6 Seat Heater SW

- G 1 Security Indicator Lamp
- G 2 Speaker (Center)
- G 3 Automatic Light Control Sensor

- L 1 Airbag Sensor Assembly Center
- L 1 Airbag Sensor Assembly Center
- L 17 Junction Connector

- M 1 Airbag Sensor Assembly Center
- M 1 Airbag Sensor Assembly Center
- M 13 Junction Connector
- M 14 Junction Connector

- Y 1 A/C Amplifier , A/C Blower Assembly

- d 1 Spiral Cable , Steering Pad SW

- e 1 Cruise Control SW , Spiral Cable

- z 1 Stereo Jack Adapter
- z 2 Display & Navigation Module Display
- z 3 Multi-Media Module Navigation Assembly
- z 4 Multi-Media Module Navigation Assembly
- z 5 Display & Navigation Module Display
