| <b>DTC</b> | <b>B0136/74</b> | <b>Open in P/T Squib (LH) Circuit</b> |

## CIRCUIT DESCRIPTION

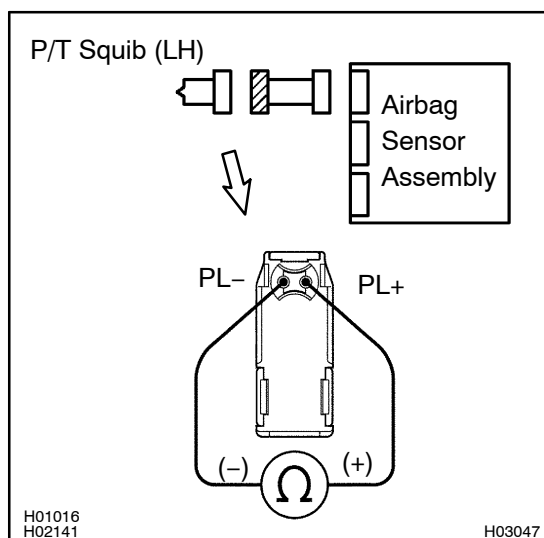
| <b>2</b> | <b>Check P/T squib (LH) circuit.</b> |

For the connector (on the seat belt pretensioner side) between the seat belt pretensioner (LH) and airbag sensor assembly, measure the resistance between PL+ and PL-.

**Resistance: Below 1 Ω**

**Repair or replace harness or connector between the seat belt pretensioner (LH) and airbag sensor assembly.**

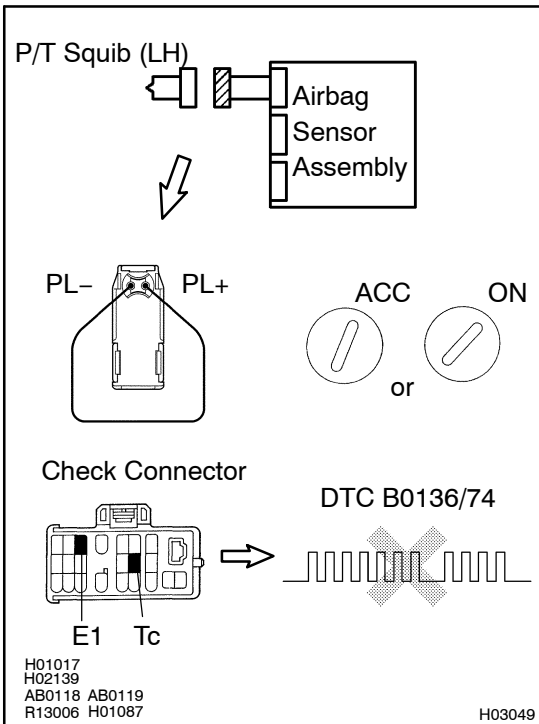
### 3 Check airbag sensor assembly.

- Connect the connector to airbag sensor assembly.
- Using a service wire, connect PL+ and PL- of the connector (on the seat belt pretensioner side) between the seat belt pretensioner (LH) and airbag sensor assembly.
- Connect negative (-) terminal cable to the battery, and wait at least for 2 seconds.

- Turn ignition switch to ACC or ON and wait at least for 20 seconds.
- Clear DTC stored in memory.  
(See page DI-386)
- Turn ignition switch to LOCK, and wait at least for 20 seconds.
- Turn ignition switch to ACC or ON, and wait at least for 20 seconds.
- Check DTC.  
(See page DI-386)

**DTC B0136/74 is not output.**

**Replace airbag sensor assembly.**

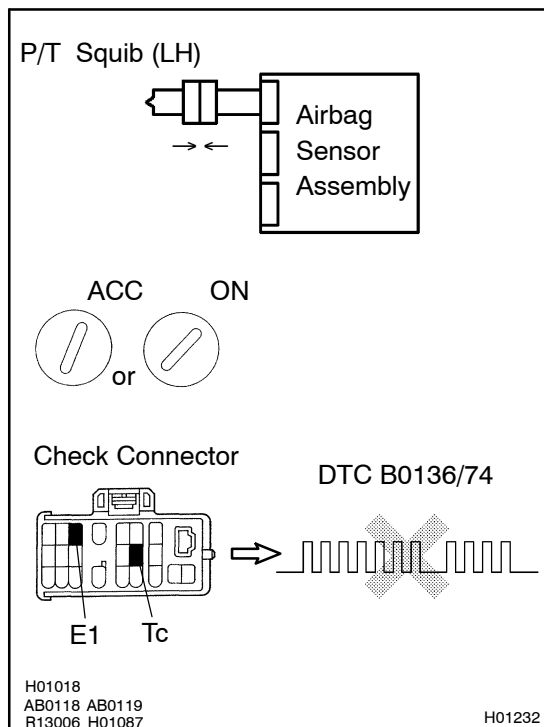
# 4 Check P/T squib (LH).

- Turn ignition switch to LOCK.
- Disconnect negative (-) terminal cable from the battery, and wait at least for 90 seconds.
- Connect the seat belt pretensioner (LH) connector.
- Connect negative (-) terminal cable to the battery, and wait at least for 2 seconds.

- Turn ignition switch to ACC or ON, and wait at least for 20 seconds.
- Clear DTC stored in memory.  
(See page DI-386)
- Turn ignition switch to LOCK, and wait at least for 20 seconds.
- Turn ignition switch to ACC or ON, and wait at least for 20 seconds.
- Check DTC.  
(See page DI-386)

**DTC B0136/74 is not output.**

**Replace seat belt pretensioner (LH).**
