| <b>DTC</b> | <b>B0136/74</b> | <b>Open in P/T Squib (LH) Circuit</b> |

## CIRCUIT DESCRIPTION

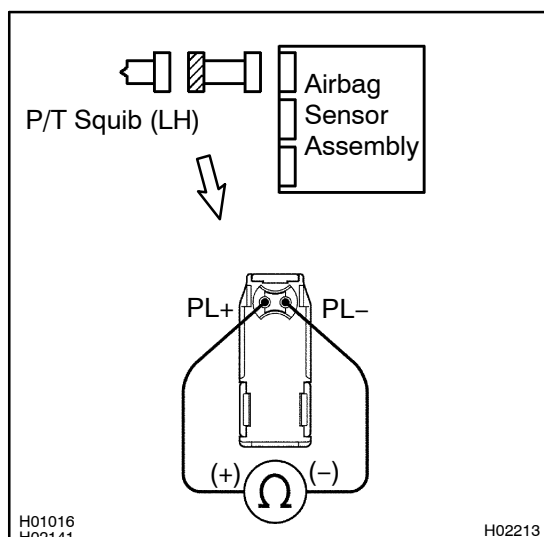
| <b>2</b> | <b>Check P/T squib (LH) circuit.</b> |

For the connector (on the seat belt pretensioner side) between the seat belt pretensioner (LH) and the airbag sensor assembly, measure the resistance between PL+ and PL-.

**Resistance: Below 1 Ω**

**Repair or replace harness or connector between seat belt pretensioner (LH) and airbag sensor assembly.**

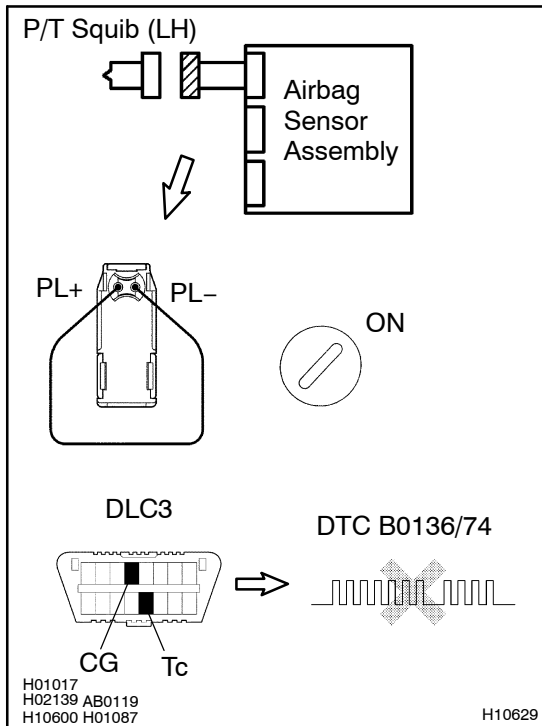
### 3 Check airbag sensor assembly.

- Connect the connector to the airbag sensor assembly.
- Using a service wire, connect PL+ and PL- of the connector (on the seat belt pretensioner side) between the seat belt pretensioner (LH) and the airbag sensor assembly.
- Connect negative (-) terminal cable to the battery, and wait at least for 2 seconds.

- Turn the ignition switch to ON and wait at least for 20 seconds.
- Clear the DTC stored in memory ([See page DI-369](#)).
- Turn the ignition switch to LOCK, and wait at least for 20 seconds.
- Turn the ignition switch to ON, and wait at least for 20 seconds.
- Check the DTC ([See page DI-369](#)).

**DTC B0136/74 is not output.**

**Replace airbag sensor assembly.**
