| <b>DTC</b> | <b>B0137/71</b> | <b>Short in P/T Squib (LH) Circuit (to Ground)</b> |

## CIRCUIT DESCRIPTION

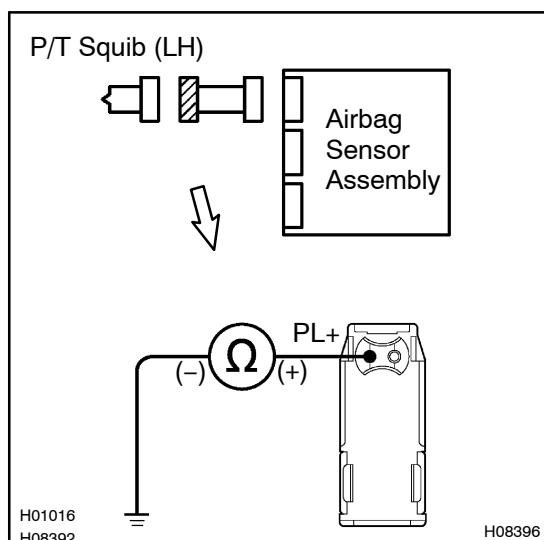
| <b>2</b> | <b>Check P/T squib (LH) circuit.</b> |

For the connector (on the seat belt pretensioner side) between the seat belt pretensioner (LH) and the airbag sensor assembly, measure the resistance between PL+ and body ground.

**Resistance: 1 MΩ or Higher**

**Repair or replace harness or connector between seat belt pretensioner (LH) and airbag sensor assembly.**

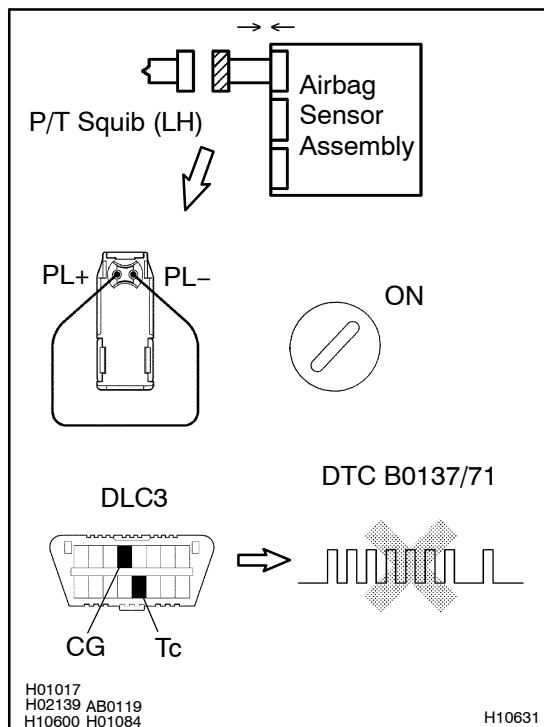
### 3 Check airbag sensor assembly.

- Connect the connector to the airbag sensor assembly.
- Using a service wire, connect PL+ and PL- of the connector (on the seat belt pretensioner side) between the seat belt pretensioner (LH) and the airbag sensor assembly.
- Connect negative (-) terminal cable to the battery, and wait at least for 2 seconds.

- Turn the ignition switch to ON and wait at least for 20 seconds.
- Clear the DTC stored in memory (See step 5 on [page DI-369](#)).
- Turn the ignition switch to LOCK, and wait at least for 20 seconds.
- Turn the ignition switch to ON, and wait at least for 20 seconds.
- Check the DTC (See [page DI-369](#)).

**DTC B0137/71 is not output.**

**Replace airbag sensor assembly.**

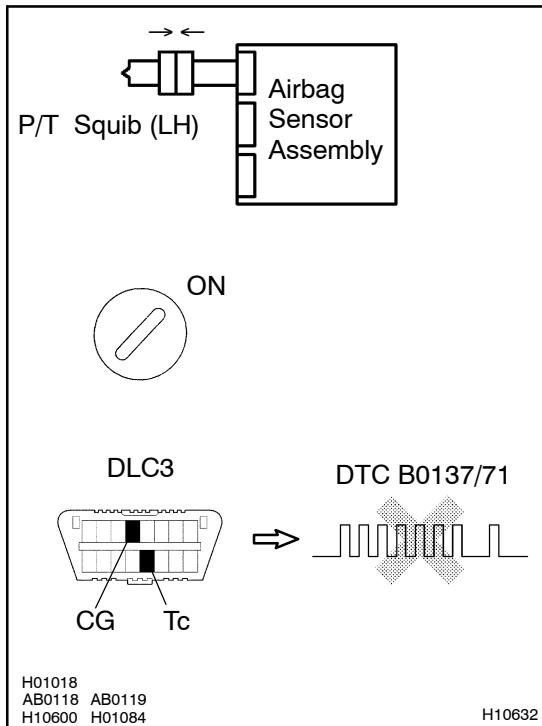
# 4 Check P/T squib (LH).

- Turn the ignition switch to LOCK.
- Disconnect negative (-) terminal cable from the battery, and wait at least for 90 seconds.
- Connect the seat belt pretensioner (LH) connector.
- Connect negative (-) terminal cable to the battery, and wait at least for 2 seconds.

- Turn the ignition switch to ON, and wait at least for 20 seconds.
- Clear the DTC stored in memory (See step 5 on [page DI-369](#)).
- Turn the ignition switch to LOCK, and wait at least for 20 seconds.
- Turn the ignition switch to ON, and wait at least for 20 seconds.
- Check the DTC ([See page DI-369](#)).

**DTC B0137/71 is not output.**

**Replace seat belt pretensioner (LH).**
