Position of Parts in Instrument Panel <LHD From Jul. 2006 Production>

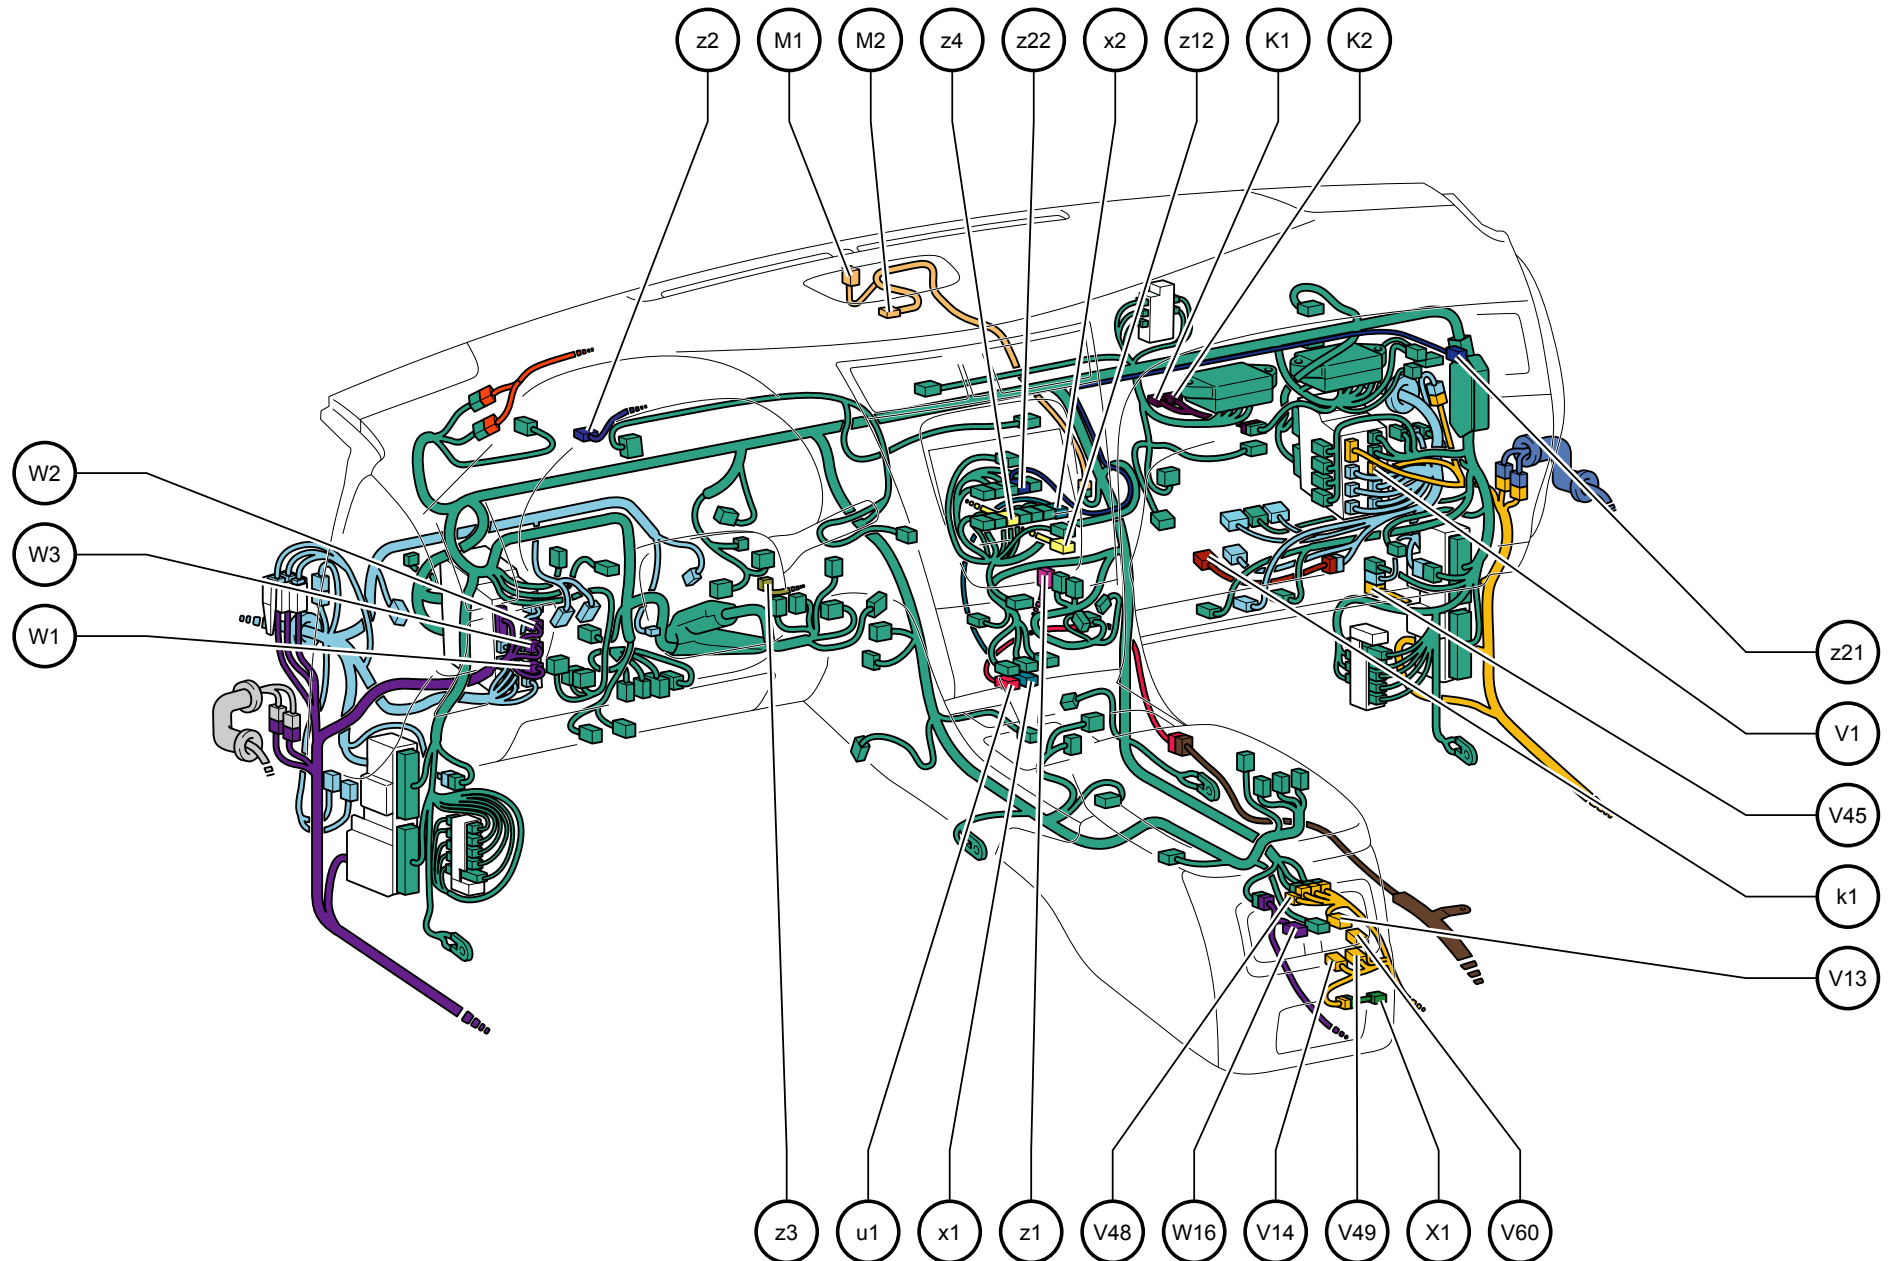
- K 1 Airbag Squib (Front Passenger's Airbag Assembly)
- K 2 Airbag Squib (Front Passenger's Airbag Assembly)

- M 1 Automatic Light Control Sensor
- M 2 Speaker (Center)

- V 1 Body ECU (Cowl Side J/B RH)
- V 13 Airbag Sensor Assembly Center
- V 14 Power Outlet Socket
- V 45 Absorber Control ECU
- V 48 Electrical Key Oscillator (Console)
- V 49 Stereo Jack Adapter
- V 60 No.1 Stereo Jack Adapter Assembly

- W 1 Body ECU (Cowl Side J/B LH)
- W 2 Body ECU (Cowl Side J/B LH)
- W 3 Body ECU (Cowl Side J/B LH)
- W 16 Airbag Sensor Assembly Center

- X 1 Console Box Lamp

- k 1 Blower Motor

- u 1 Radio Receiver Assembly

- x 1 Radio Receiver Assembly
- x 2 Multi-Display

- z 1 A/C Amplifier , A/C Blower Assembly
- z 2 Combination Meter , Telltale Lamp Assembly
- z 3 Windshield Wiper SW Assembly , Headlamp Dimmer SW Assembly
- z 4 Multi-Display , Multi-Media Module Navigation Assembly
- z 12 Multi-Display , Multi-Media Module Navigation Assembly
- z 21 Telematics Transceiver
- z 22 Display & Navigation Module Display

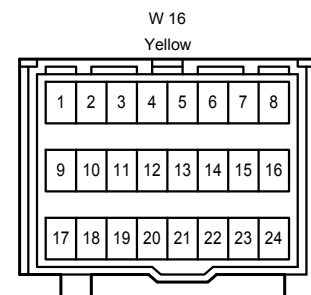
(From Sep. 2007 Production)

z 2  
White

z 3  
White

z 4  
White

z 12  
Blue

z 21  
White

z 22  
White
