**Position of Parts in Instrument Panel (Before Aug. 2013 Production)**

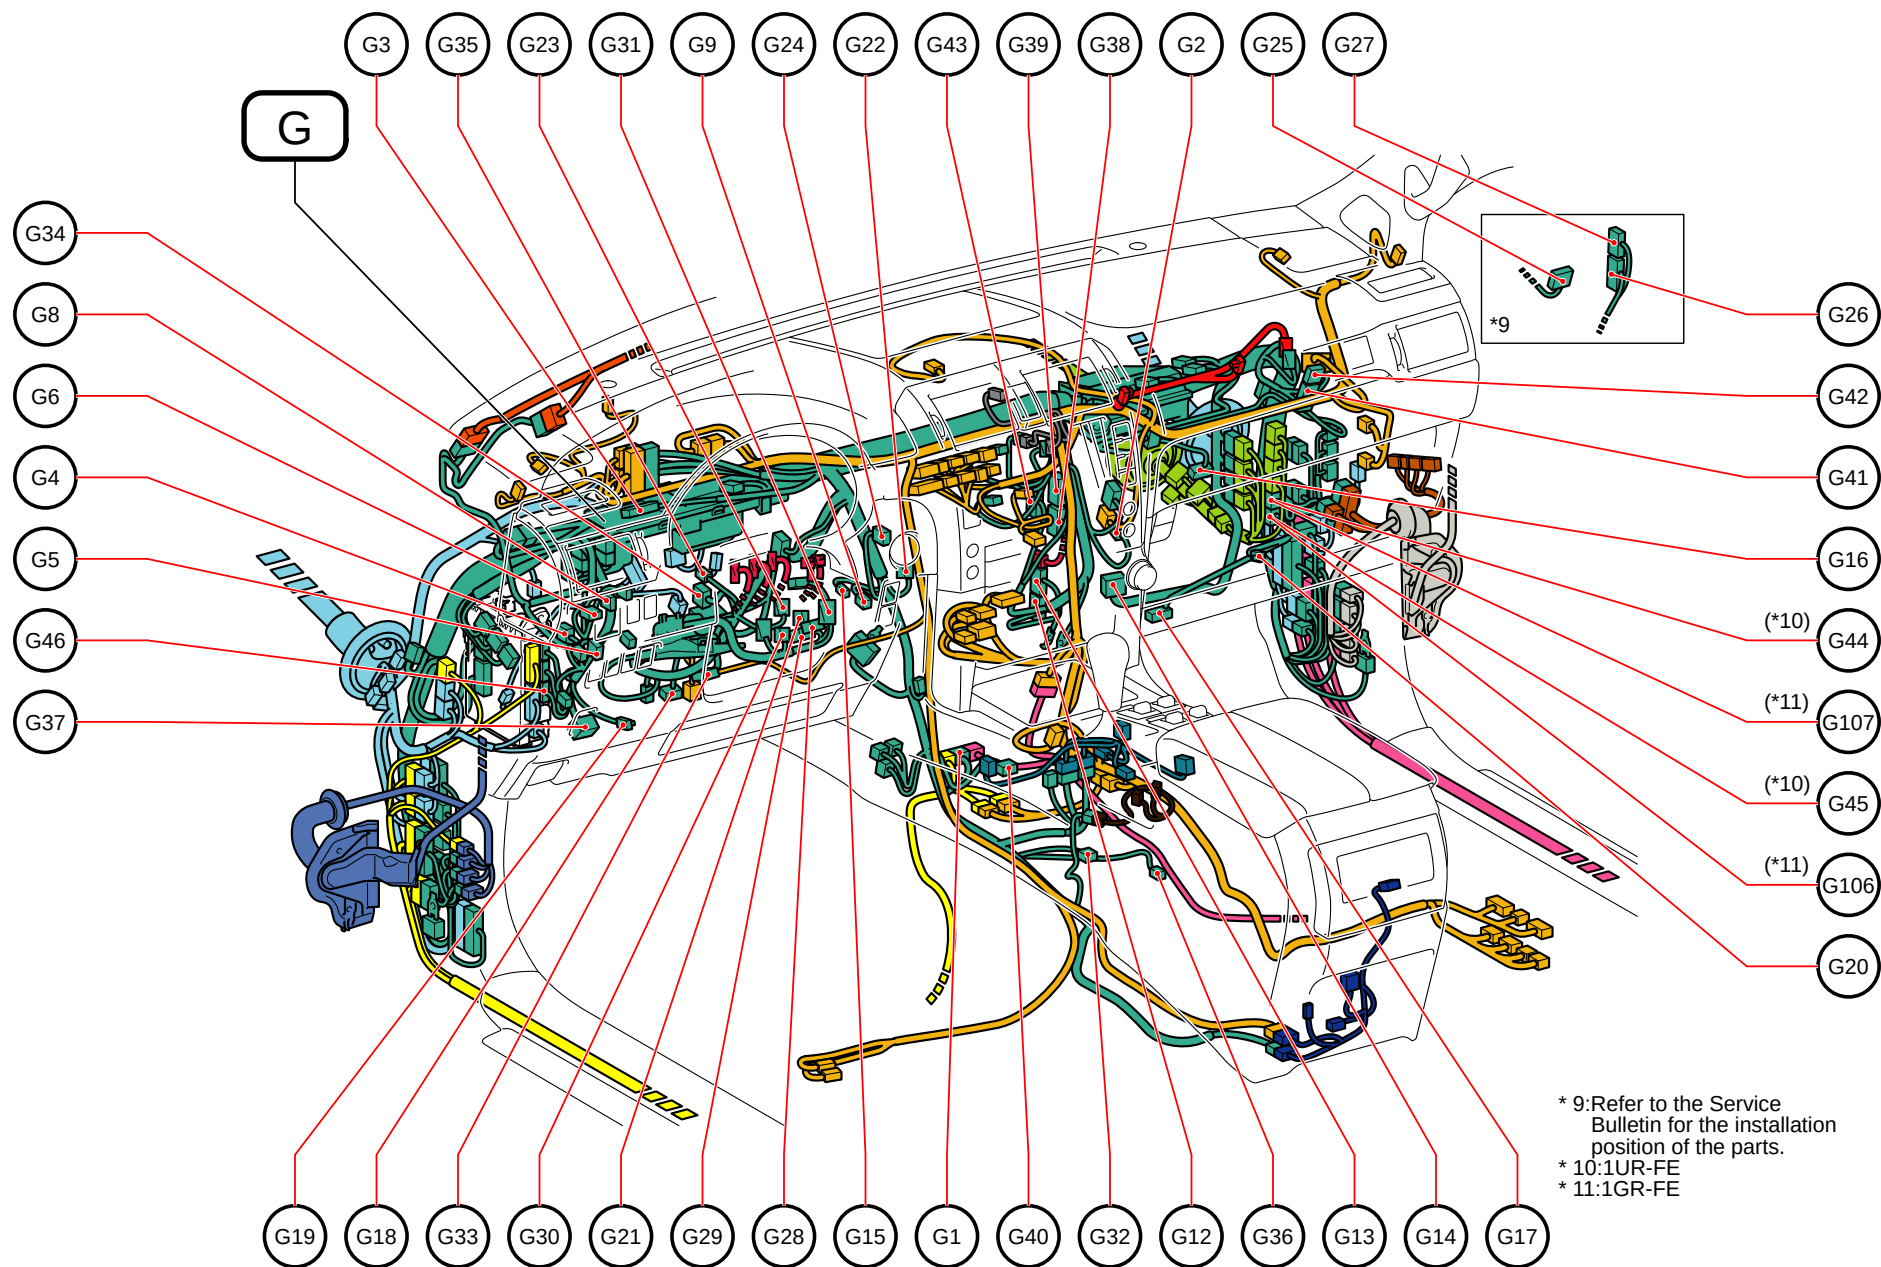
| G1 | Airbag Sensor Assembly |
| G2 | Mayday Battery |
| G3 | Combination Meter Assembly |
| G4 | Turn Signal Flasher Assembly |
| G5 | VSC Off Switch |
| G6 | Outer Mirror Switch Assembly |
| G8 | Light Control Rheostat |
| G9 | Center Differential Lock Switch |
| G12 | A/C Amplifier Assembly |
| G13 | A/C Amplifier Assembly |
| G14 | Front Blower with Fan Motor Sub-Assembly |
| G15 | Intake Air Temperature Sensor |
| G16 | Glove Box Light |
| G17 | Interior Foot Light RH |
| G18 | Interior Foot Light LH |
| G19 | Lower No. 1 Instrument Panel Airbag Assembly |
| G20 | Lower No. 2 Instrument Panel Airbag Assembly |
| G21 | Steering Sensor |
| G22 | No. 1 Clearance Warning Buzzer |
| G23 | Steering Lock Actuator Assembly |
| G24 | Engine Switch |
| G25 | ID Code Box |
| G26 | Certification ECU Assembly |
| G27 | Certification ECU Assembly |
| G28 | Spiral Cable Sub-Assembly |
| G29 | Spiral Cable Sub-Assembly |
| G30 | Spiral Cable Sub-Assembly , Steering Wheel Heater Control Assembly |
| G31 | Headlight Dimmer Switch Assembly |
| G32 | Shift Lock Control ECU Sub-Assembly |
| G33 | Multiplex Tilt & Telescopic ECU |
| G34 | Seat Belt Control ECU |
| G35 | Seat Belt Control ECU |
| G36 | Transmission Control Switch |
| G37 | DLC3 |
| G38 | Power Management Control ECU |
| G39 | Power Management Control ECU |
| G40 | Yaw Rate Sensor Assembly |
| G41 | Four Wheel Drive Control ECU |
| G42 | Four Wheel Drive Control ECU |
| G43 | Driving Support ECU Assembly |
| G44 | ECM |
| G45 | ECM |
| G46 | Main Body ECU |
| G106 | ECM |
| G107 | ECM |
