Seat Heater <Rear Passenger's Seat , From Sep. 2012 Production>

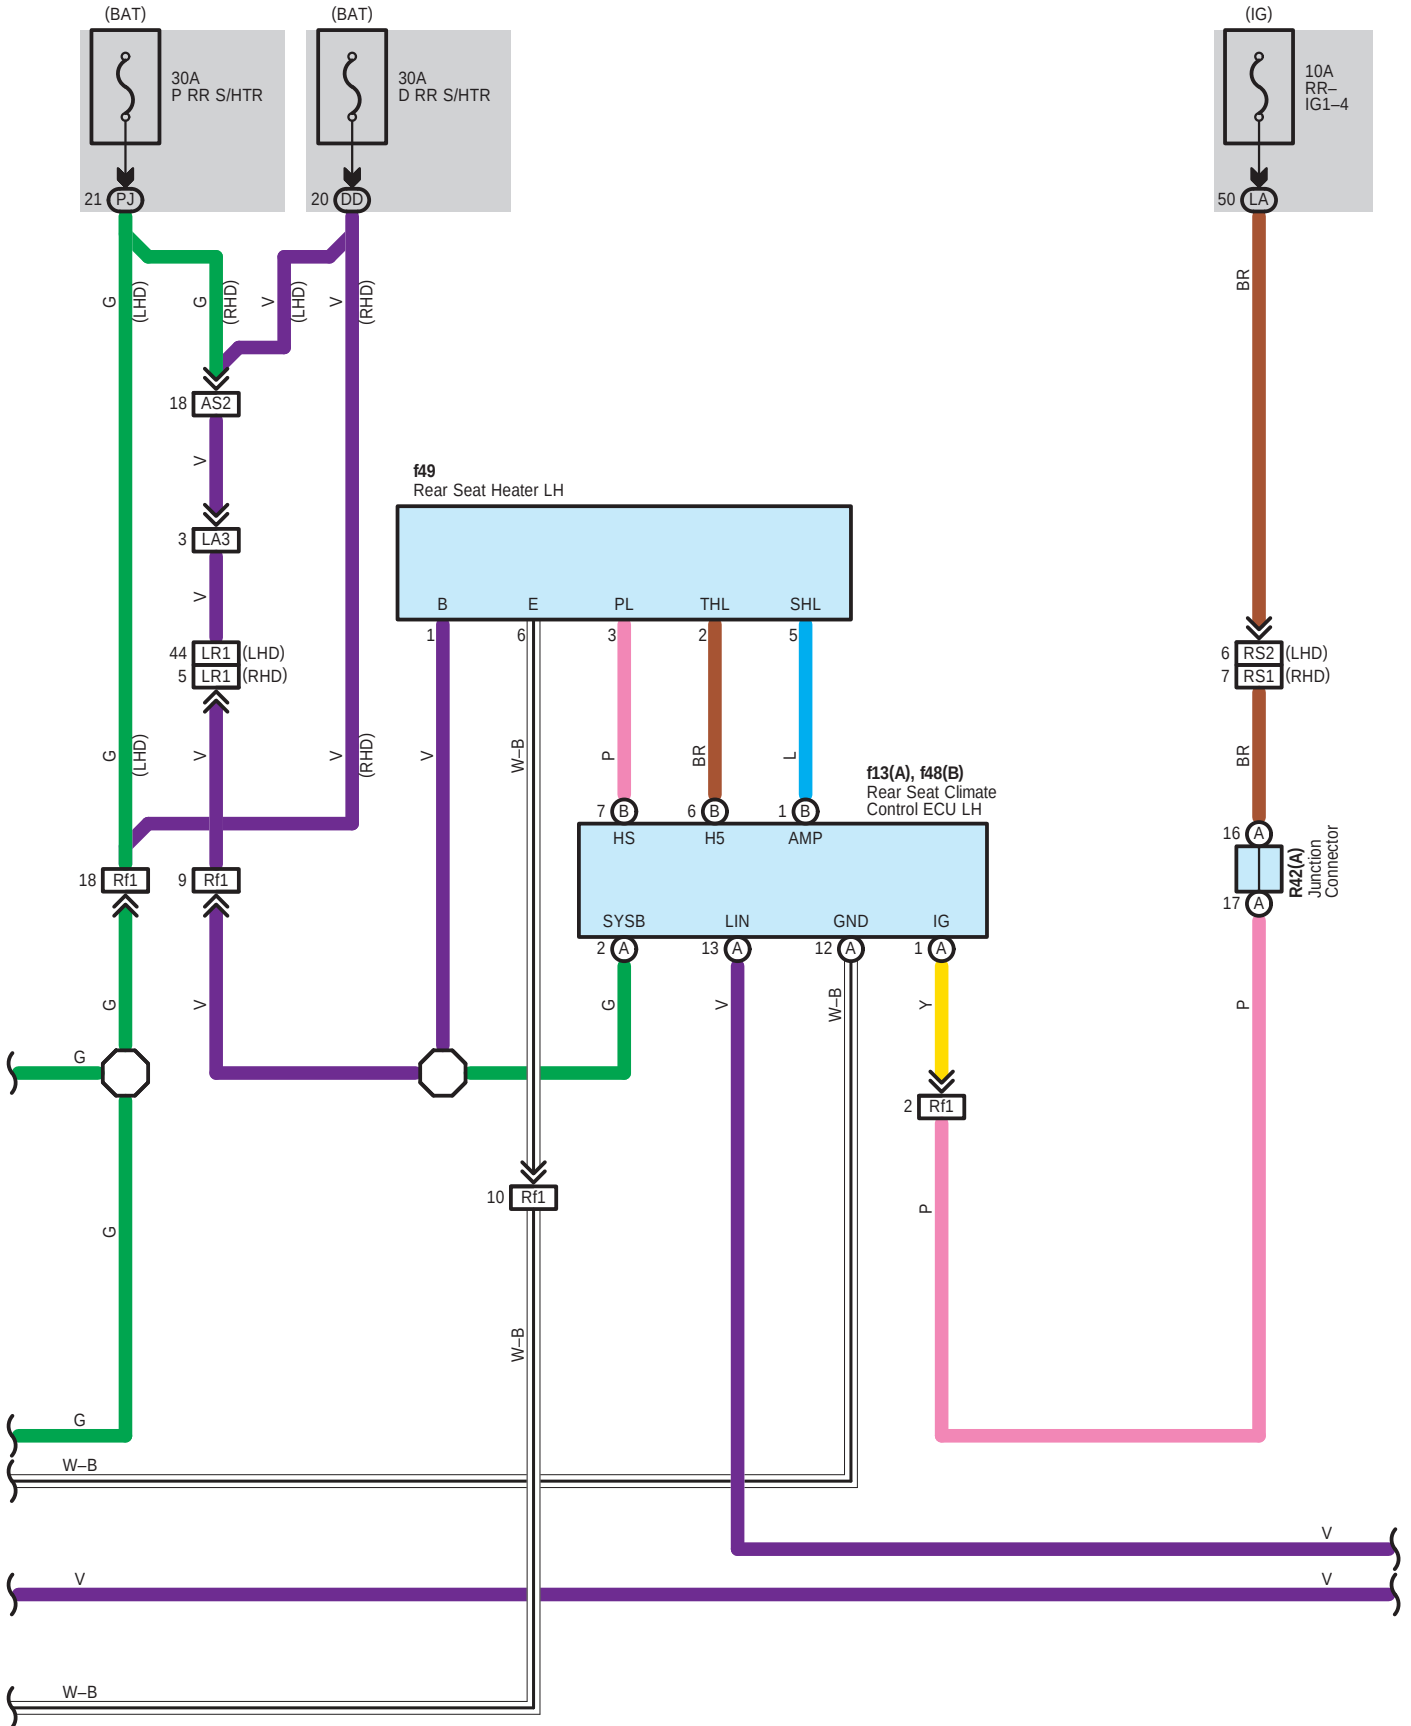
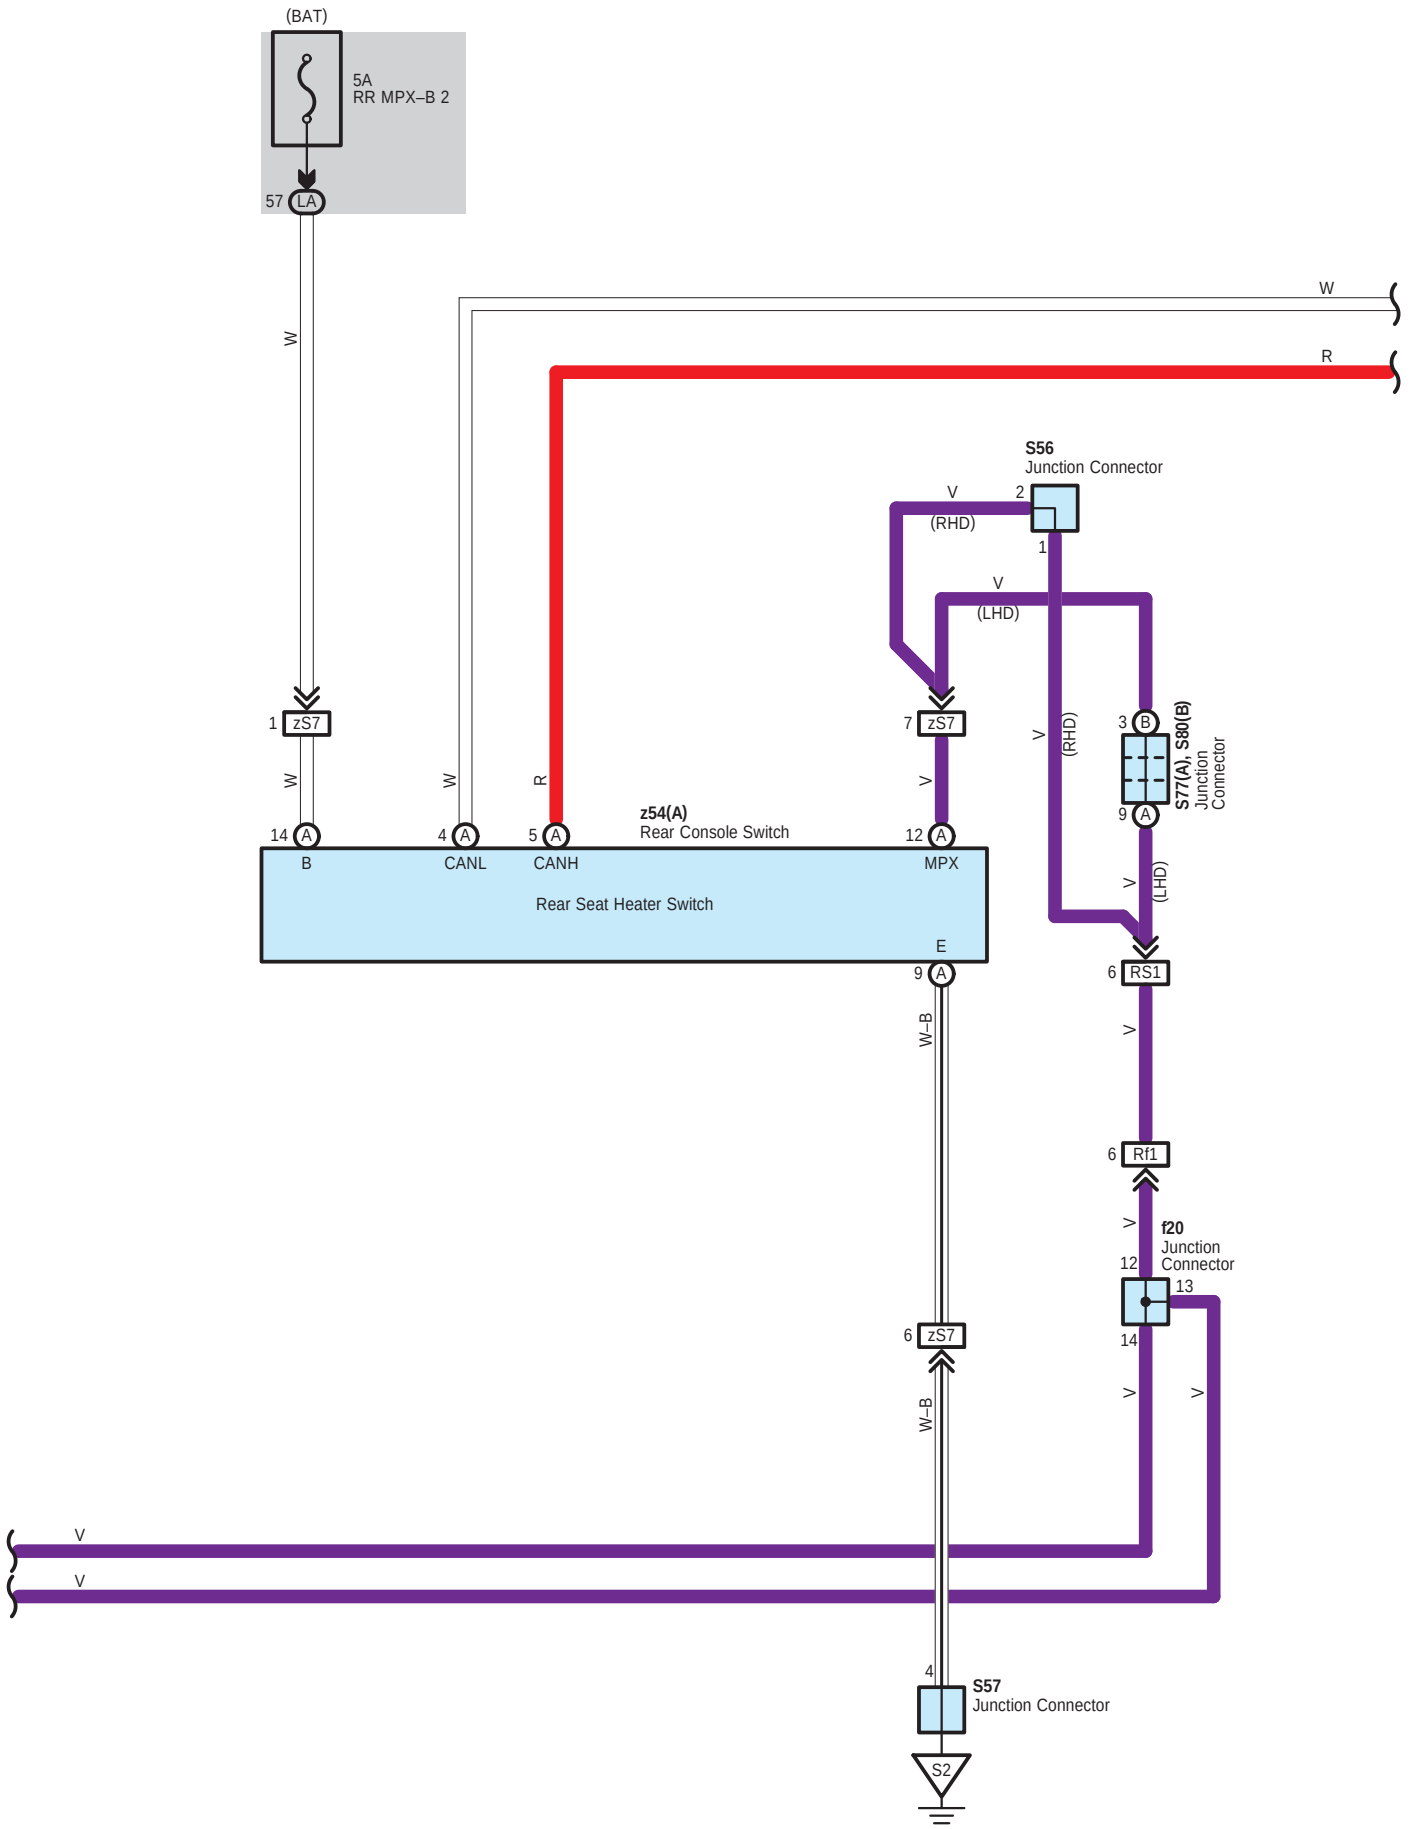
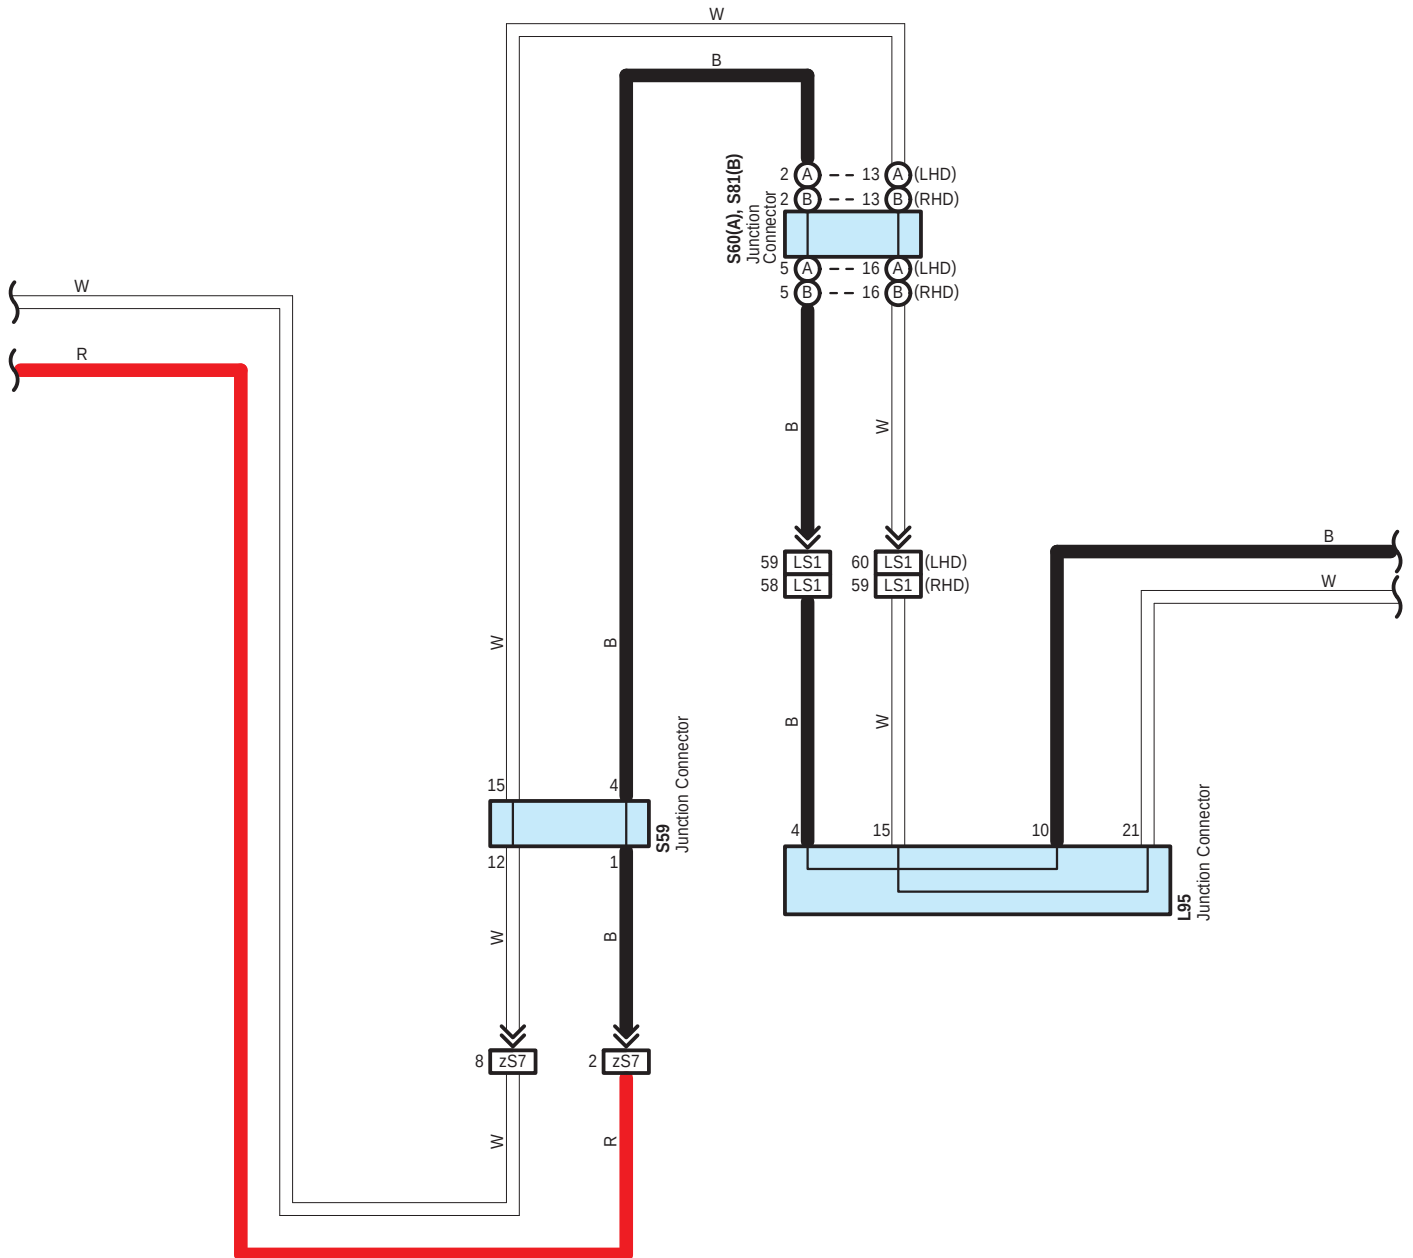
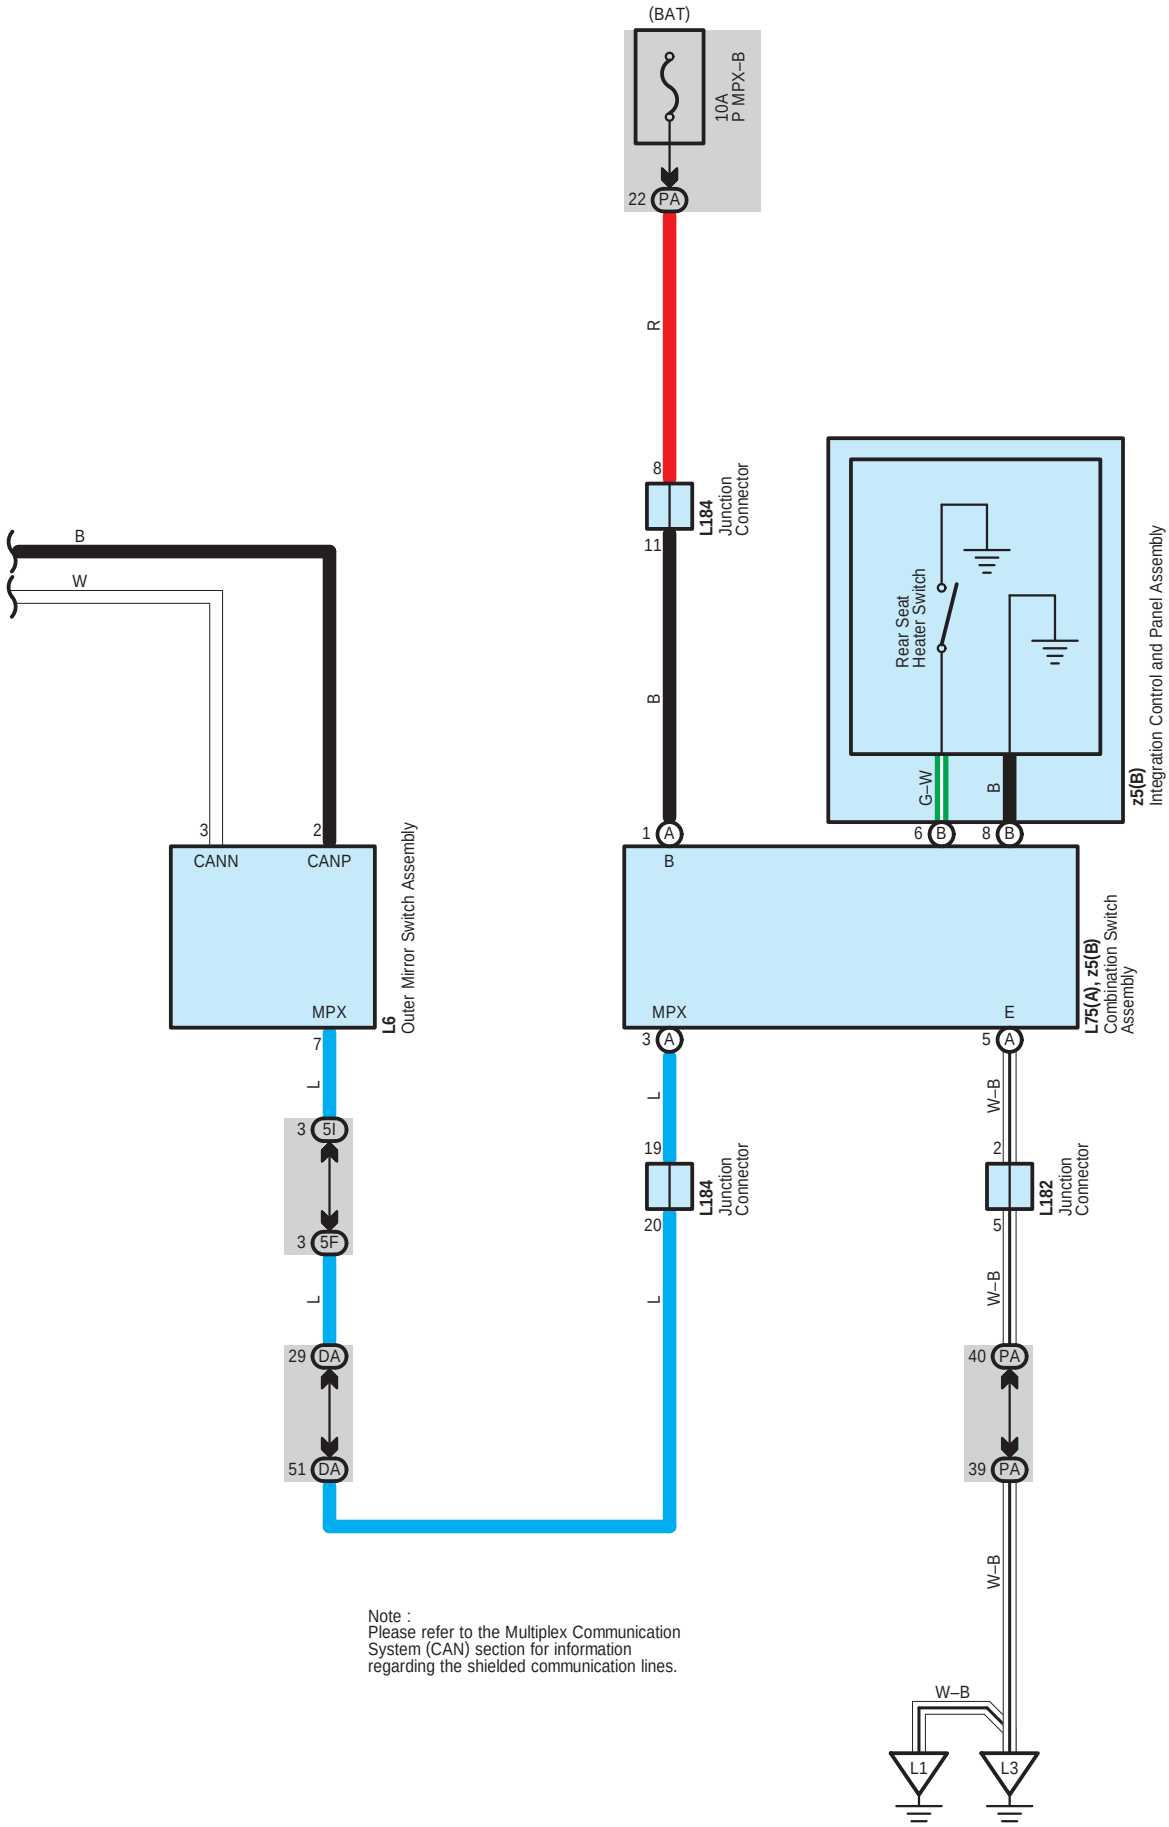
Note :  
Please refer to the Multiplex Communication System (CAN) section  
for information regarding the shielded communication lines.
