Position of Parts in Instrument Panel <LHD>

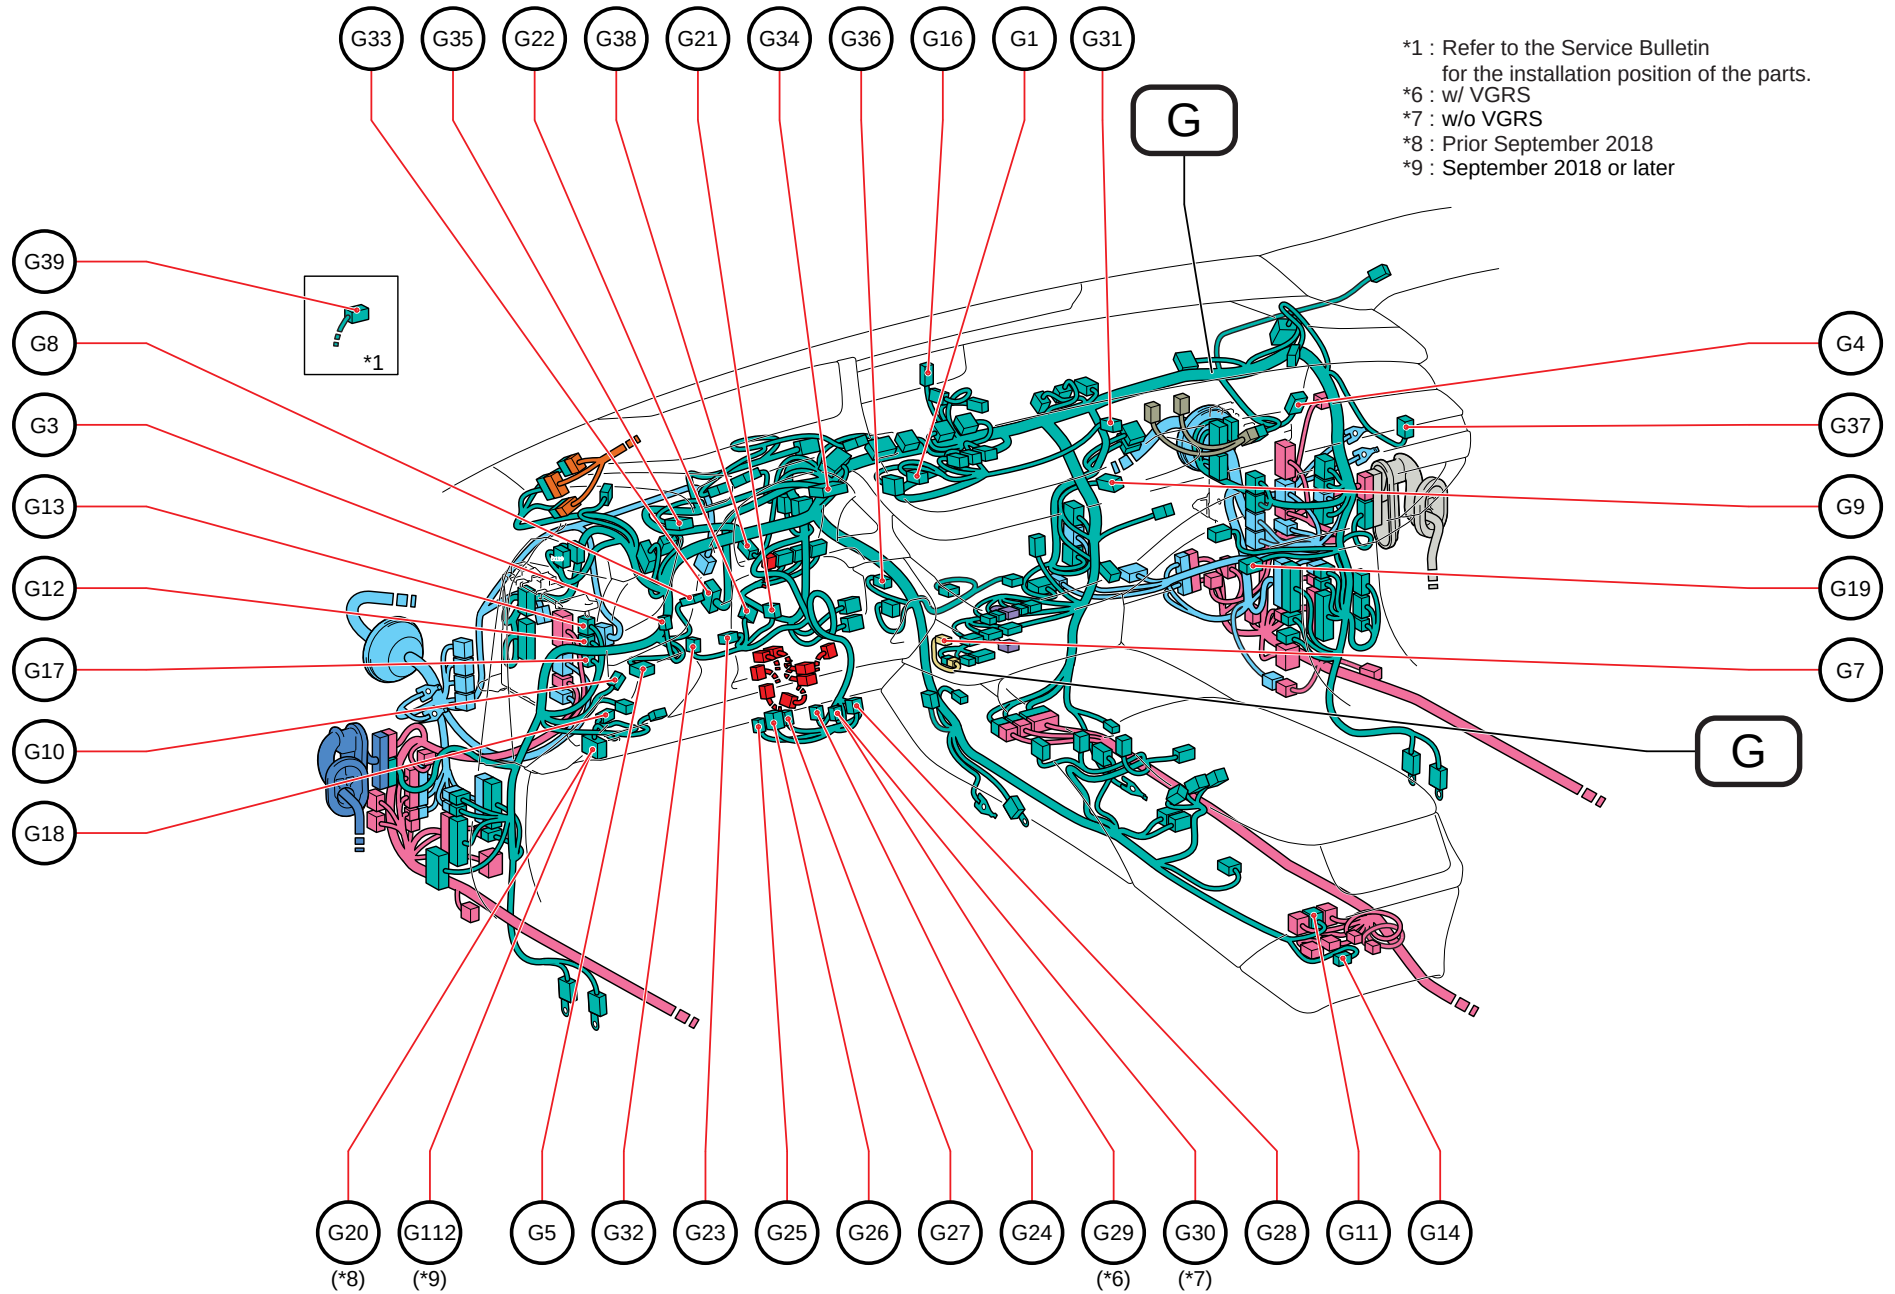
- 1 Multi-Display
- 3 No. 1 Instrument Panel Register Assembly (Driver Side)
- 4 No. 1 Instrument Panel Register Assembly (Passenger Side)
- 5 Integration Control & Panel Assembly

- 7 Brake Hold Switch
- 8 Trip Switch
- 9 Glove Box Light Assembly
- 10 Coin Box Light Assembly
- 11 Airbag ECU Assembly
- 12 Main Body ECU
- 13 Main Body ECU

- 14 Console Box Illumination Light Assembly (Console Box Wire)
- 16 Automatic Light Control Sensor
- 17 Main Body ECU
- 18 Foot Light (No. 1 Interior Illumination Light Assembly) (Driver Side)

- 19 Foot Light (No. 2 Interior Illumination Light Assembly) (Passenger Side)
- 20 Data Link Connector 3
- 21 Multiplex Tilt & Telescopic ECU
- 22 Steering Lock Actuator or Upper Bracket Assembly

- 23 Steering Column Assembly
- 24 Steering Column Assembly
- 25 Tilt & Telescopic Switch
- 26 Spiral Cable with Sensor Sub-Assembly
- 27 Spiral Cable with Sensor Sub-Assembly

- 28 Spiral Cable with Sensor Sub-Assembly
- 29 Steering Sensor
- 30 Steering Sensor
- 31 Telltale Light Assembly
- 32 Steering Column Assembly
- 33 Steering Actuator Assembly

- 34 Combination Meter Assembly
- 35 Combination Meter Assembly
- 36 Cooler (Room Temp. Sensor) Thermistor
- 37 Airbag Cut Off Switch Cylinder Sub-Assembly

- 38 No. 1 Clearance Warning Buzzer
- 39 Option Connector (DCM for Brazil)
- 112 Data Link Connector 3
