Position of Parts in Engine Compartment <RHD 3UR-FE From Sep. 2015 Production>

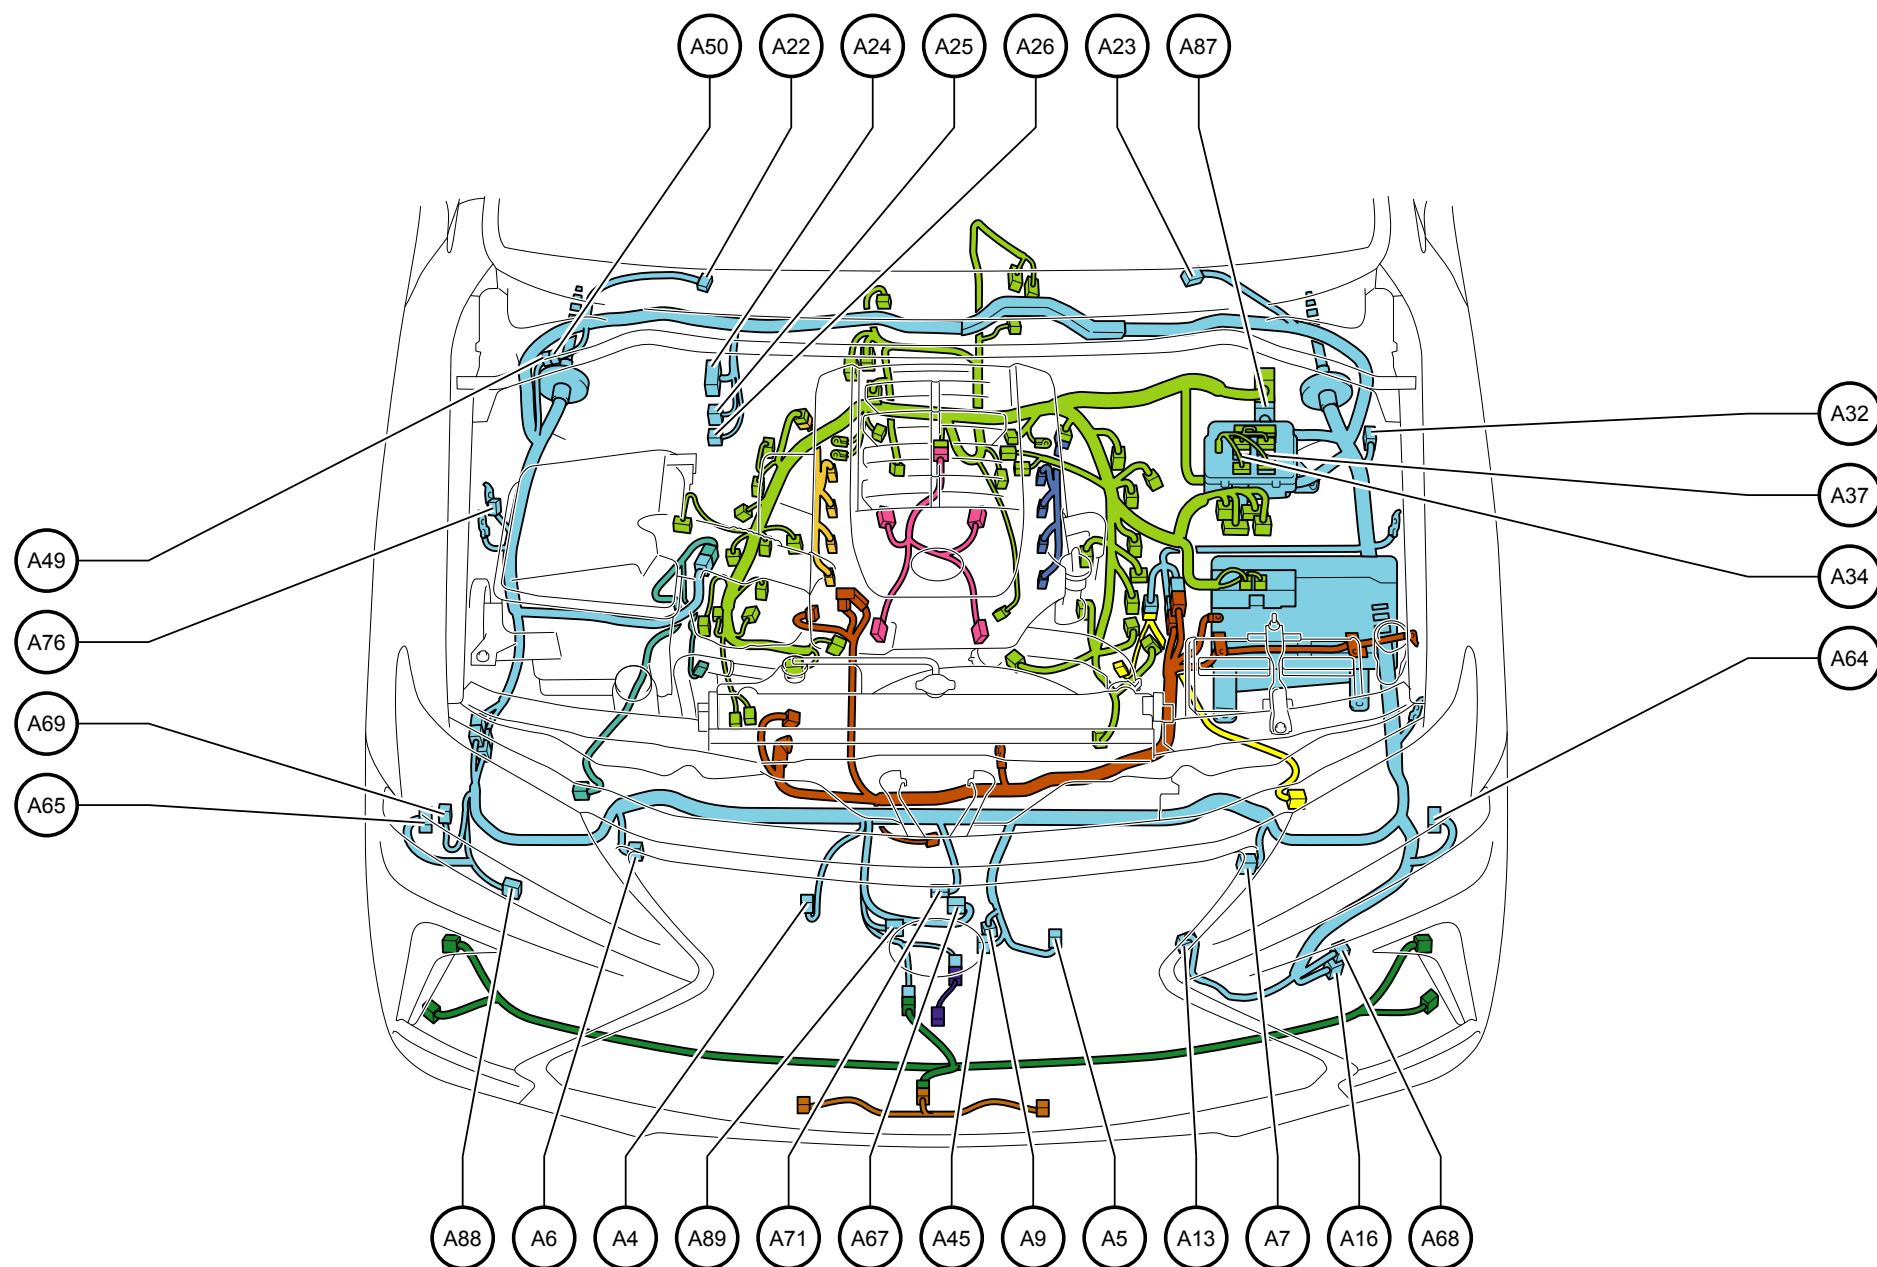
- A 4 High Pitched Horn Assembly
- A 5 Low Pitched Horn Assembly
- A 6 Front Airbag Sensor RH
- A 7 Front Airbag Sensor LH
- A 9 Condenser Blower Motor Assembly

- A 13 A/C Pressure Sensor
- A 16 Windshield Washer Motor and Pump Assembly
- A 22 Windshield Wiper Motor Assembly
- A 23 Front Wiper Deicer (Windshield Glass)

- A 24 Skid Control ECU with Actuator Assembly
- A 25 Skid Control ECU with Actuator Assembly
- A 26 Brake Fluid Level Warning Switch (Brake Master Cylinder Reservoir Assembly)

- A 32 Noise Filter
- A 34 Junction Connector
- A 37 Junction Connector
- A 45 Exhaust Gas Sensor
- A 49 Short Connector
- A 50 Short Connector
- A 64 Headlight ECU Sub-Assembly LH

- A 65 Headlight ECU Sub-Assembly RH
- A 67 Millimeter Wave Radar Sensor Assembly
- A 68 Headlight Cleaner Motor and Pump Assembly
- A 69 Wireless Door Lock Buzzer

- A 71 Hood Lock Assembly
- A 76 Junction Connector
- A 87 ECM
- A 88 Front Tire Pressure Warning Antenna
- A 89 Cooler (Ambient Temperature Sensor) Thermistor
