Position of Parts in Engine Compartment <LHD 3UR-FE Before Sep. 2015 Production>

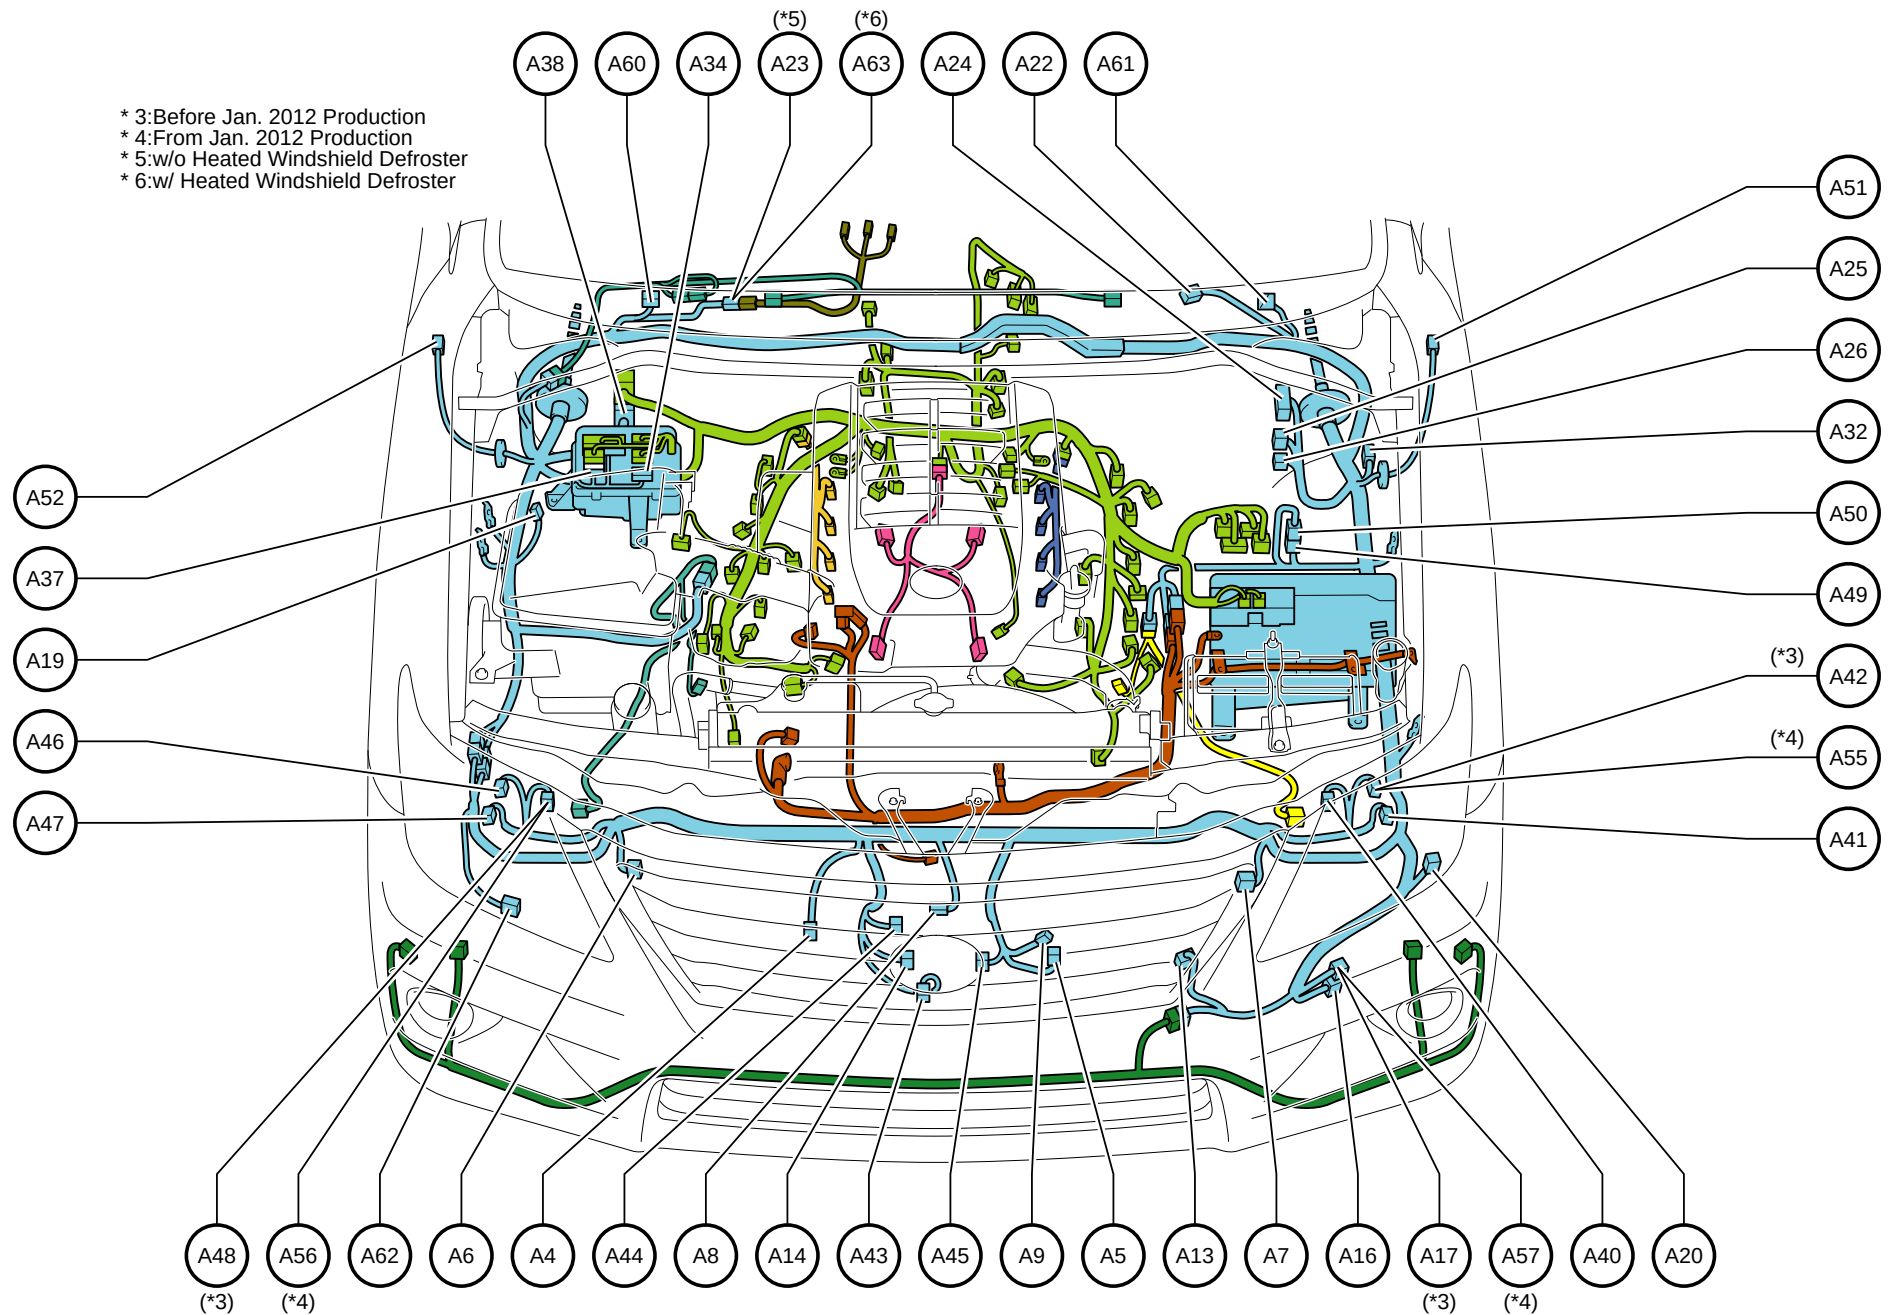
- A 4 High Pitched Horn Assembly
- A 5 Low Pitched Horn Assembly
- A 6 Front Airbag Sensor RH
- A 7 Front Airbag Sensor LH
- A 8 Engine Hood Courtesy Switch

- A 9 Condenser Blower Motor Assembly
- A 13 A/C Pressure Sensor
- A 14 Ambient Temperature Sensor
- A 16 Windshield Washer Motor and Pump Assembly
- A 17 Headlight Cleaner Control Relay and Motor

- A 19 Security Horn Assembly
- A 20 Wireless Door Lock Buzzer
- A 22 Windshield Wiper Motor Assembly
- A 23 Front Wiper Deicer (Windshield Glass)
- A 24 Skid Control ECU with Actuator Assembly

- A 25 Skid Control ECU with Actuator Assembly
- A 26 Brake Fluid Level Warning Switch (Brake Master Cylinder Reservoir Assembly)
- A 32 Noise Filter
- A 34 Junction Connector

- A 37 Junction Connector
- A 38 ECM
- A 40 Headlight Assembly LH
- A 41 Headlight Assembly LH
- A 42 Headlight Assembly LH
- A 43 Front Television Camera Assembly

- A 44 Millimeter Wave Radar Sensor Assembly
- A 45 Exhaust Gas Sensor
- A 46 Headlight Assembly RH
- A 47 Headlight Assembly RH
- A 48 Headlight Assembly RH

- A 49 Short Connector
- A 50 Short Connector
- A 51 Side Turn Signal Light Assembly LH
- A 52 Side Turn Signal Light Assembly RH
- A 55 Headlight Assembly LH

- A 56 Headlight Assembly RH
- A 57 Headlight Cleaner Control Relay and Motor
- A 60 Heated Windshield Defroster (Windshield Glass)
- A 61 Heated Windshield Defroster (Windshield Glass)

- A 62 Front Tire Pressure Warning Antenna
- A 63 Heated Windshield Defroster (Windshield Glass)
