## FRONT A/C EVAPORATOR ON-VEHICLE INSPECTION

AC1L9-01

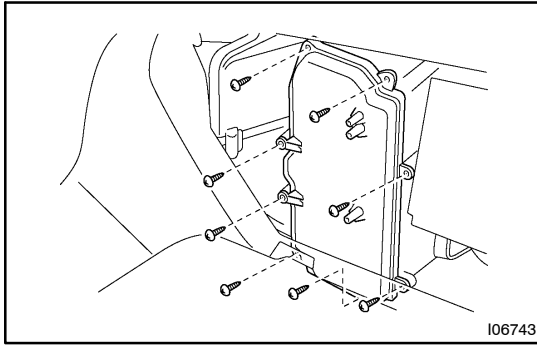
### 1. INSPECT FOR LEAKAGE OF REFRIGERANT

- (a) Remove these parts:
  - (1) Glove compartment door
  - (2) Lower No. 2 finish panel  
(See page [BO-96](#))
- (b) Remove the No. 1 cooler cover.
  - (1) Disconnect the connector clamp.
  - (2) Remove the 8 screws and cover.
