## INSPECTION

### 1. PRETENSIONER IS NOT ACTIVATED

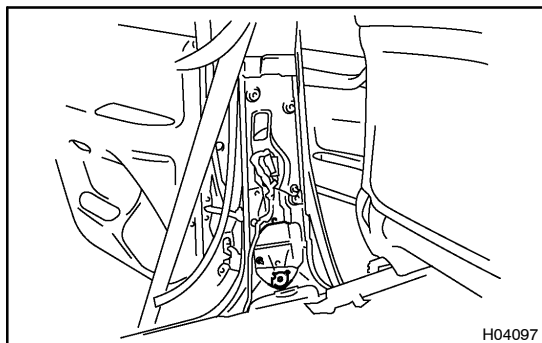
H04097

- (a) Perform a diagnostic system check.  
(See page [DI-432](#))
- (b) Perform a visual check which includes the following items with the front seat outer belt removed from the vehicle.
  - Check for cuts and cracks in, or marked discoloration of the center pillar lower garnish.
  - Check for cuts and cracks in wire harness, and for chipping in connectors.
  - Check for deformation of the center pillar.
