| <b>DTC</b> | <b>B0135/73</b> | <b>Short in P/T Squib (LH) Circuit</b> |

## CIRCUIT DESCRIPTION

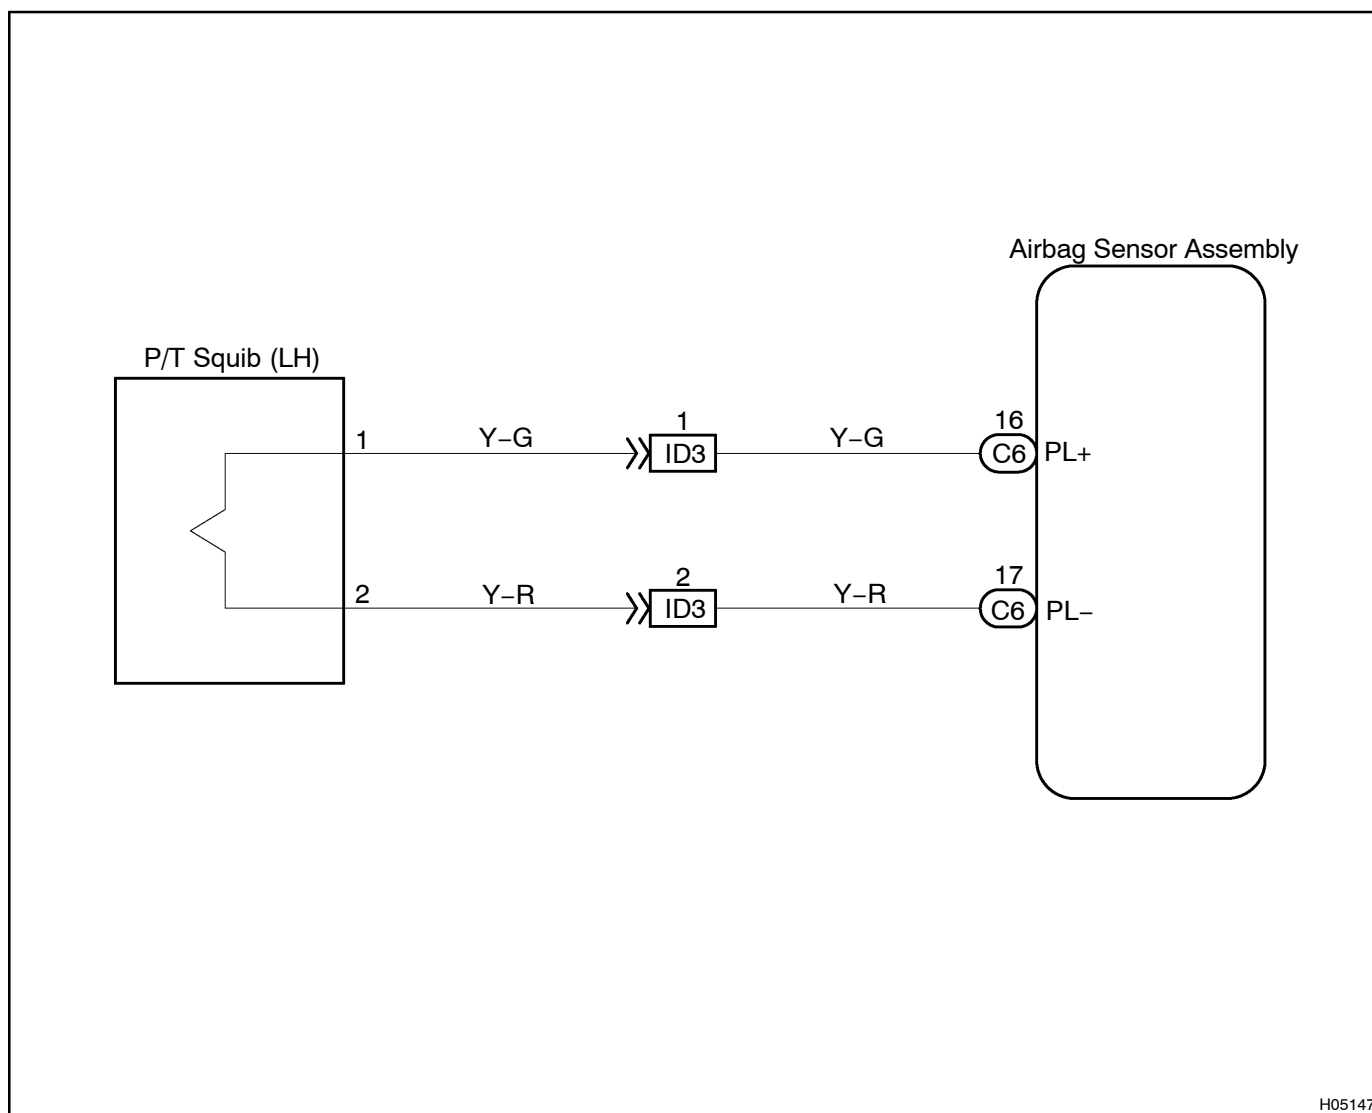
H05147

The P/T squib (LH) circuit consists of the airbag sensor assembly and seat belt pretensioner (LH). It causes the seat belt pretensioner (LH) to activate when the seat belt pretensioner (LH) activation conditions are satisfied.

## WIRING DIAGRAM

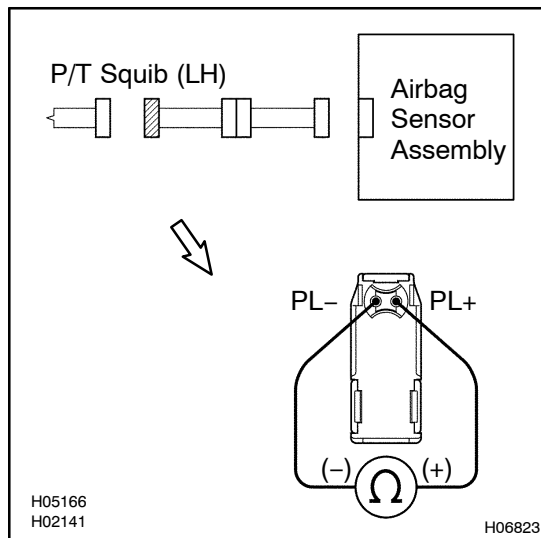
**2** Check P/T squib (LH) circuit.

Release airbag activation prevention mechanism of the connector (on the airbag sensor assembly side) between the airbag sensor assembly and the seat belt pretensioner (LH).  
(See page [DI-432](#))

For the connector (on the seat belt pretensioner side) between the seat belt pretensioner (LH) and the airbag sensor assembly, measure the resistance between PL+ and PL-.

**Resistance: 1 MΩ or Higher**

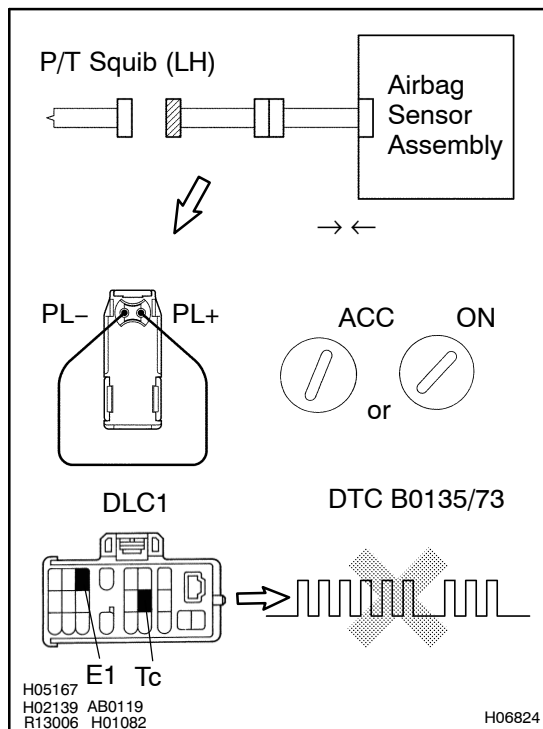
### 3 Check airbag sensor assembly.

- Connect the connector to the airbag sensor assembly.
- Using a service wire, connect PL+ and PL- of the connector (on the seat belt pretensioner side) between the airbag sensor assembly and the seat belt pretensioner (LH).
- Connect negative (-) terminal cable to the battery, and wait at least for 2 seconds.

- Turn ignition switch to ACC or ON and wait at least for 20 seconds.
- Clear DTC stored in memory.  
(See page [DI-432](#))
- Turn ignition switch to LOCK, and wait at least for 20 seconds.
- Turn ignition switch to ACC or ON, and wait at least for 20 seconds.
- Check DTC.  
(See page [DI-432](#))

**DTC B0135/73 is not output.**

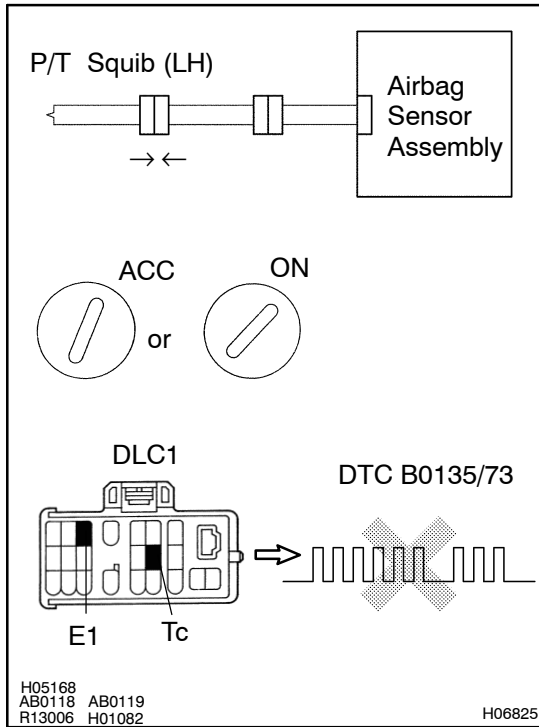
**4 Check P/T squib (LH).**

- Turn ignition switch to LOCK.
- Disconnect negative (-) terminal cable from the battery, and wait at least for 90 seconds.
- Connect the seat belt pretensioner (LH) connector.
- Connect negative (-) terminal cable to the battery, and wait at least for 2 seconds.

- Turn ignition switch to LOCK, and wait at least for 20 seconds.
- Turn ignition switch to ACC or ON, and wait at least for 20 seconds.
- Clear DTC stored in memory.  
(See page [DI-432](#))
- Turn ignition switch to LOCK, and wait at least for 20 seconds.
- Turn ignition switch to ACC or ON, and wait at least for 20 seconds.
- Check DTC.  
(See page [DI-432](#))

**OK:****DTC B0135/73 is not output.****HINT:**

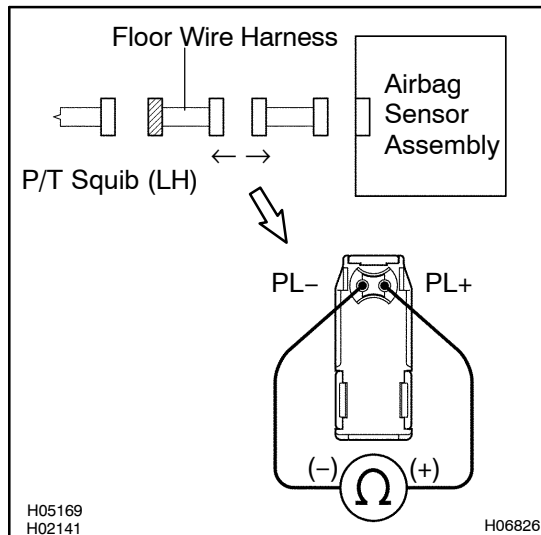
## 5 Check floor wire harness.

- Disconnect floor wire harness connector on the airbag sensor assembly side.
- Release airbag activation prevention mechanism of the floor wire harness connector on the airbag sensor assembly side. (See page [DI-432](#))

For the connector (on the floor wire harness side) between the seat belt pretensioner and the floor wire harness, measure the resistance between PL+ and PL-.

**Resistance: 1 MΩ or Higher**

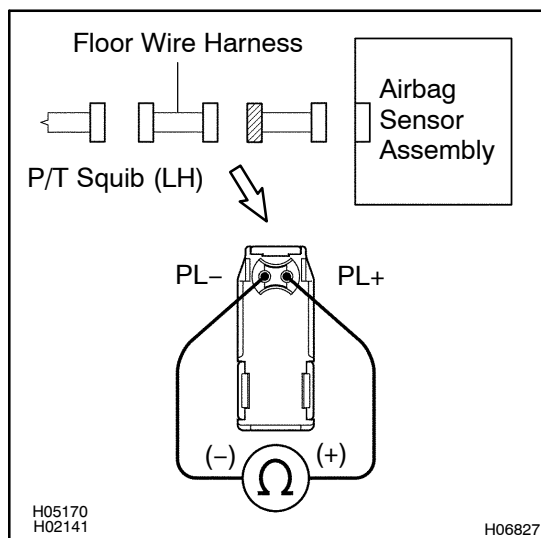
## 6 Check harness between airbag sensor assembly and floor wire harness.

Release airbag activation prevention mechanism of the airbag sensor assembly connector. (See page [DI-432](#))

For the connector (on the floor wire harness side) between the airbag sensor assembly and floor wire harness, measure the resistance between PL+ and PL-.

**Resistance: 1 MΩ or Higher**
