| <b>DTC</b> | <b>B1215 / 15</b> | <b>Door system communication bus malfunction (GND short)</b> |

## CIRCUIT DESCRIPTION

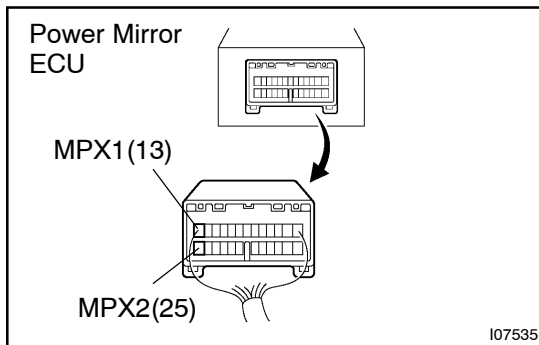
| <b>1</b> | <b>Check the communication circuit inside power mirror ECU.</b> |

### **PREPARATION:**

Disconnect the connector power mirror ECU.

Check the DTC.

Code B1215/15 is not output

**Replace the power mirror ECU.**

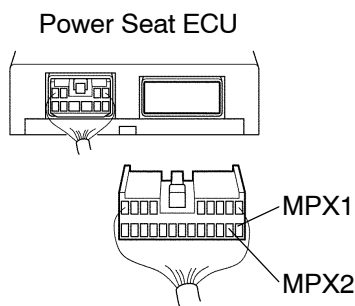
**Check for short circuit between tilt & telescopic ECU and power seat ECU.**

Disconnect the connector power seat ECU.

Check the DTC.

Code B1215/15 is not output

**OK****Repair or replace the wire harness between and tilt & telescopic ECU and power seat ECU****NG****Replace the body ECU.**
