| <b>DTC</b> | <b>B0130/63</b> | <b>Short in P/T Squib (RH) Circuit</b> |

## CIRCUIT DESCRIPTION

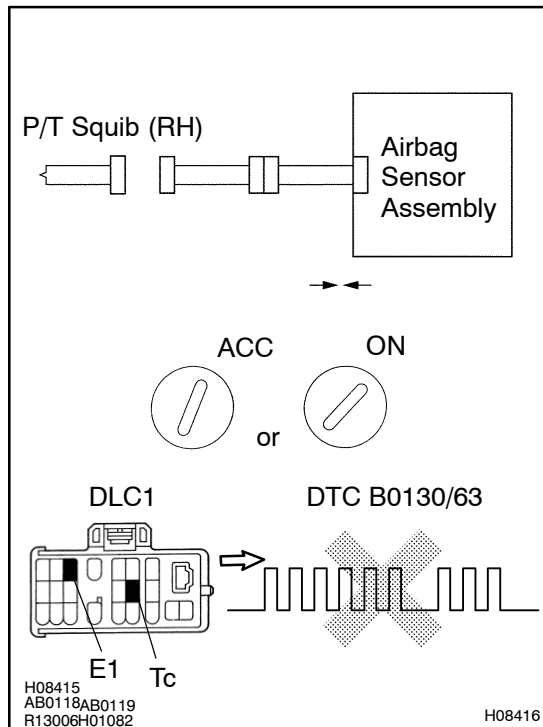
### 3 Check airbag sensor assembly.

- Connect the connector to the airbag sensor assembly.
- Connect negative (-) terminal cable to the battery, and wait at least for 2 seconds.

- Turn ignition switch to ACC or ON and wait at least for 20 seconds.
- Clear DTC stored in memory.  
(See page [DI-449](#))
- Turn ignition switch to LOCK, and wait at least for 20 seconds.
- Turn ignition switch to ACC or ON, and wait at least for 20 seconds.
- Check DTC.  
(See page [DI-449](#))

**DTC B0130/63 is not output.**

**Replace airbag sensor assembly.**
