| <b>DTC</b> | <b>B0135/73</b> | <b>Short in P/T Squib (LH) Circuit</b> |

## CIRCUIT DESCRIPTION

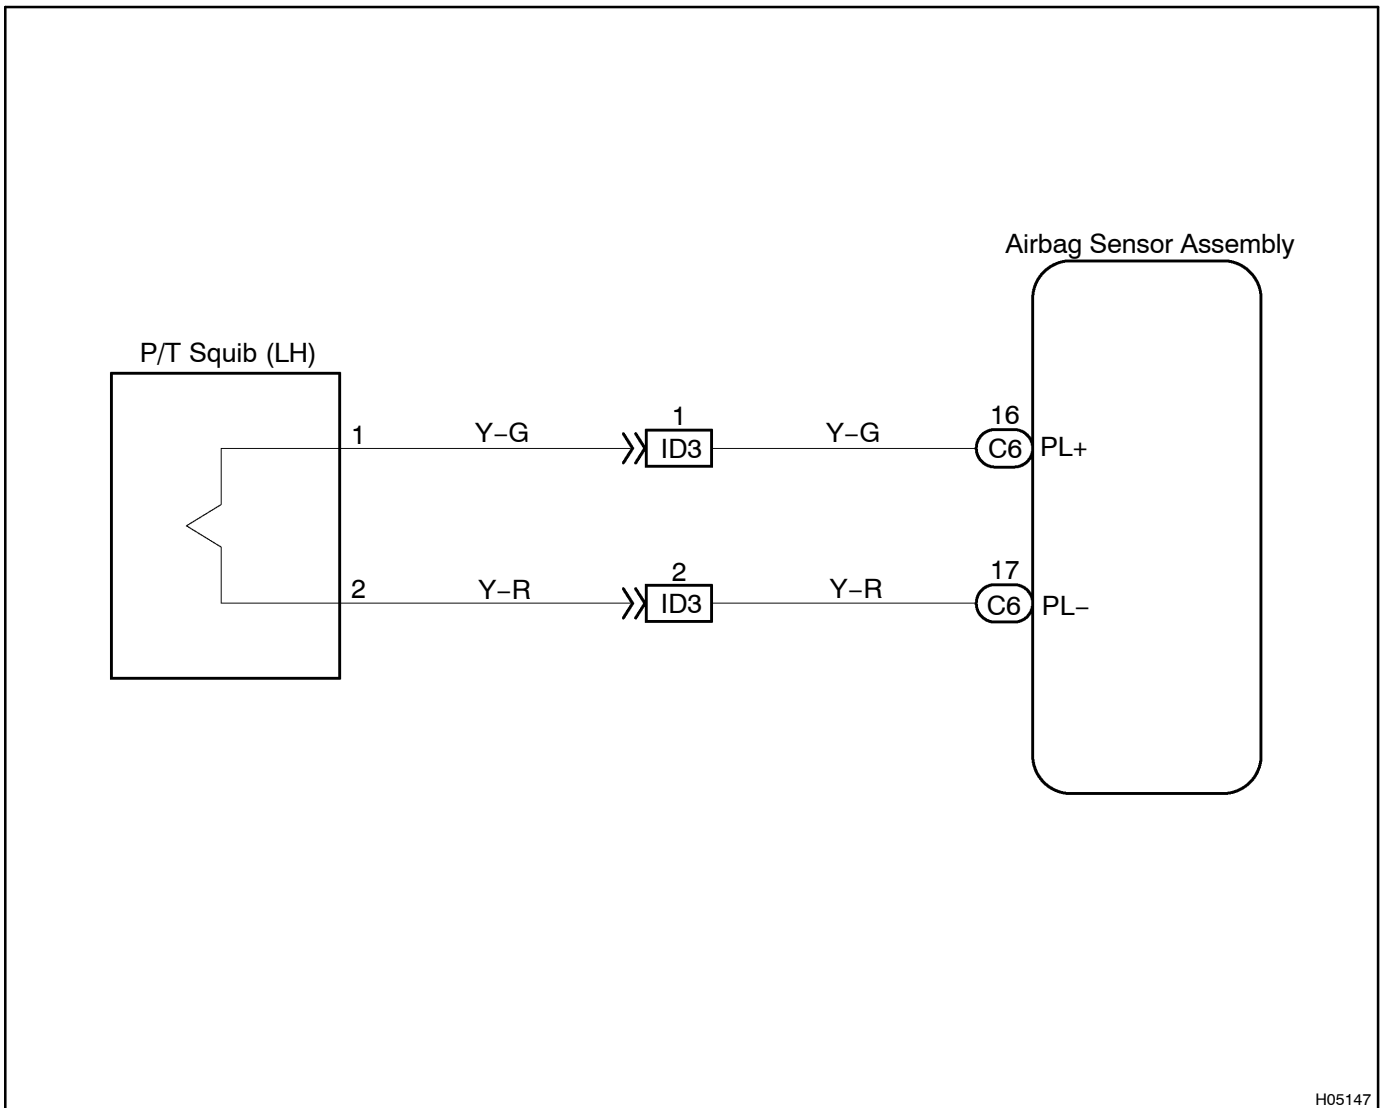
## WIRING DIAGRAM

The P/T squib (LH) circuit consists of the airbag sensor assembly and seat belt pretensioner (LH). It causes the seat belt pretensioner (LH) to activate when the seat belt pretensioner (LH) activation conditions are satisfied.

DTC B0135/73 is recorded when a short is detected in the P/T squib (LH) circuit.

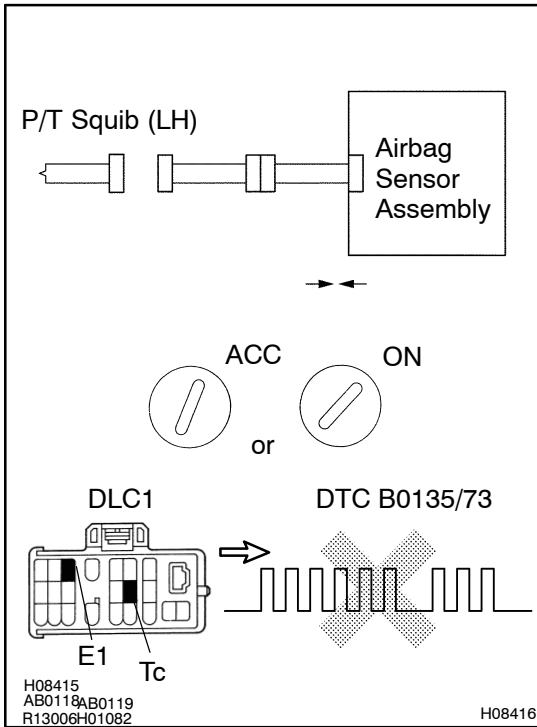
### 3 Check airbag sensor assembly.

- Connect the connector to the airbag sensor assembly.
- Connect negative (-) terminal cable to the battery, and wait at least for 2 seconds.

- Turn ignition switch to ACC or ON and wait at least for 20 seconds.
- Clear DTC stored in memory.  
(See page [DI-449](#))
- Turn ignition switch to LOCK, and wait at least for 20 seconds.
- Turn ignition switch to ACC or ON, and wait at least for 20 seconds.
- Check DTC.  
(See page [DI-449](#))

**DTC B0135/73 is not output.**

**Replace airbag sensor assembly.**

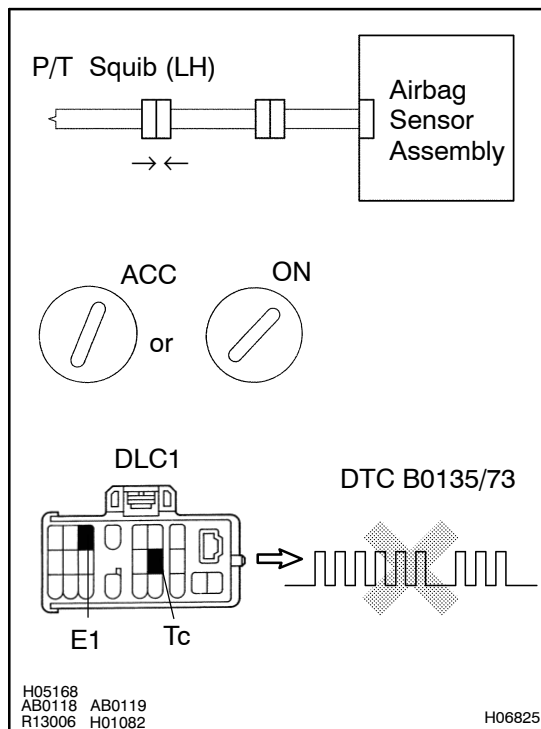
**4 Check P/T squib (LH).**

- Turn ignition switch to LOCK.
- Disconnect negative (-) terminal cable from the battery, and wait at least for 90 seconds.
- Connect the seat belt pretensioner (LH) connector.
- Connect negative (-) terminal cable to the battery, and wait at least for 2 seconds.

- Turn ignition switch to LOCK, and wait at least for 20 seconds.
- Turn ignition switch to ACC or ON, and wait at least for 20 seconds.
- Clear DTC stored in memory.  
(See page [DI-449](#))
- Turn ignition switch to LOCK, and wait at least for 20 seconds.
- Turn ignition switch to ACC or ON, and wait at least for 20 seconds.
- Check DTC.  
(See page [DI-449](#))

**OK:****DTC B0135/73 is not output.****HINT:**

**NG****Replace seat belt pretensioner (LH).****OK**
