| <b>DTC</b> | <b>B1215 / 15</b> | <b>Door system communication bus malfunction (GND short)</b> |

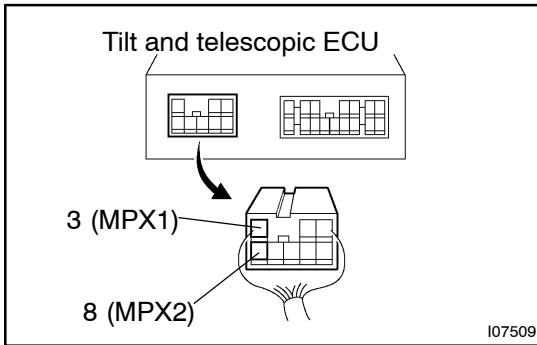
## 2 Check the communication circuit inside tilt and telescopic ECU.

- (a) Connect the connector power mirror ECU.
- (b) Disconnect the connector tilt and telescopic ECU.

Check the DTC.

Code B1215/15 is not output

Replace the tilt and telescopic ECU.

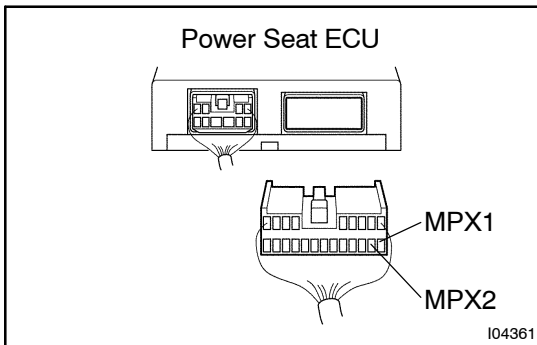
## 3 Check the communication circuit inside power seat ECU.

- (a) Connect the connector tilt and telescopic ECU.
- (b) Disconnect the connector power seat ECU.

Check the DTC.

Code B1215/15 is not output

Replace the power seat ECU.

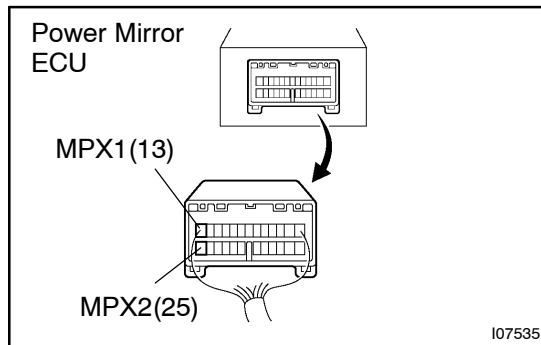
#### 4 Check for short circuit between body ECU and power mirror ECU.

Disconnect the connector power mirror ECU.

Check the DTC.

Code B1215/15 is not output

Repair or replace the wire harness between body ECU and power mirror ECU.

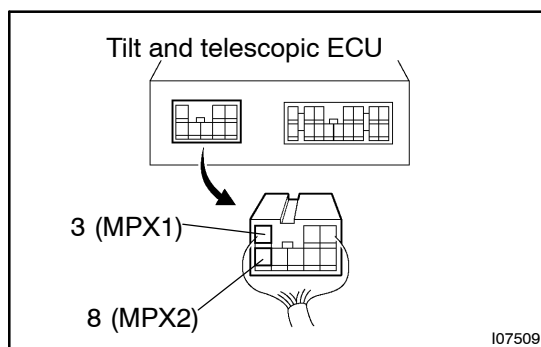
#### 5 Check for short circuit between power mirror ECU and tilt & telescopic ECU.

Disconnect the connector tilt & telescopic ECU.

Check the DTC.

Code B1215/15 is not output

Repair or replace the wire harness between power mirror ECU and tilt & telescopic ECU.

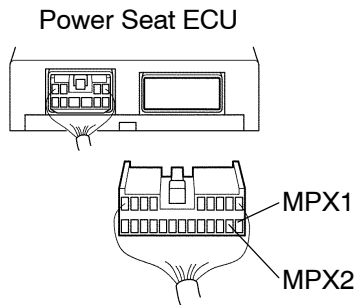
**6****Check for short circuit between tilt & telescopic ECU and power seat ECU.**

Disconnect the connector power seat ECU.

Check the DTC.

Code B1215/15 is not output

**OK****Repair or replace the wire harness between and tilt & telescopic ECU and power seat ECU****NG****Replace the body ECU.**
