| <b>DTC</b> | <b>B0130/63</b> | <b>Short in P/T Squib (RH) Circuit</b> |

## CIRCUIT DESCRIPTION

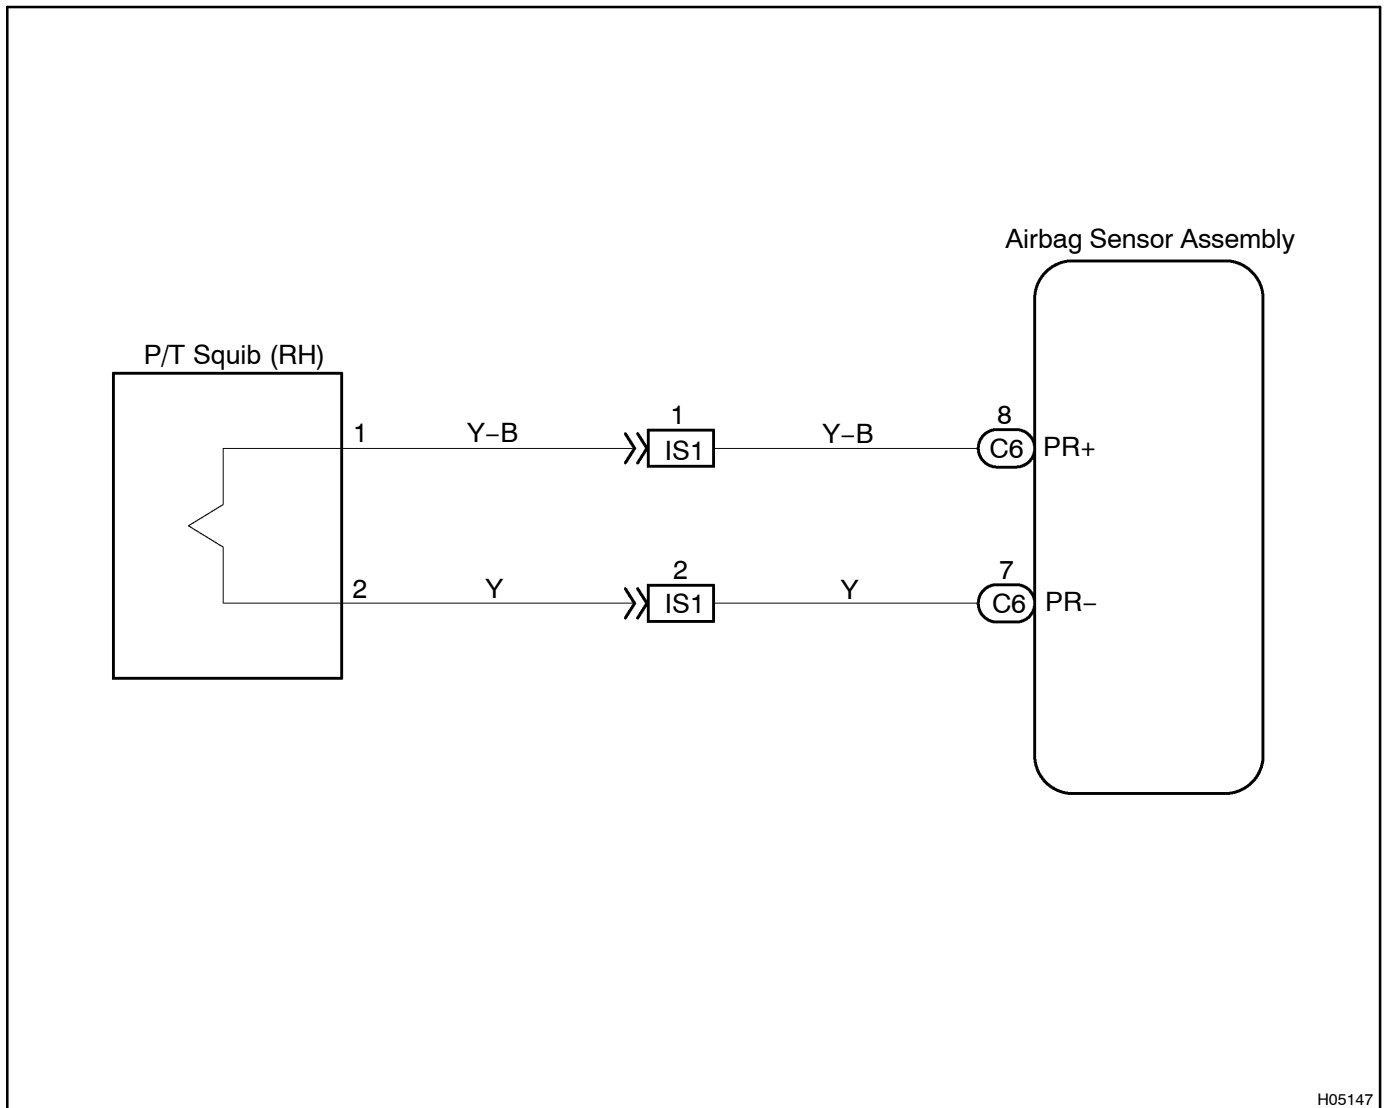
H05147

The P/T squib (RH) circuit consists of the airbag sensor assembly and seat belt pretensioner (RH). It causes the seat belt pretensioner (RH) to activate when the seat belt pretensioner (RH) activation conditions are satisfied.

DTC B0130/63 is recorded when a short is detected in the P/T squib (RH) circuit.
