| <b>DTC</b> | <b>B0135/73</b> | <b>Short in P/T Squib (LH) Circuit</b> |

## CIRCUIT DESCRIPTION

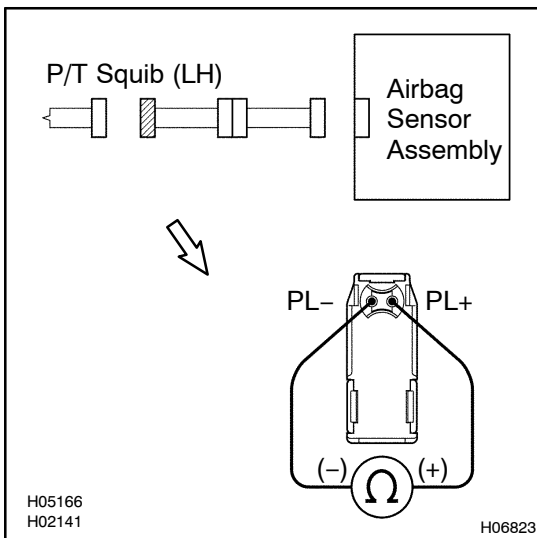
**2** Check P/T squib (LH) circuit.

Release the airbag activation prevention mechanism of the connector (on the airbag sensor assembly side) between the airbag sensor assembly and the seat belt pretensioner (LH). (See page [DI-490](#))

For the connector (on the seat belt pretensioner side) between the seat belt pretensioner (LH) and the airbag sensor assembly, measure the resistance between PL+ and PL-.

**Resistance: 1 MΩ or Higher**

**Go to step 5.**

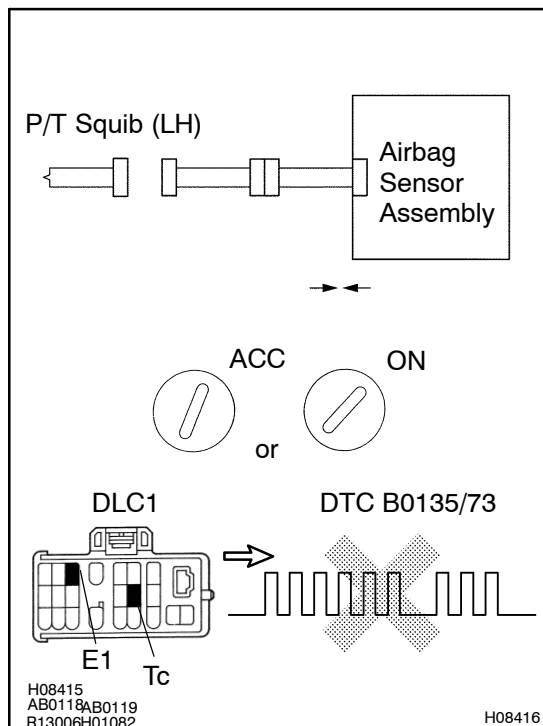
### 3 Check airbag sensor assembly.

- Connect the connector to the airbag sensor assembly.
- Connect negative (-) terminal cable to the battery, and wait at least for 2 seconds.

- Turn ignition switch to ACC or ON and wait at least for 20 seconds.
- Clear DTC stored in memory.  
(See page [DI-490](#))
- Turn ignition switch to LOCK, and wait at least for 20 seconds.
- Turn ignition switch to ACC or ON, and wait at least for 20 seconds.
- Check DTC.  
(See page [DI-490](#))

**DTC B0135/73 is not output.**

**Replace airbag sensor assembly.**
