| <b>DTC</b> | <b>C1242 / 42</b> | <b>IG2 Power Source Circuit</b> |

## CIRCUIT DESCRIPTION

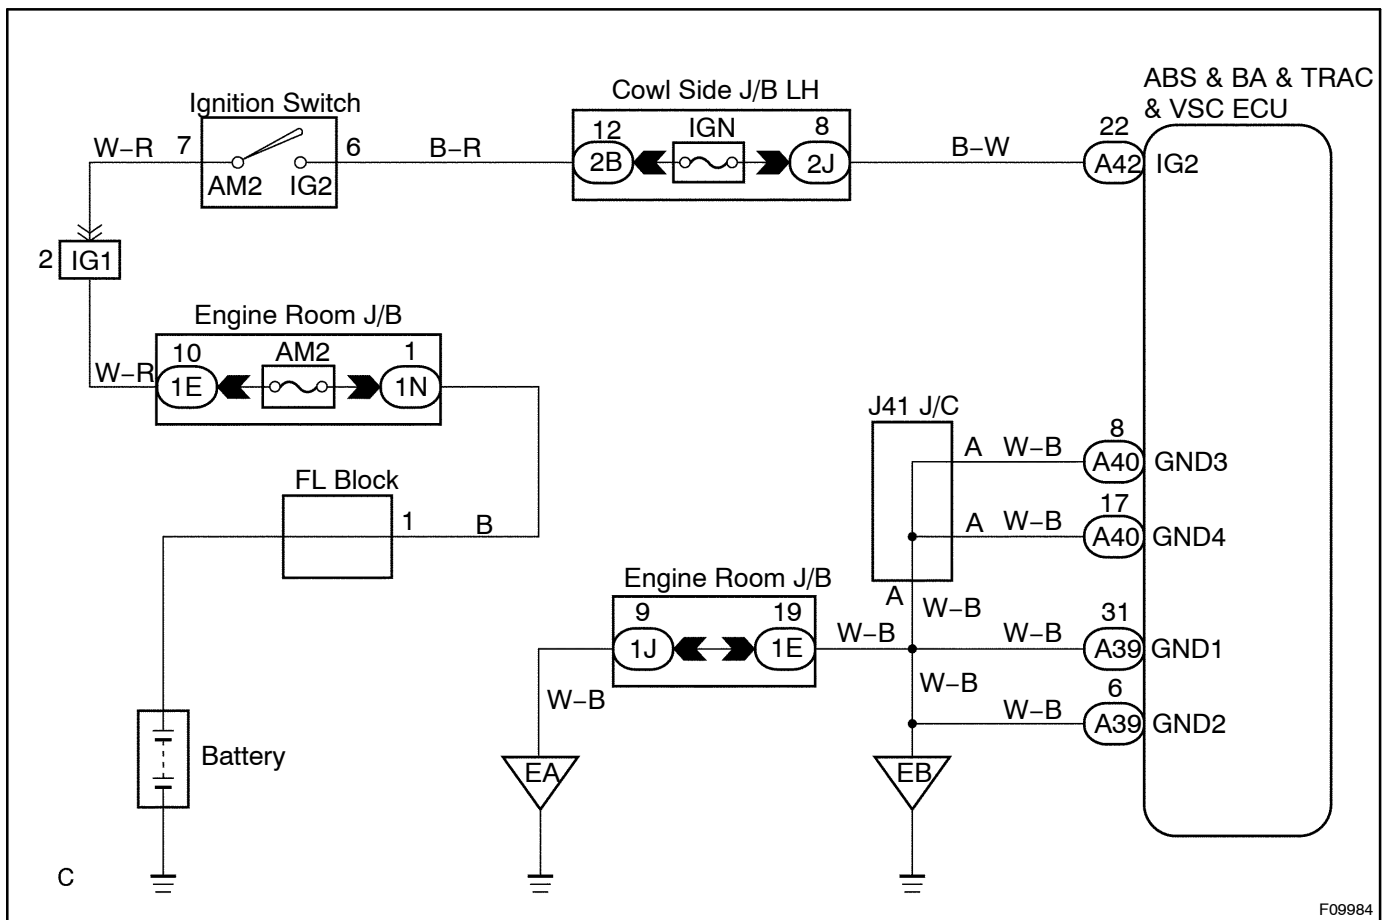
F09984

## WIRING DIAGRAM

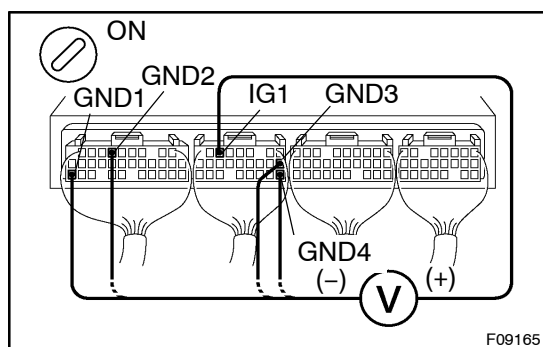
In case of not using the LEXUS hand-held tester:

PREPARATION:

Remove the ABS &amp; BA &amp; TRAC &amp; VSC ECU with connectors still connected.

CHECK:

- (a) Turn the ignition switch ON.
- (b) Measure voltage between terminals IG2 and GND of ABS & BA & TRAC & VSC ECU connector.

OK:

Voltage: 10 – 14 V

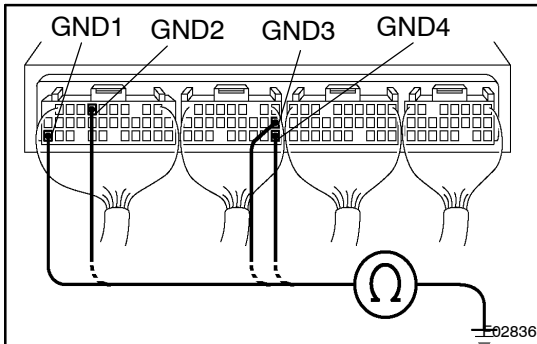
**3 Check continuity between terminal GND of ABS & BA & TRAC & VSC ECU connector and body ground.**

Measure resistance between terminal GND of ABS & BA & TRAC & VSC ECU connector and body ground.

**Resistance: 1 Ω or less**

**Repair or replace harness or connector.**
