| <b>DTC</b> | <b>47</b> | <b>Rear Air Mix Damper Control Servomotor Circuit</b> |

## CIRCUIT DESCRIPTION

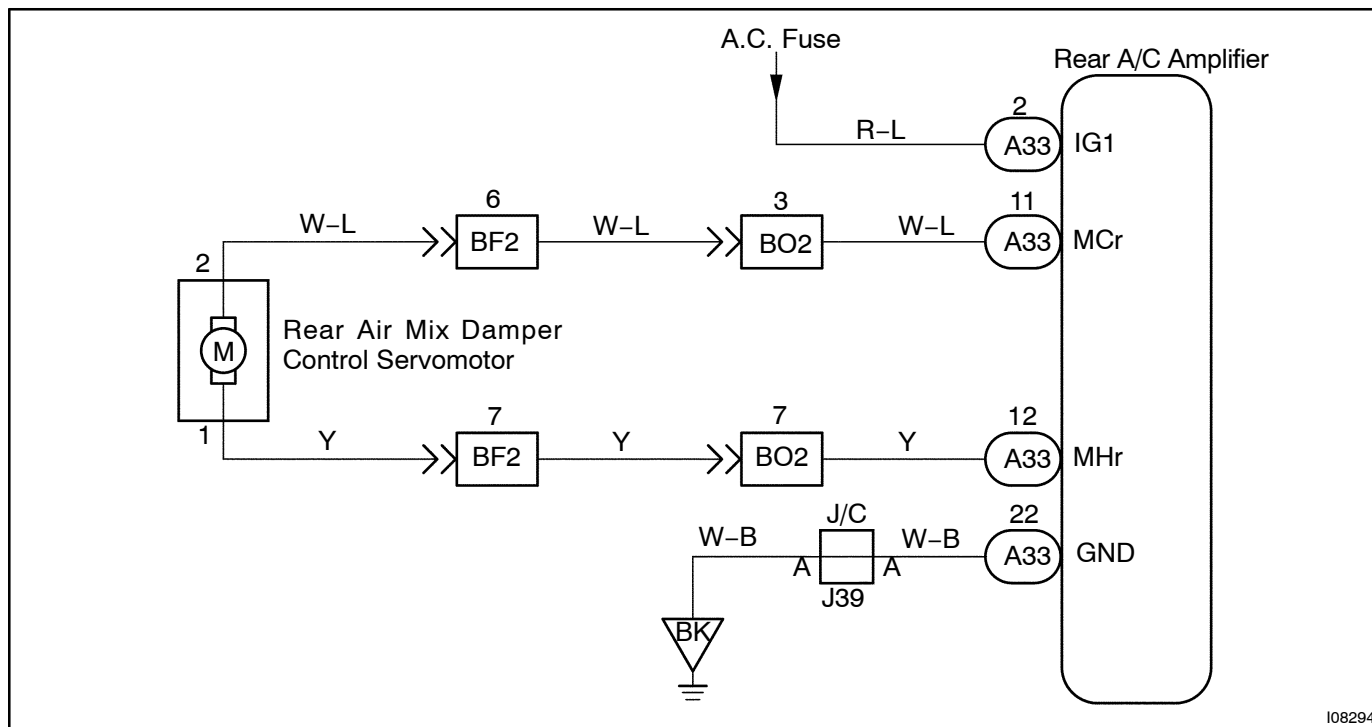
I08294

The rear air mix damper control servomotor is controlled by the A/C control assembly and moves the air mix damper to the desired position.

## WIRING DIAGRAM

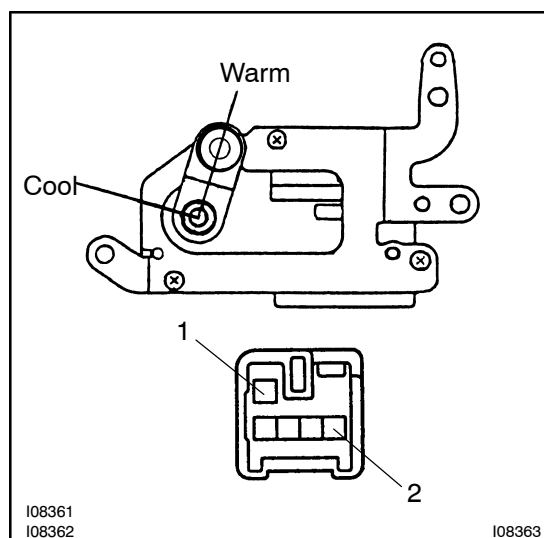
| 2 | <b>Check rear air mix damper control servomotor.</b> |

Connect positive (+) lead to terminal 1 and negative (-) lead to terminal 2.

The lever turns smoothly to Warm side.

Connect positive (+) lead to terminal 2 and negative (-) lead to terminal 1.

The lever turns smoothly to Cool side.

Replace rear air mix damper control servomotor assembly.
