| <b>DTC</b> | <b>B0130/63</b> | <b>Short in P/T Squib (RH) Circuit</b> |

## CIRCUIT DESCRIPTION

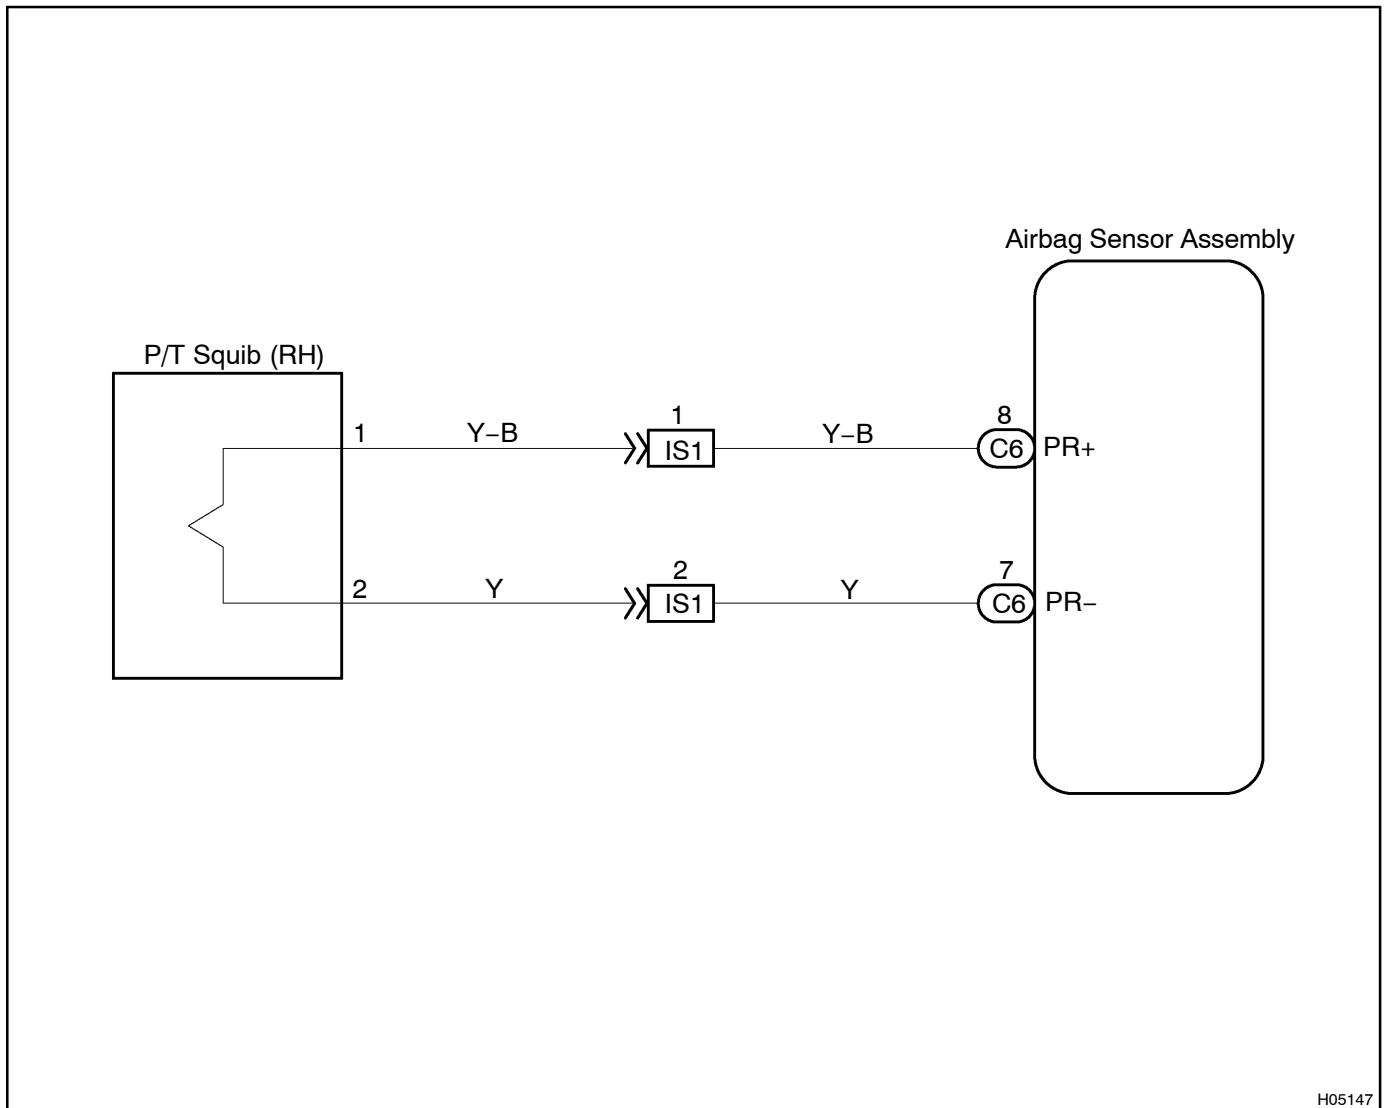
H05147

The P/T squib (RH) circuit consists of the airbag sensor assembly and seat belt pretensioner (RH). It causes the seat belt pretensioner (RH) to activate when the seat belt pretensioner (RH) activation conditions are satisfied.

## WIRING DIAGRAM

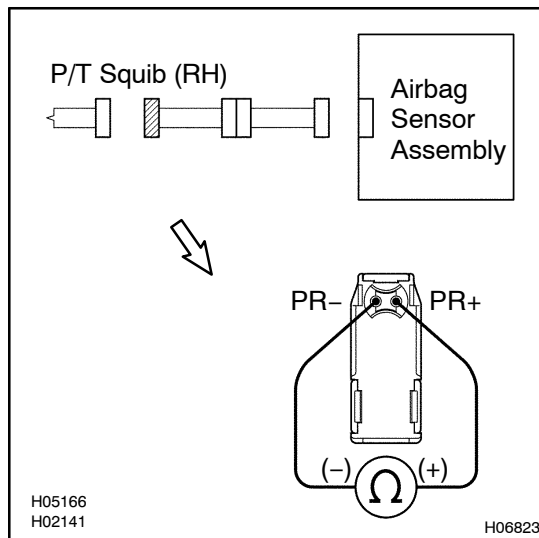
**2** Check P/T squib (RH) circuit.

Release the airbag activation prevention mechanism of the connector (on the airbag sensor assembly side) between the airbag sensor assembly and the seat belt pretensioner (RH). (See page [DI-494](#))

For the connector (on the seat belt pretensioner side) between the seat belt pretensioner (RH) and the airbag sensor assembly, measure the resistance between PR+ and PR-.

**Resistance: 1 MΩ or Higher**

**Go to step 5.**

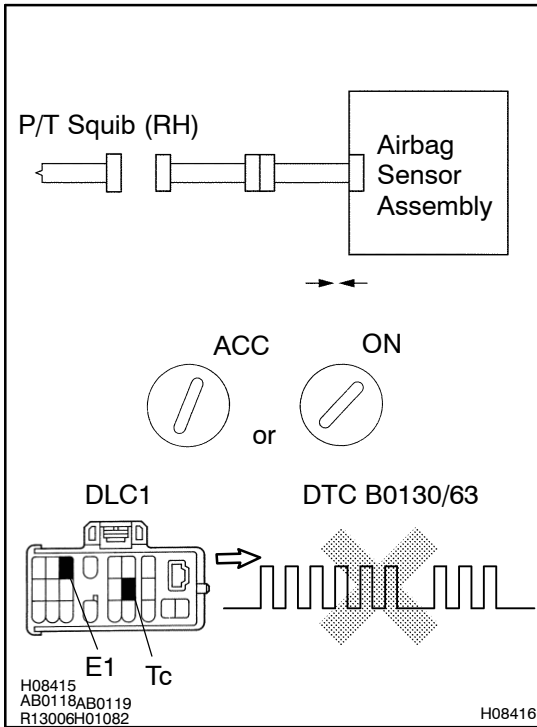
### 3 Check airbag sensor assembly.

- Connect the connector to the airbag sensor assembly.
- Connect negative (-) terminal cable to the battery, and wait at least for 2 seconds.

- Turn ignition switch to ACC or ON and wait at least for 20 seconds.
- Clear DTC stored in memory.  
(See page [DI-494](#))
- Turn ignition switch to LOCK, and wait at least for 20 seconds.
- Turn ignition switch to ACC or ON, and wait at least for 20 seconds.
- Check DTC.  
(See page [DI-494](#))

**DTC B0130/63 is not output.**

**Replace airbag sensor assembly.**

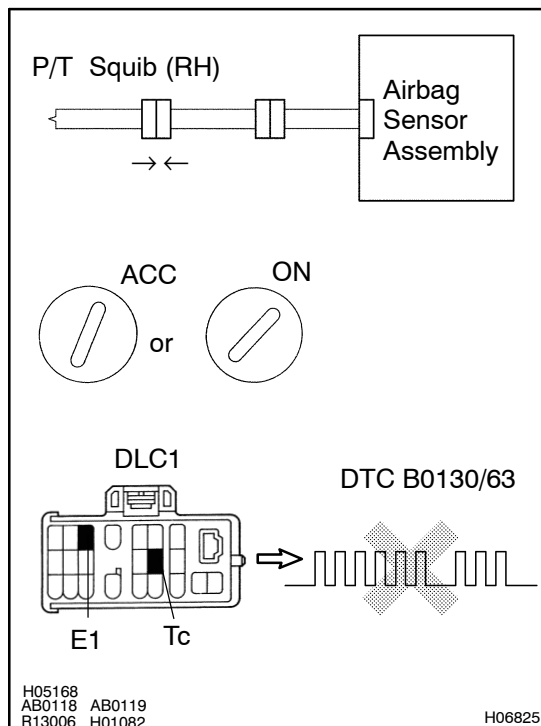
#### 4 Check P/T squib (RH).

- Turn ignition switch to LOCK.
- Disconnect negative (-) terminal cable from the battery, and wait at least for 90 seconds.
- Connect the seat belt pretensioner (RH) connector.
- Connect negative (-) terminal cable to the battery, and wait at least for 2 seconds.

- Turn ignition switch to LOCK, and wait at least for 20 seconds.
- Turn ignition switch to ACC or ON, and wait at least for 20 seconds.
- Clear DTC stored in memory.  
(See page [DI-494](#))
- Turn ignition switch to LOCK, and wait at least for 20 seconds.
- Turn ignition switch to ACC or ON, and wait at least for 20 seconds.
- Check DTC.  
(See page [DI-494](#))

**DTC B0130/63 is not output.**

**Replace seat belt pretensioner (RH).**
