| <b>DTC</b> | <b>B1215 / 15</b> | <b>Door system communication bus malfunction (GND short)</b> |

## CIRCUIT DESCRIPTION

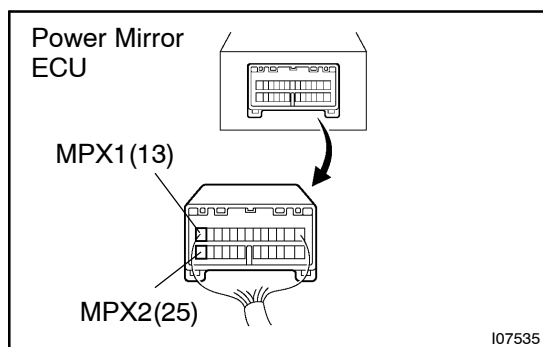
| <b>1</b> | <b>Check the communication circuit inside power mirror ECU.</b> |

Disconnect the connector power mirror ECU.

Check the DTC.

Code B1215/15 is not output

**Replace the power mirror ECU.**

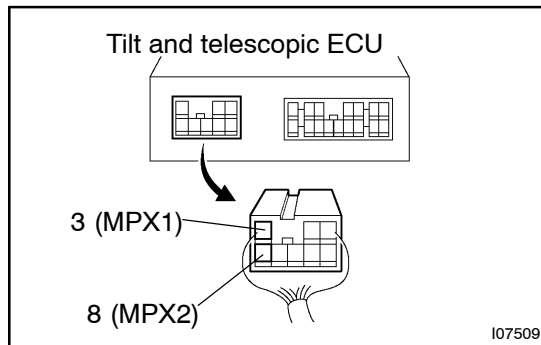
## 2 Check the communication circuit inside tilt and telescopic ECU.

- (a) Connect the connector power mirror ECU.
- (b) Disconnect the connector tilt and telescopic ECU.

Check the DTC.

Code B1215/15 is not output

Replace the tilt and telescopic ECU.

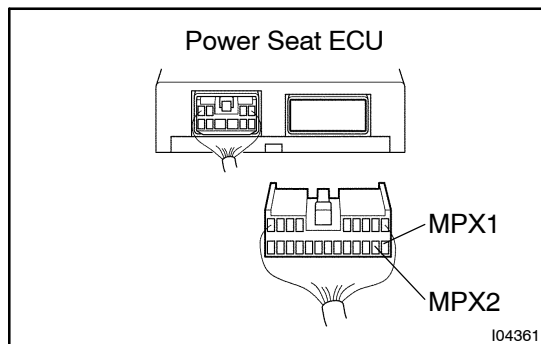
## 3 Check the communication circuit inside power seat ECU.

- (a) Connect the connector tilt and telescopic ECU.
- (b) Disconnect the connector power seat ECU.

Check the DTC.

Code B1215/15 is not output

Replace the power seat ECU.

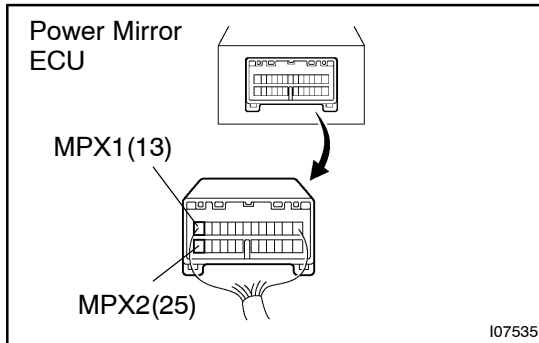
#### 4 Check for short circuit between body ECU and power mirror ECU.

Disconnect the connector power mirror ECU.

Check the DTC.

Code B1215/15 is not output

Repair or replace the wire harness between body ECU and power mirror ECU.

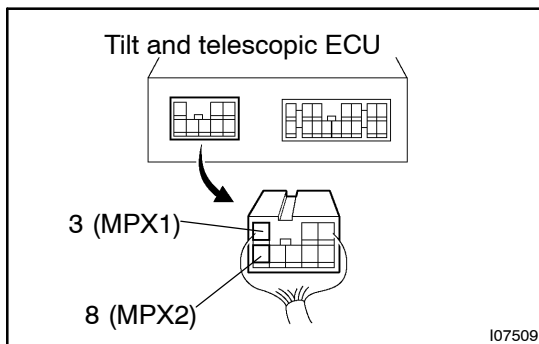
#### 5 Check for short circuit between power mirror ECU and tilt & telescopic ECU.

Disconnect the connector tilt & telescopic ECU.

Check the DTC.

Code B1215/15 is not output

Repair or replace the wire harness between power mirror ECU and tilt & telescopic ECU.

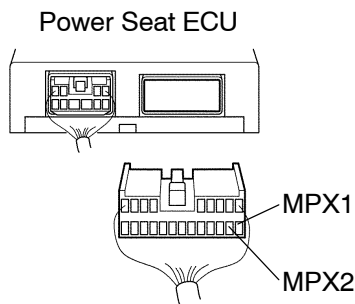
**6****Check for short circuit between tilt & telescopic ECU and power seat ECU.**

Disconnect the connector power seat ECU.

Check the DTC.

Code B1215/15 is not output

**OK****Repair or replace the wire harness between and tilt & telescopic ECU and power seat ECU****NG****Replace the body ECU.**
