| <b>DTC</b> | <b>B0130/63</b> | <b>Short in P/T Squib (RH) Circuit</b> |

## CIRCUIT DESCRIPTION

## WIRING DIAGRAM

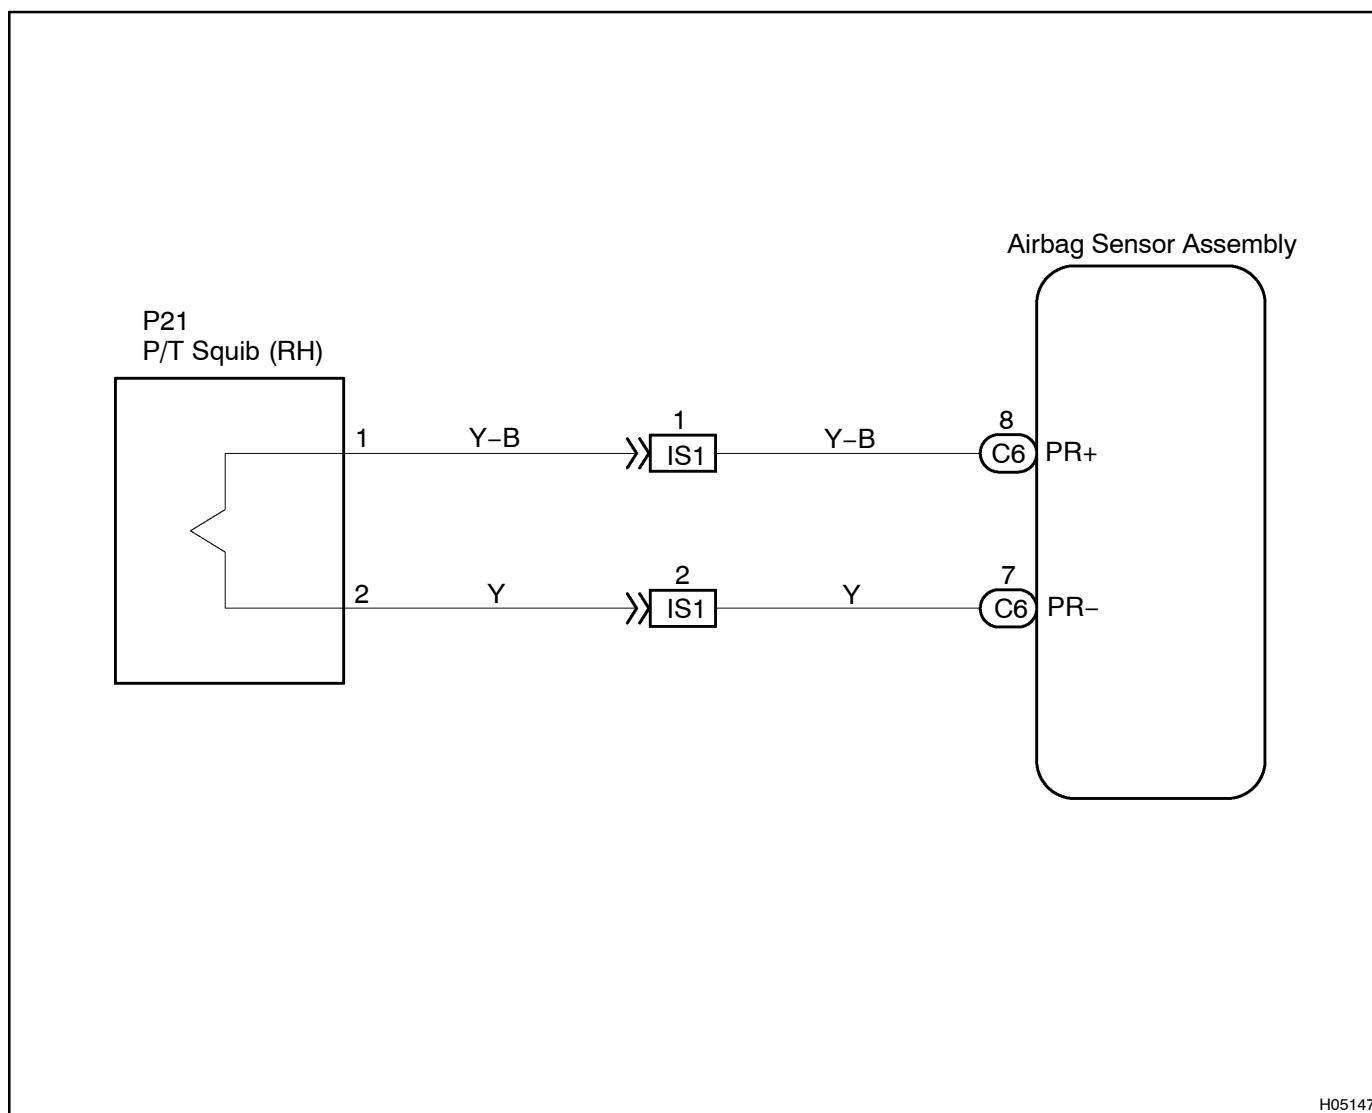
H05147

The P/T squib (RH) circuit consists of the airbag sensor assembly and seat belt pretensioner (RH). It causes the seat belt pretensioner (RH) to activate when the seat belt pretensioner (RH) activation conditions are satisfied.

DTC B0130/63 is recorded when a short is detected in the P/T squib (RH) circuit.

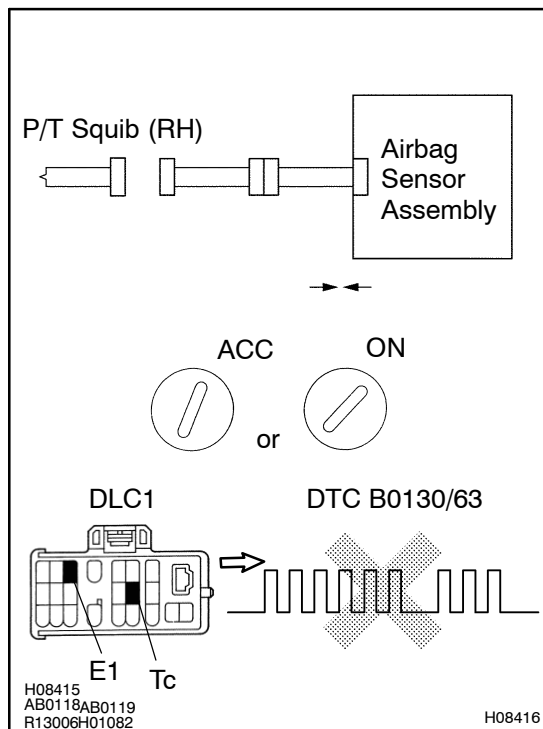
### 3 Check airbag sensor assembly.

- Connect the connector to the airbag sensor assembly.
- Connect negative (-) terminal cable to the battery, and wait at least for 2 seconds.

- Turn ignition switch to ACC or ON and wait at least for 20 seconds.
- Clear DTC stored in memory.  
(See page [DI-513](#))
- Turn ignition switch to LOCK, and wait at least for 20 seconds.
- Turn ignition switch to ACC or ON, and wait at least for 20 seconds.
- Check DTC.  
(See page [DI-513](#))

**DTC B0130/63 is not output.**

**Replace airbag sensor assembly.**

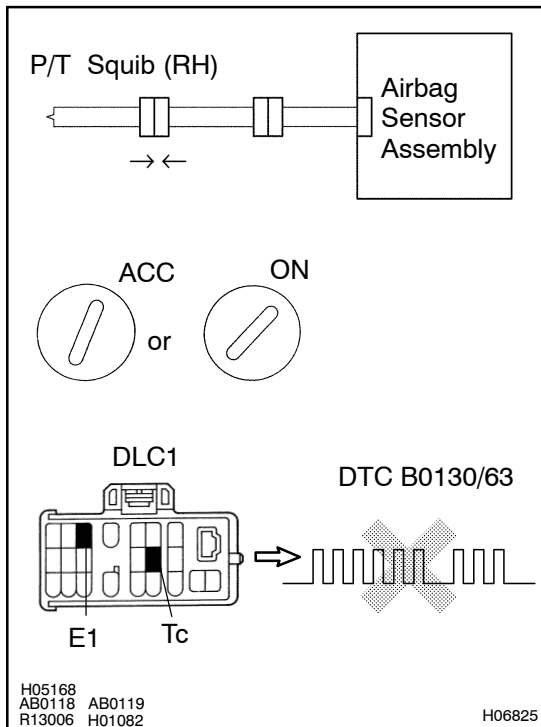
**Check P/T squib (RH).**

- Turn ignition switch to LOCK.
- Disconnect negative (-) terminal cable from the battery, and wait at least for 90 seconds.
- Connect the seat belt pretensioner (RH) connector.
- Connect negative (-) terminal cable to the battery, and wait at least for 2 seconds.

- Turn ignition switch to LOCK, and wait at least for 20 seconds.
- Turn ignition switch to ACC or ON, and wait at least for 20 seconds.
- Clear DTC stored in memory.  
(See page [DI-513](#))
- Turn ignition switch to LOCK, and wait at least for 20 seconds.
- Turn ignition switch to ACC or ON, and wait at least for 20 seconds.
- Check DTC.  
(See page [DI-513](#))

**OK:****DTC B0130/63 is not output.****HINT:**

**NG****Replace seat belt pretensioner (RH).****OK**

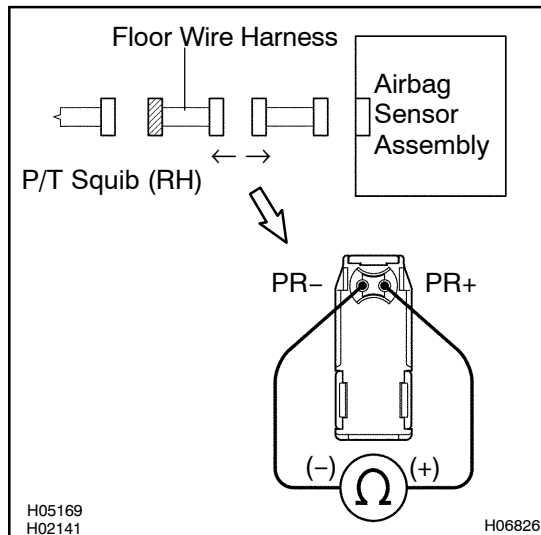
## 5 Check floor wire harness.

- Disconnect floor wire harness connector on the airbag sensor assembly side.
- Release the airbag activation prevention mechanism of the floor wire harness connector on the airbag sensor assembly side. (See page [DI-513](#))

For the connector (on the floor wire harness side) between the seat belt pretensioner and the floor wire harness, measure the resistance between PR+ and PR-.

**Resistance: 1 MΩ or Higher**

**Replace floor wire harness.**

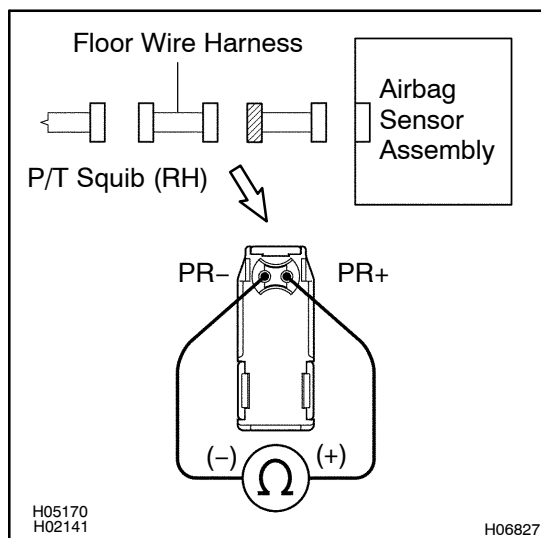
## 6 Check harness between airbag sensor assembly and floor wire harness.

Release the airbag activation prevention mechanism of the airbag sensor assembly connector. (See page [DI-513](#))

For the connector (on the floor wire harness side) between the airbag sensor assembly and floor wire harness, measure the resistance between PR+ and PR-.

**Resistance: 1 MΩ or Higher**

**Replace harness and connector between airbag sensor assembly and floor wire harness.**
