## FRONT A/C EVAPORATOR ON-VEHICLE INSPECTION

AC1L9-06

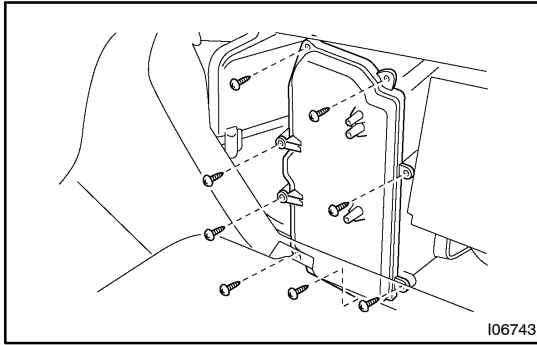
### 1. INSPECT FOR LEAKAGE OF REFRIGERANT

- (a) Remove the glove compartment door.
- (b) Remove the lower No. 2 finish panel  
(See page [BO-104](#)).
- (c) Remove the No. 1 cooler cover.
  - (1) Disconnect the connector clamp.
  - (2) Remove the 8 screws and No. 1 cooler cover.
- (d) Using a gas leak detector, check for leaks of refrigerant. If there is a leakage of refrigerant, check the tightening torque at the joints or check the evaporator.
- (e) Install the No. 1 cooler cover.
