## IG Power Source Circuit

### CIRCUIT DESCRIPTION

This is the power source for A/C amplifier and servomotors, etc.

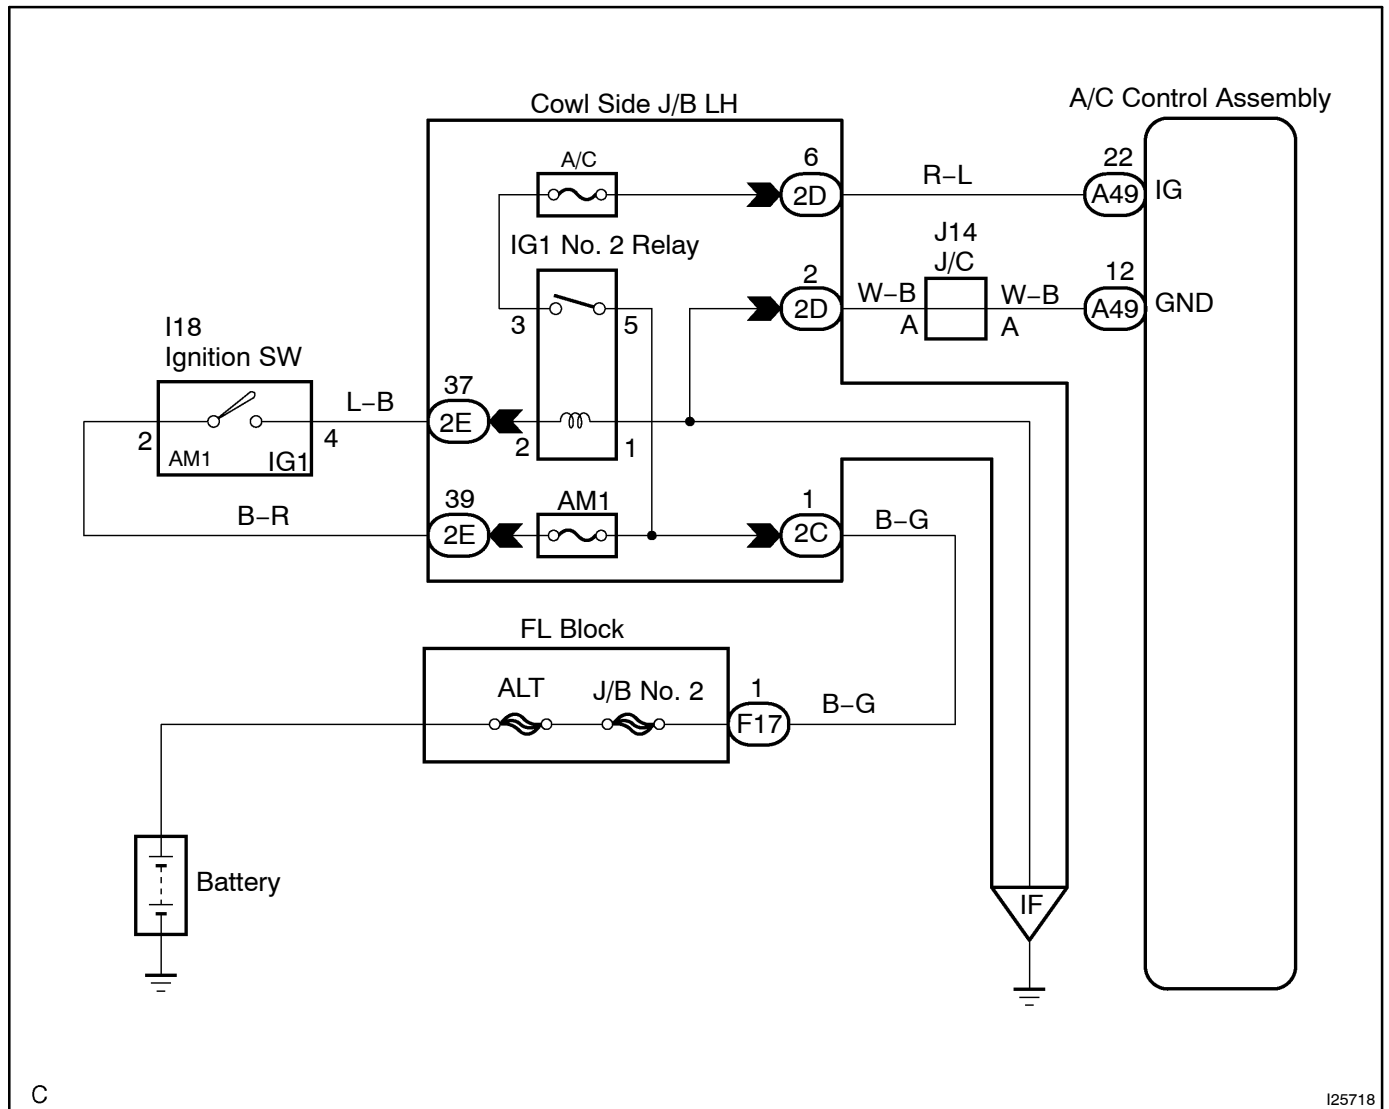
I25718

### WIRING DIAGRAM

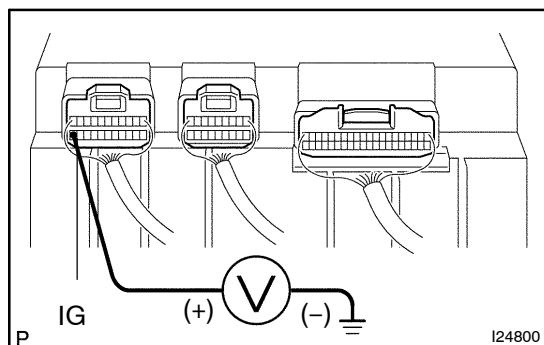
### 1 Check voltage between terminals IG and GND of A/C amplifier.

Remove A/C amplifier with connectors still connected.

- (a) Turn ignition switch to ON.
- (b) Measure voltage between terminals IG and GND of A/C amplifier.

**Voltage : Battery positive voltage**

Proceed to next circuit inspection shown on problem symptoms table (See page [DI-1529](#)).

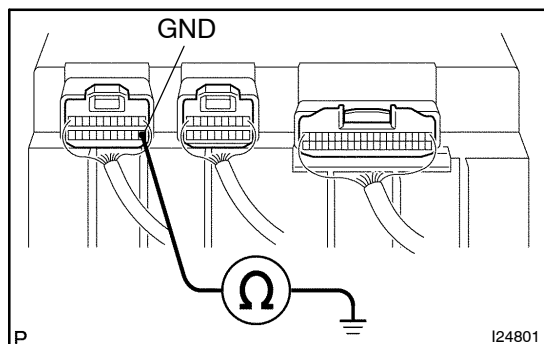
### 2 Check continuity between terminal GND of A/C amplifier and body ground.

Measure resistance between terminal GND of A/C amplifier and body ground.

**Resistance : 0 Ω (continuity)**

**Repair or replace harness or connector.**

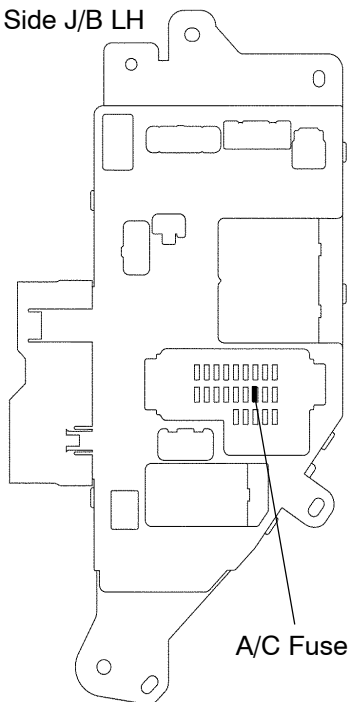
I25186

**3****Check A/C fuse.**

Cowl Side J/B LH

Remove A/C fuse from cowl side J/B LH.

Check continuity of A/C fuse.

**OK:****Continuity****NG****Check for short in all the harness and components connected to the IGN fuse (See attached wiring diagram).****OK****Check and repair harness and connector between A/C amplifier and battery.**
