| <b>DTC</b> | <b>B1272</b> | <b>Power seat ECU communication stop</b> |

## CIRCUIT DESCRIPTION

This DTC is output when communication stops between the Power seat ECU (driver seat ECU) and the Body ECU (Main).

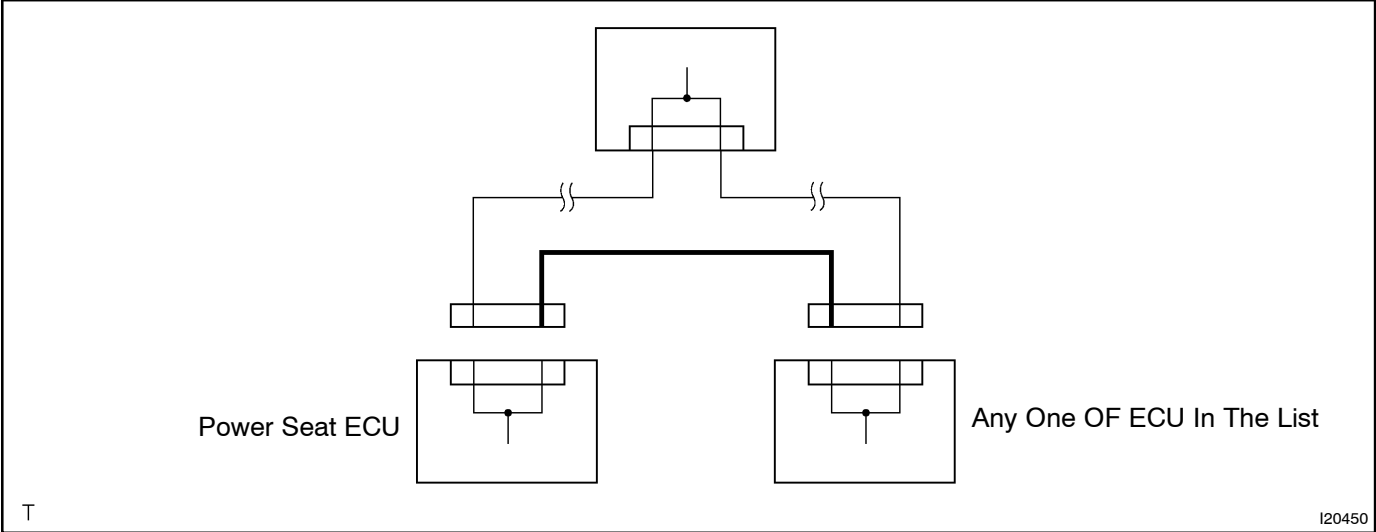
Pull out the ECU connectors below.

| Wire harness side connector of ECU | Terminal |
| Power seat control ECU - Body ECU (Main) | MPX1 (S28-4) - MPX2 (B7-23) |
| Power seat control ECU - Remote control mirror ECU (Main) | MPX2 (S28-9) - MPX1 (R30-25) |

**CHECK:**

Check continuity of the wire harness between the connectors.

**OK:**

There is a continuity between the connectors.

If there is OPEN in any wire harness, please repair it.

Repair or replace wire harness.
