| <b>DTC</b> | <b>B1275</b> | <b>Accessory Bus Buffer communication stop</b> |

## CIRCUIT DESCRIPTION

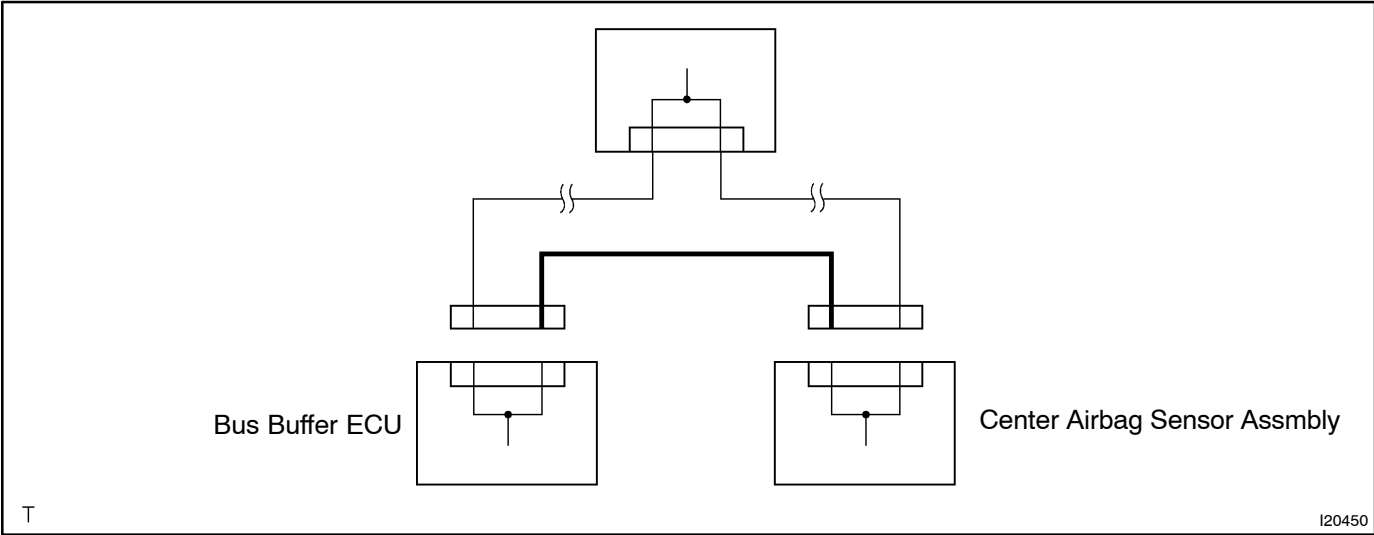
| Wire harness side connector of ECU | Terminal |
|---|---|
| Bus buffer ECU (Mayday ECU) – Center airbag sensor assembly | MPX1 (M11-6) – MPX1 (C32-24) |

CHECK:

Check the continuity between the connectors on the wire harness.

OK:

Continuity
