## Front Wiper Position Circuit

### CIRCUIT DESCRIPTION

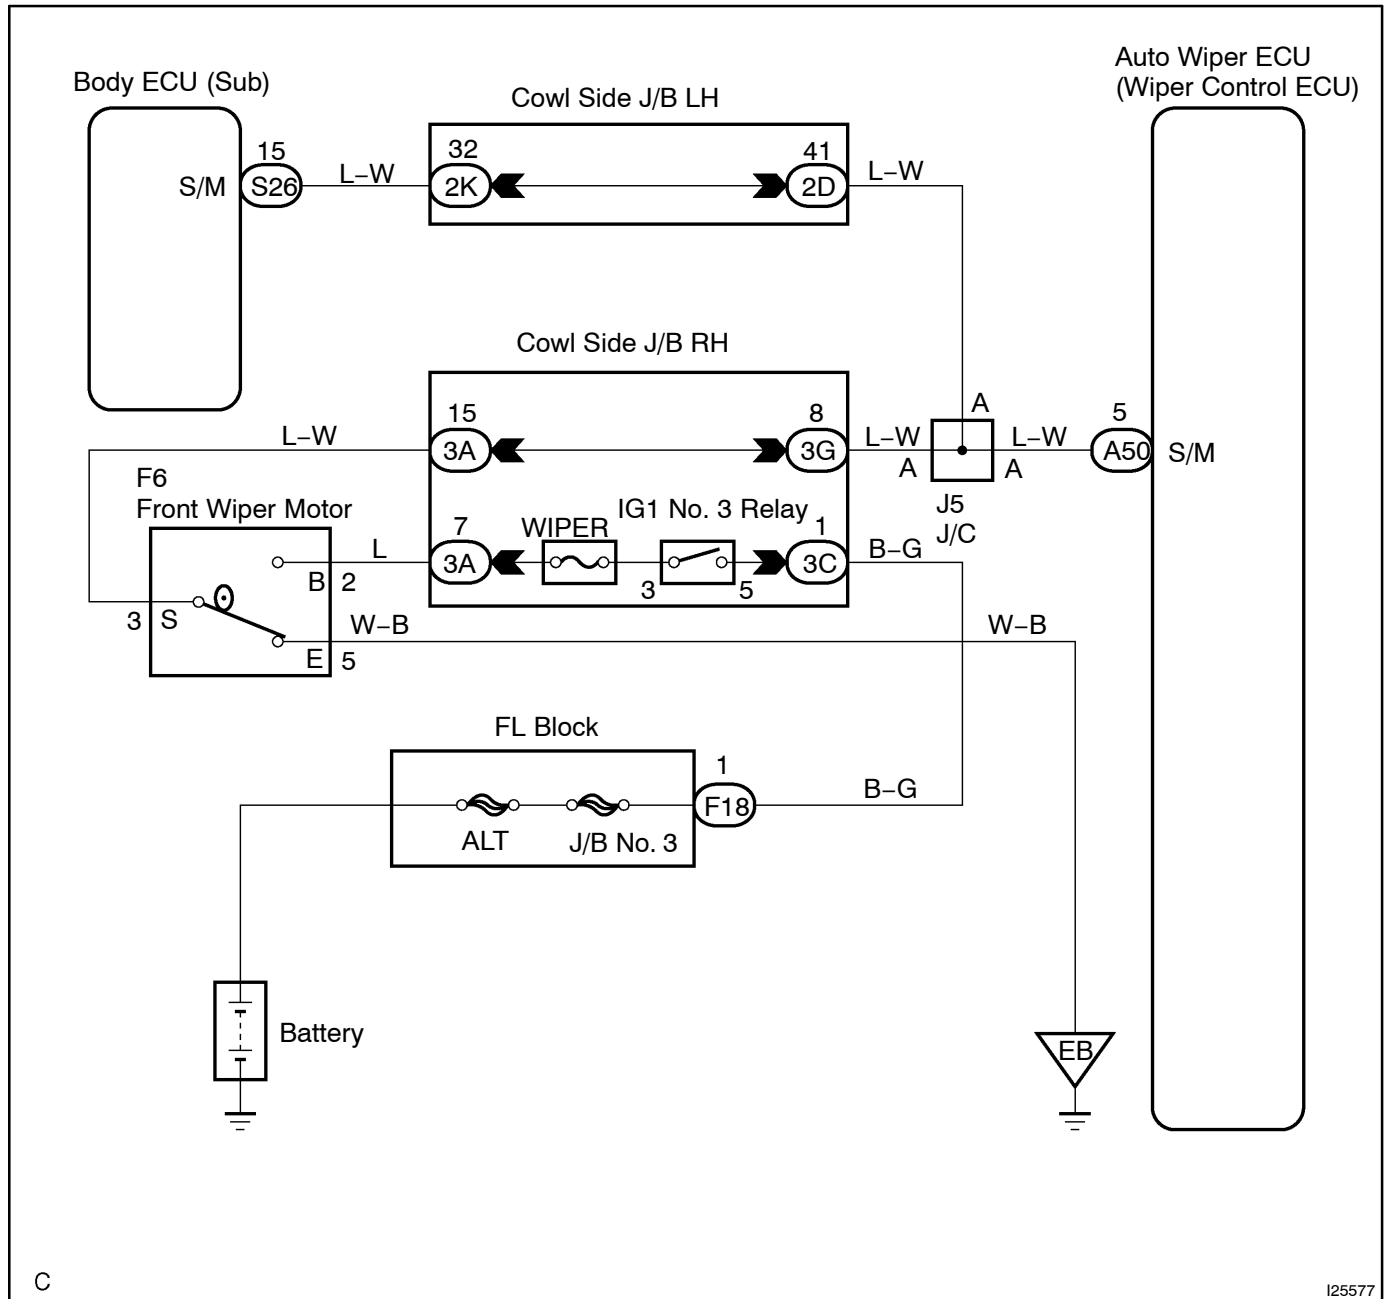
I25577

This signal is taken into Body ECU (Sub). If this signal cannot be received, Body ECU (Main), (Sub) does not perform reverse linked function control.

### WIRING DIAGRAM
