The connection to LEXUS Link Center cannot be cut off.

INSPECTION PROCEDURE

Check Mayday switch (Overhead J/B).

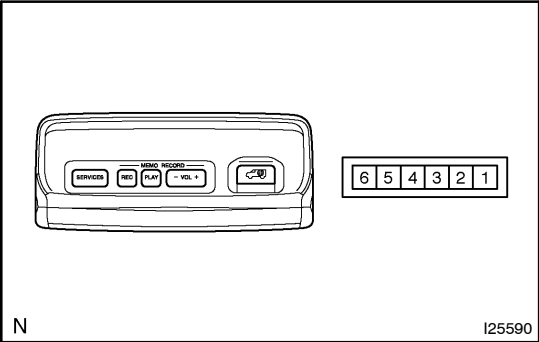
**PREPARATION:**  
Disconnect the Mayday switch connector.

**CHECK:**  
Check that the continuity exists between terminals of Mayday switch when each switch is pressed.

| Switch position | Tester connection | Specified condition |
| Service<br>Play back<br>Record | 1 – 2 | Continuity |
| Emergency<br>Volume UP<br>Volume DOWN | 2 – 3 | Continuity |

NG

Replace the Mayday switch (overhead J/B).
