## FRONT A/C EVAPORATOR ON-VEHICLE INSPECTION

AC1L9-06

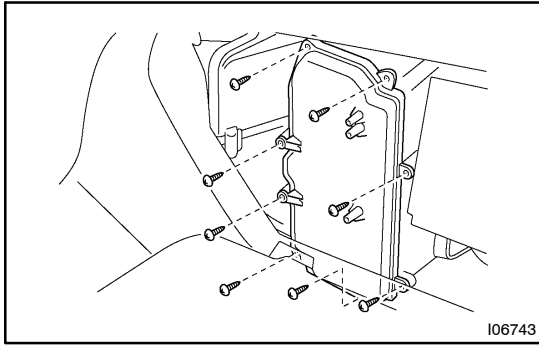
### 1. INSPECT FOR LEAKAGE OF REFRIGERANT

- (a) Remove the glove compartment door.
- (b) Remove the lower No. 2 finish panel  
(See page [BO-104](#)).
- (c) Remove the No. 1 cooler cover.
  - (1) Disconnect the connector clamp.
  - (2) Remove the 8 screws and No. 1 cooler cover.
- (d) Using a gas leak detector, check for leaks of refrigerant. If there is a leakage of refrigerant, check the tightening torque at the joints or check the evaporator.
- (e) Install the No. 1 cooler cover.

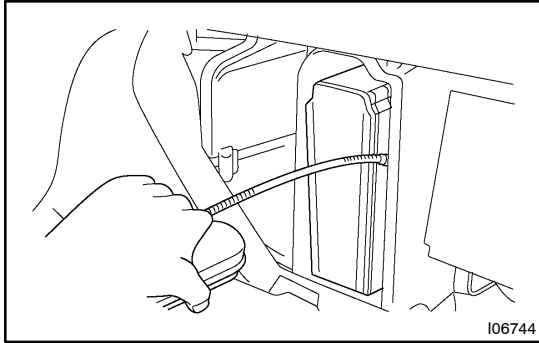
### 2. INSPECT EXPANSION VALVE

- (a) Check amount of gas during refrigeration cycle.
- (b) Set on manifold gauge set.
- (c) Operate A/C system at "MAX. COOL" for approx. 5 minutes.
- (d) Check expansion valve.  
Check the low pressure reading drops to 0 kPa (0 kgf/cm<sup>2</sup>, 0 psi).

If the low pressure reading is not as specified, replace the expansion valve with the tubes.
