# MAGNETIC CLUTCH RELAY INSPECTION

AC1LY-04

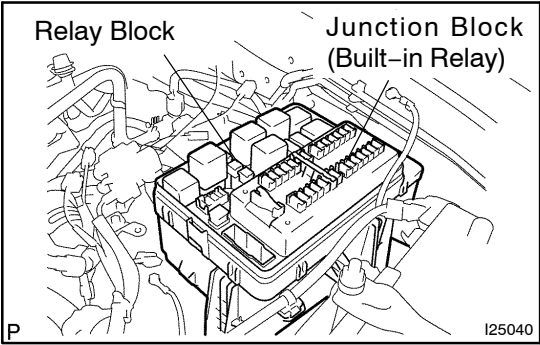
- 1. REMOVE ENGINE ROOM J/B**
- 2. INSPECT MAGNETIC CLUTCH RELAY CONTINUITY**

| Condition | Tester connection | Specified condition |
| Constant | 57 - 65 | Continuity |
| Apply B+ between terminals 57 and 65 | 63 - 65 | Continuity |

If continuity is not as specified, replace the engine room J/B.
