| <b>DTC</b> | <b>17</b> | <b>Rear Evaporator Temperature Sensor Circuit</b> |

## CIRCUIT DESCRIPTION

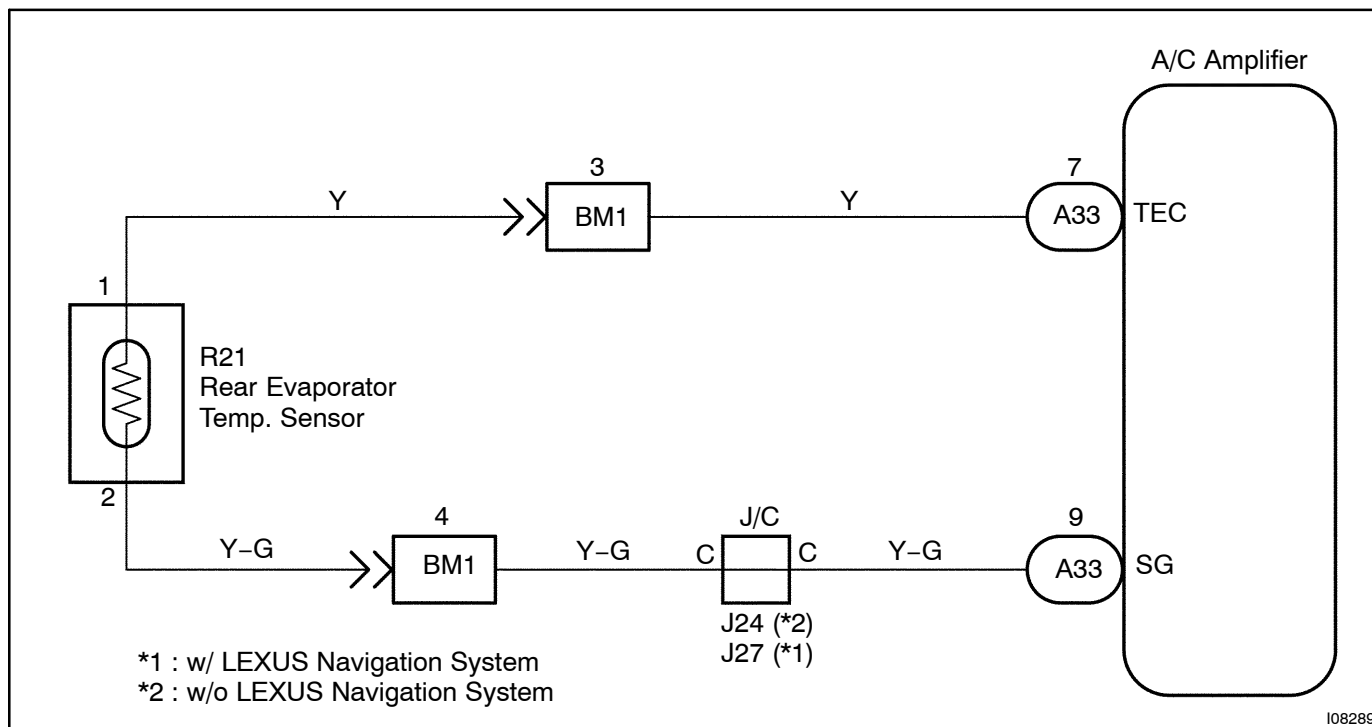
## WIRING DIAGRAM

This sensor detects the rear evaporator temperature and sends the appropriate signals to the A/C amplifier.

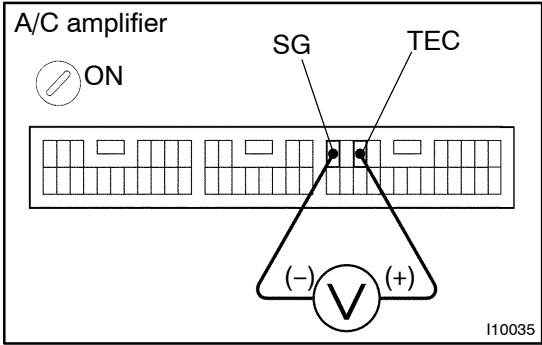
| 1 | Check voltage between terminals TEC and SG of A/C amplifier. |

- (a) Turn ignition switch to ON.
- (b) Measure voltage between terminals TEC and SG of A/C amplifier connector at each temperature.

**Voltage :**  
at 0°C (32°F) : 2.0 – 2.4 V  
at 15°C (59°F) : 1.4 – 1.8 V

As the temperature increases, the voltage decreases.

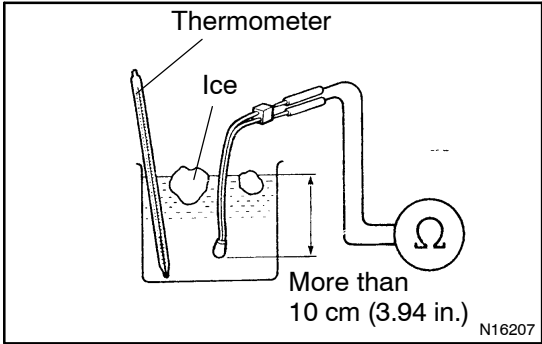
| 2 | Check rear evaporator temperature sensor. |

Measure resistance between terminals 1 and 2 of evaporator temperature sensor connector at each temperature.

**Resistance :**  
at 0°C (32°F) : 4.5 – 5.2 kΩ  
at 15°C (59°F) : 2.0 – 2.7 kΩ

As the temperature increases, the resistance decreases.

| NG | Replace rear evaporator temperature sensor. |
