| <b>DTC</b> | <b>B2797</b> | <b>Communication Malfunction No.1</b> |

## CIRCUIT DESCRIPTION

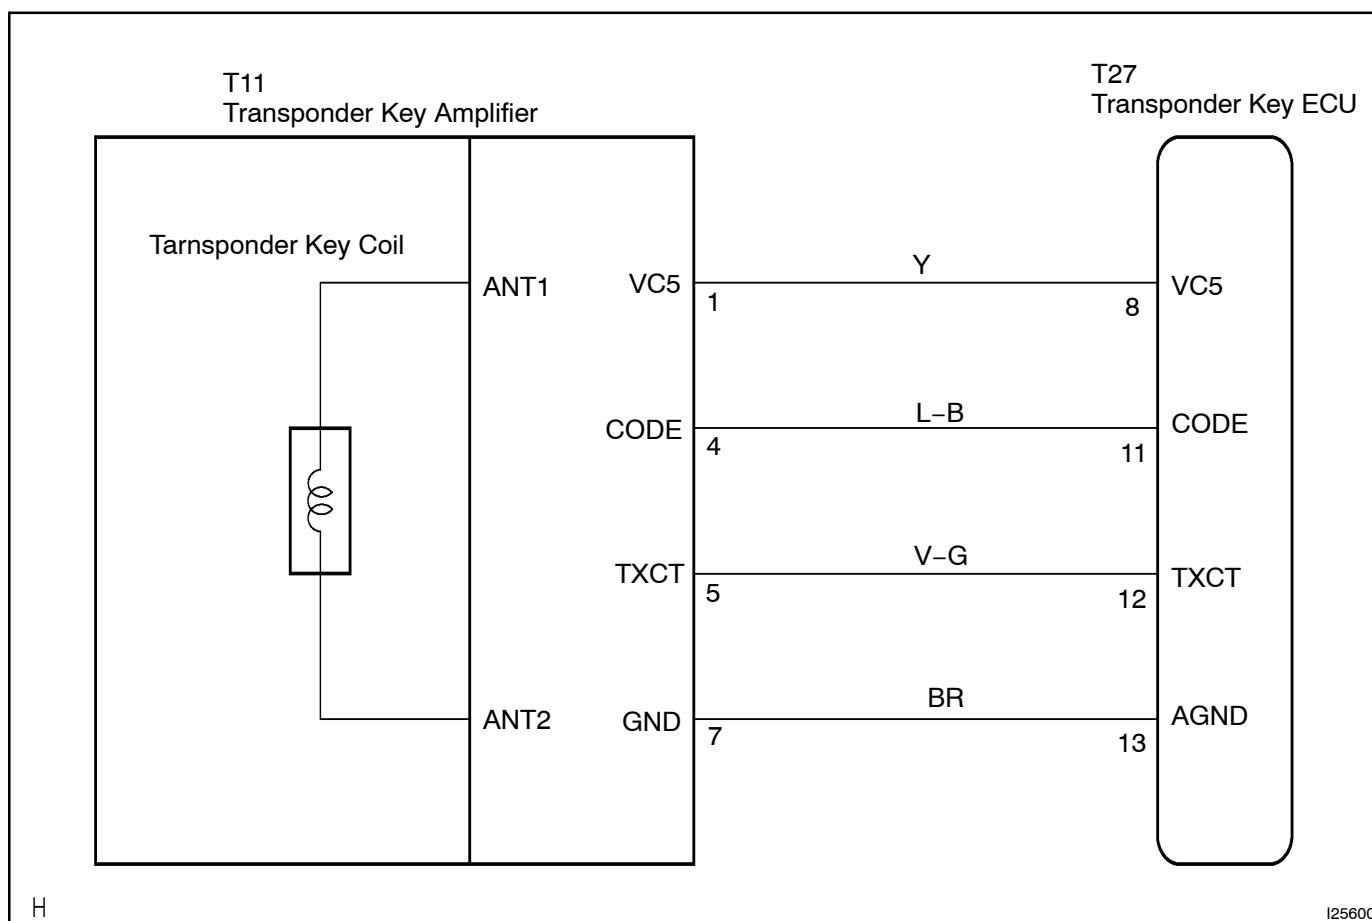
## WIRING DIAGRAM

This DTC is detected when an error occurs, although the communication is performed normally (Example. Some noise is included in communication line.).
