| <b>DTC</b> | <b>B2798</b> | <b>Communication malfunction No. 2</b> |

## CIRCUIT DESCRIPTION

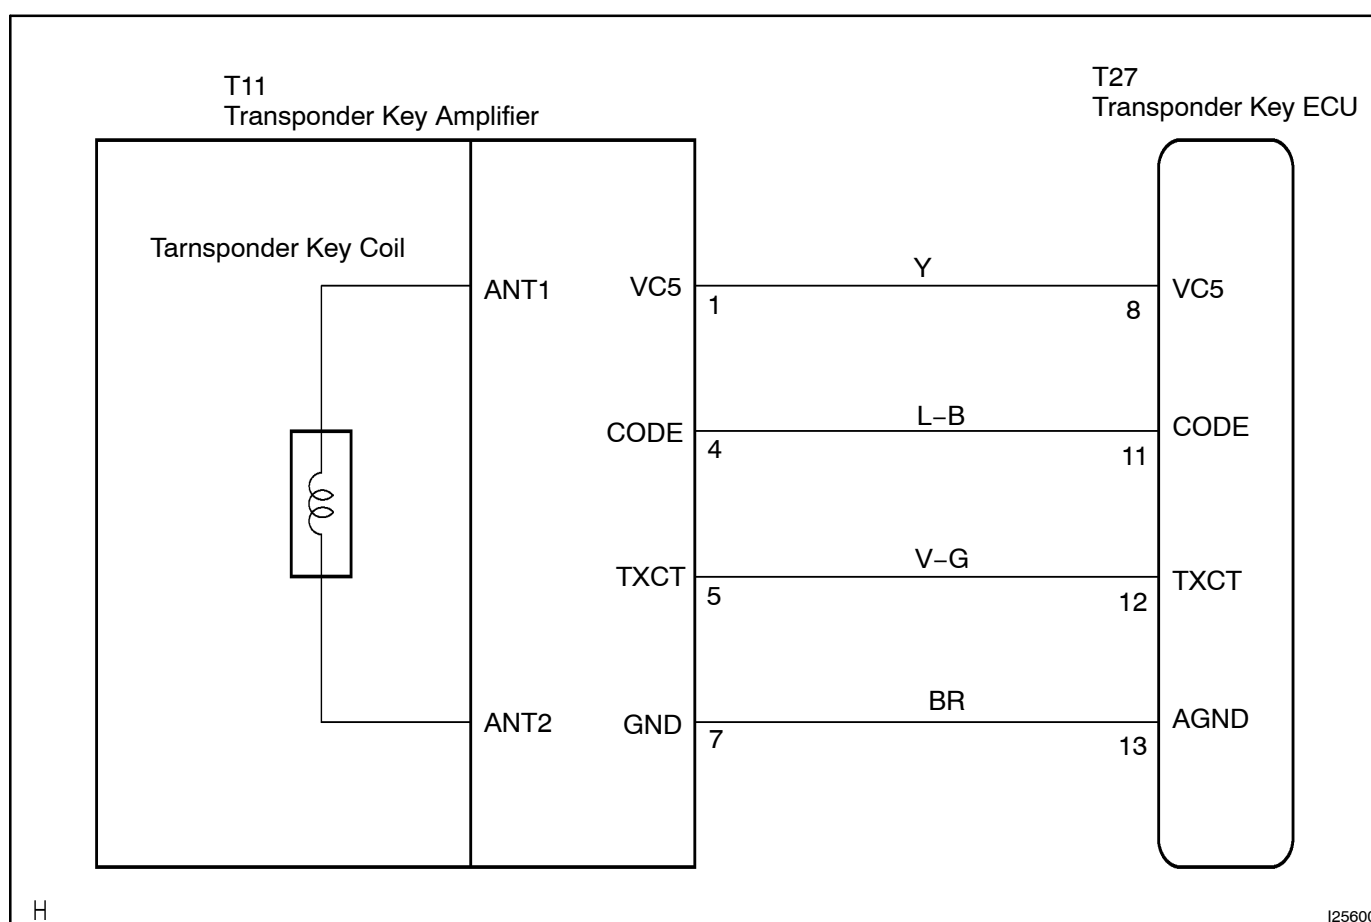
## WIRING DIAGRAM

This code is detected when an error occurs, although the communication is performed normally.  
(Example. Some noise is included in communication line.)

| DTC No. | DTC Detecting Condition | Trouble Area |
|---|---|---|
| B2798 | Communication error | <ul style="list-style-type: none"> <li>• Key</li> <li>• Transponder Key Amplifier with coil</li> <li>• Wire harness</li> <li>• Transponder key ECU</li> </ul> |
