| <b>DTC</b> | <b>B1185/57</b> | <b>Short in P Squib (2nd step) Circuit</b> |

## CIRCUIT DESCRIPTION

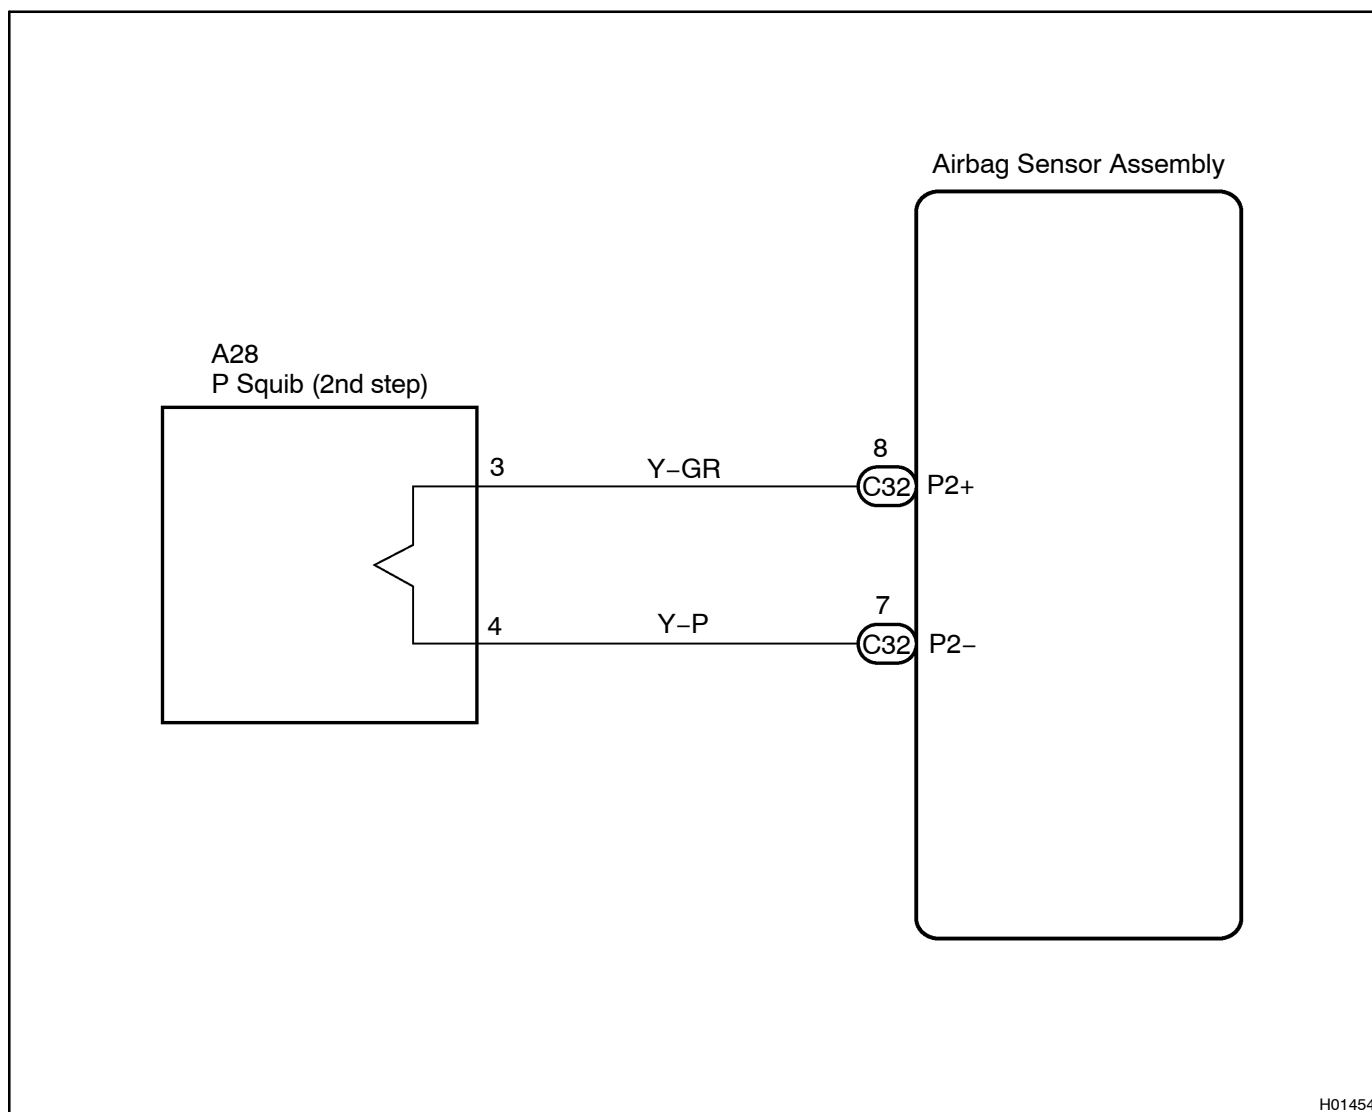
H01454

The P squib (2nd step) circuit consists of the airbag sensor assembly and the front passenger airbag assembly.

It causes the SRS to deploy when the SRS deployment conditions are satisfied.

## WIRING DIAGRAM

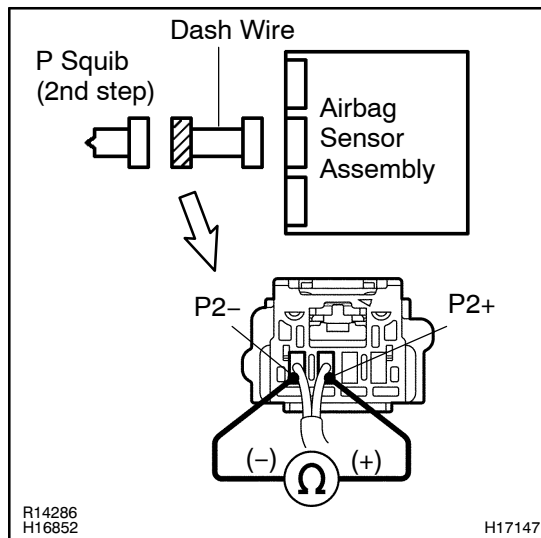
**2** Check dash wire (P squib (2nd step) circuit).

Release the airbag activation prevention mechanism built in the connector of the dash wire on the airbag sensor assembly side (See page [DI-882](#)).

Measure the resistance between P2+ and P2- of the dash wire connector on the front passenger airbag assembly (P squib (2nd step)) side.

**Resistance: 1 MΩ or Higher**

**Replace dash wire.**
