## TECHNICAL SERVICE BULLETIN

| SUBJECT: | | No: TSB-08-23-001 | |
| CORRECTED SCAN TOOL EQUIPMENT PART NUMBERS - SERVICE MANUAL REVISION | | DATE: January, 2008 | |
| | | MODEL: 2008 Outlander | |

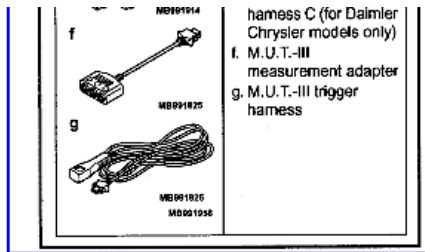
| Corrected Illustration | |

| Corrected Illustration | |
|---|---|
| | MB991955<br>a: MB991824<br>b: MB991827<br>c: MB991910<br>d: MB991911<br>e: MB991825<br>f: MB991826<br>g: MB991826<br>M.U.T.-III sub assembly |
| | a. Vehicle communication interface (V.C.I.) |
| | b. M.U.T.-III USB cable |
| | c. M.U.T.-III main harness A (Vehicles with CAN communication system) |
| | d. M.U.T.-III main harness B (Vehicles without CAN communication system) |
| | e. M.U.T.-III main |

The information for equipment associated with the MUT-III Scan Tool is incorrect in the Service Manual. This TSB corrects the information.
