OUTLINE OF CHANGE

FRONT PROPELLER SHAFT

DISASSEMBLY AND REASSEMBLY

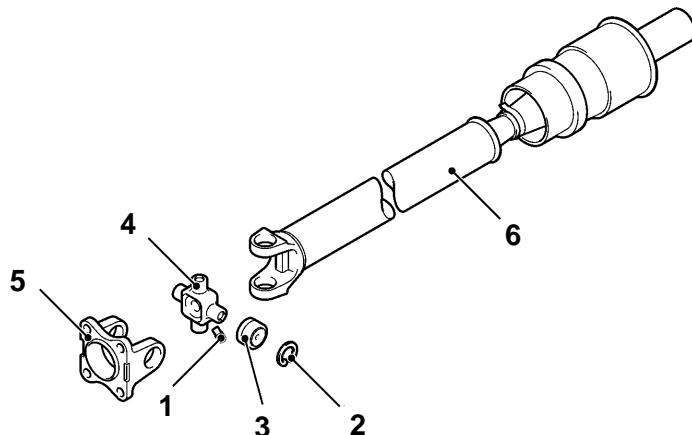
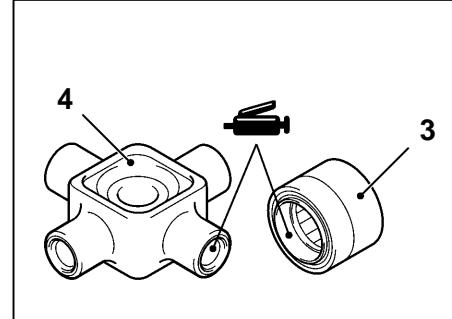
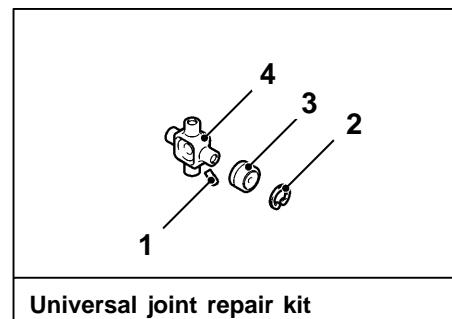
AC203529AB

Disassembly steps

1. Grease fitting
2. Snap ring
3. Journal bearing
4. Journal
5. Flange yoke

6. Propeller shaft

The service procedures have been established due to the change of the journal. The other items are the same as before.

The disassembly and reassembly service points are the same as before.
