# EXTERIOR

## BUMPER/RADIATOR GRILLE/MOULDING/GARNISH/MUDGUARD/ SIDE STEP

The following items have been changed or added for better appearance.

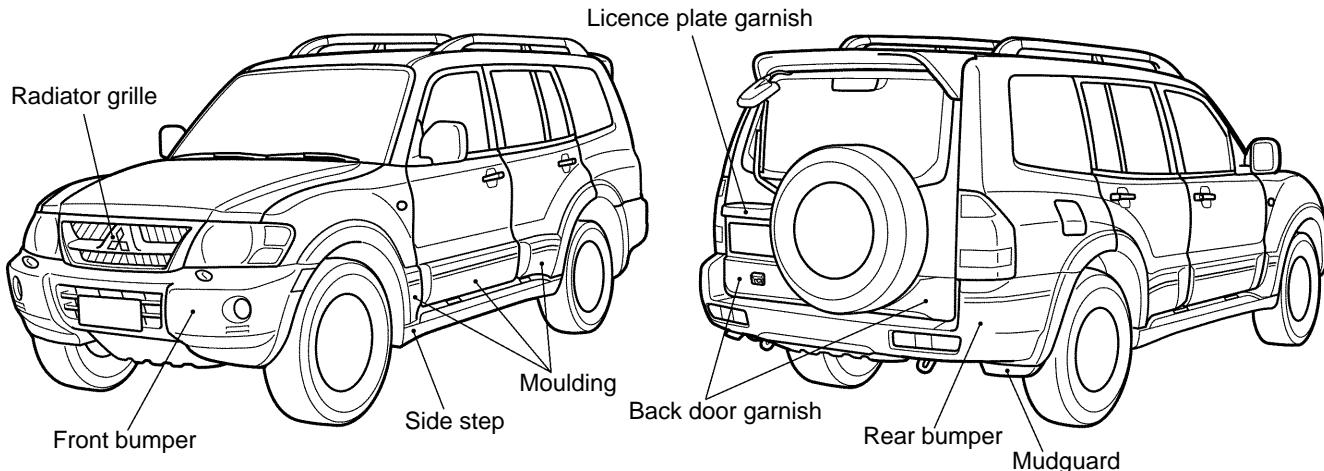
<New>

- The front bumper and the rear bumper have been redesigned.
- The radiator grille has been redesigned.
- The moulding has been redesigned.
- The licence plate garnish has been redesigned.
- The back door garnish has been added.
- The mudguard has been redesigned.
- The side steps have been redesigned.

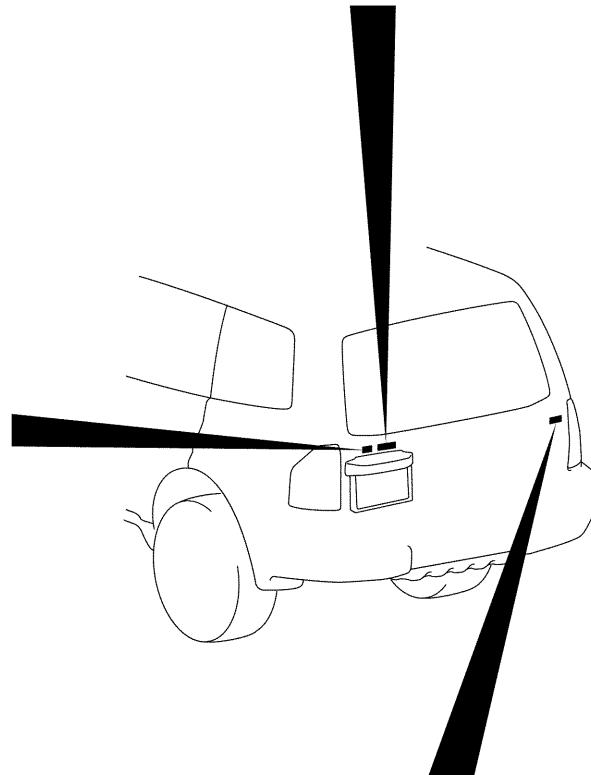
<Addition>

The marks have been redesigned or added.

New			
Old			This mark was not applicable in old models.
