# SERVICE MANUAL

DATSUN 240Z SPORTS  
MODEL S30 SERIES  
CHASSIS & BODY

### BODY ELECTRICAL

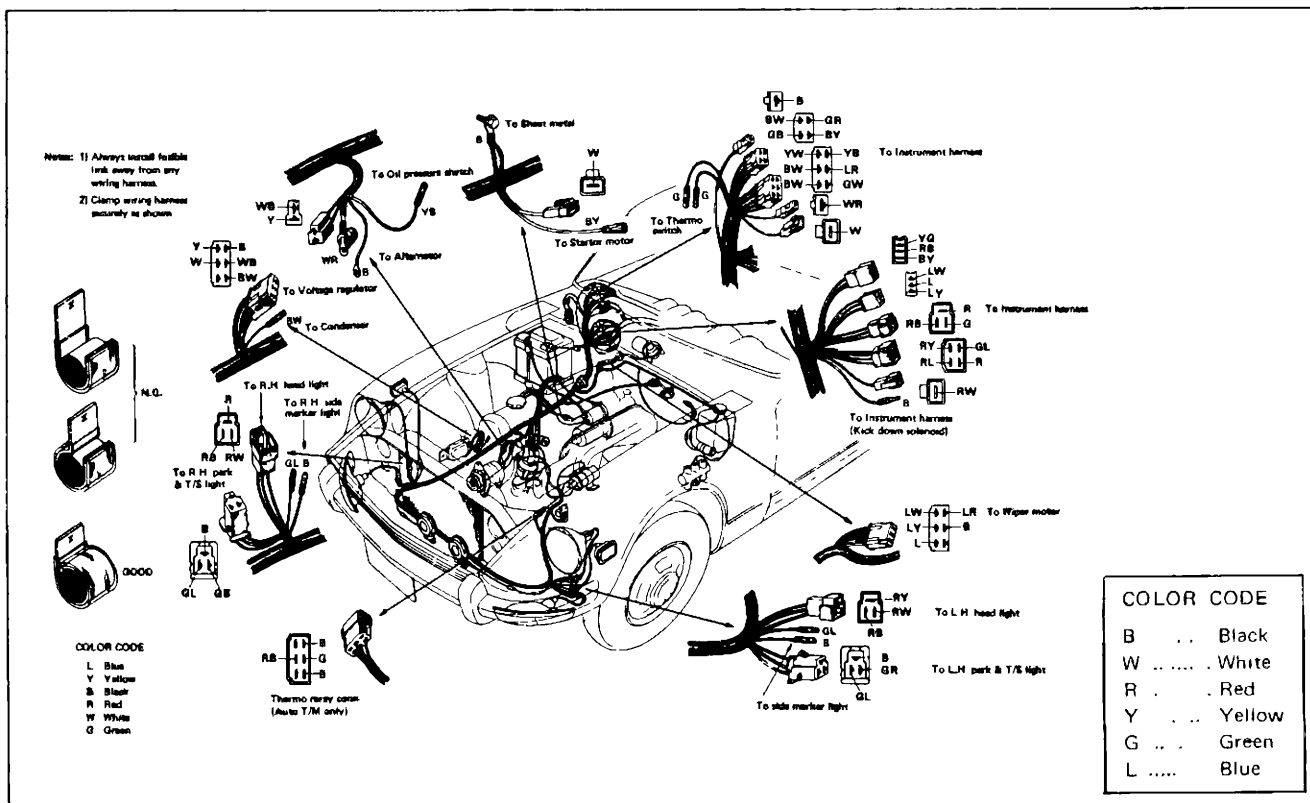
Fig. BE-1 Engine compartment harness

1. Connect the engine compartment harness to the instrument harness at the bottom of instrument.
2. Through the dash panel, extend the harness to the radiator support in the engine compartment along the right side of the hood ledge.
3. Extend the harness to the left side of the body
4. Through the radiator support, connect the wire to the ignition coil along the left hand hood ledge.

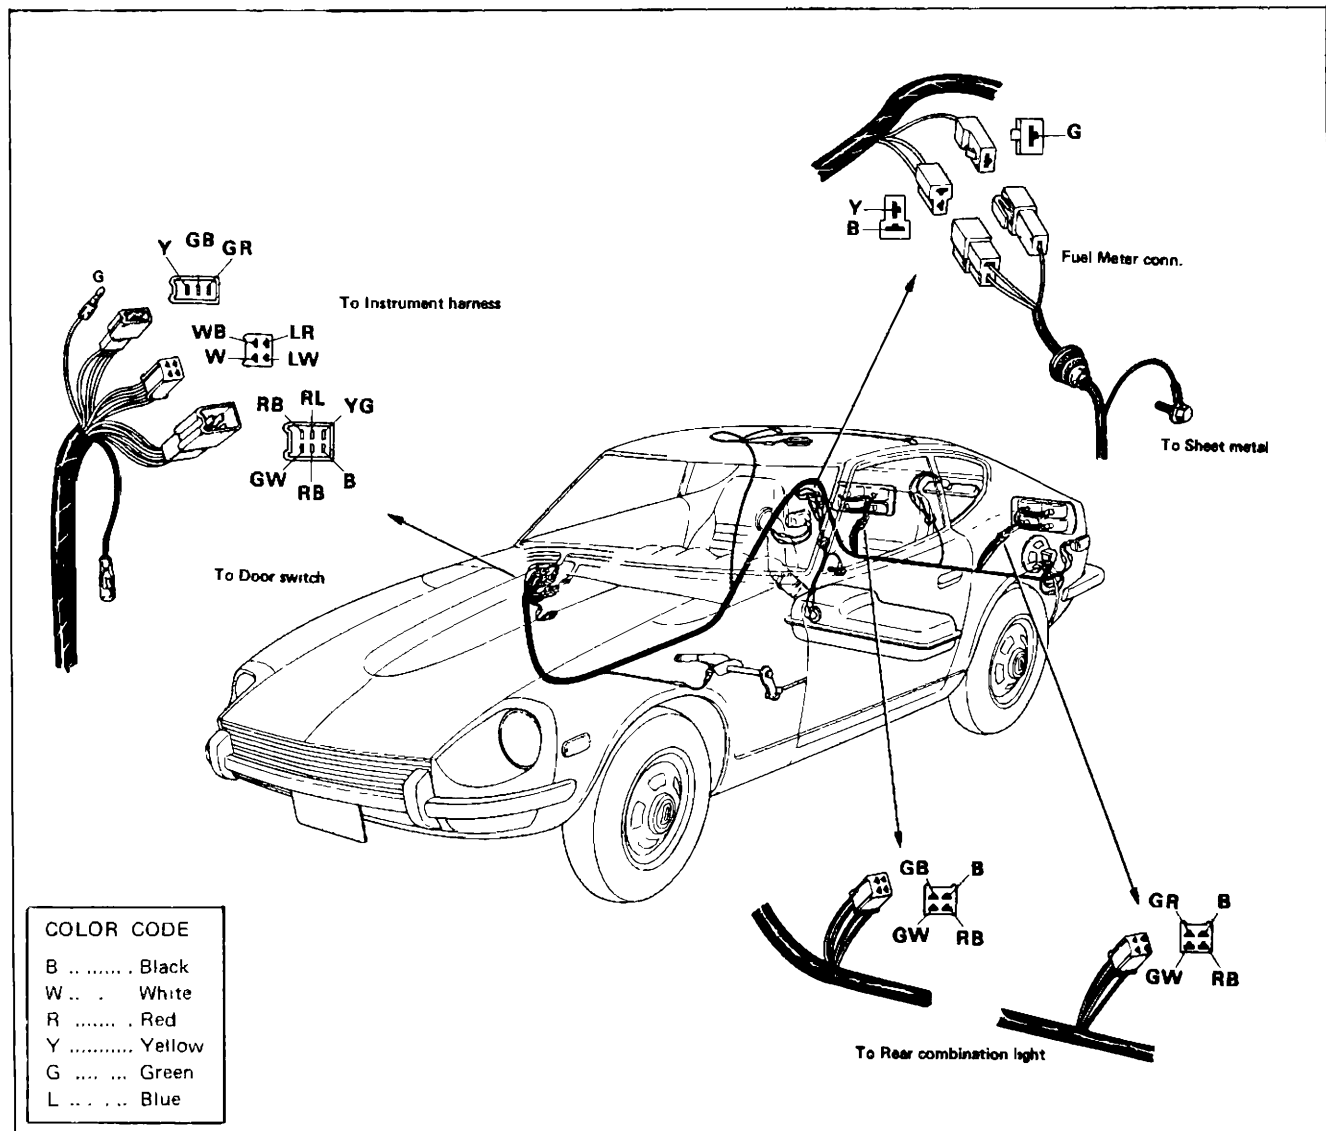
Fig. BE-3 Body harness

1. Connect the body harness to the instrument harness at the bottom of the instrument panel.
2. Extend the harness to the wheel housing along the right side floor edge.
3. Extend the harness to the tail lamps by passing it between the inner panel and outer panel
4. Branch the harness at rear side of the rear pillar, and extend the branched harness to the room lamp through the rear pillar.
5. Branch the harness at bottom of the tail lamp, and penetrating through the rear floor, extend to the fuel tank unit gauge along the inside of the right hand side member.

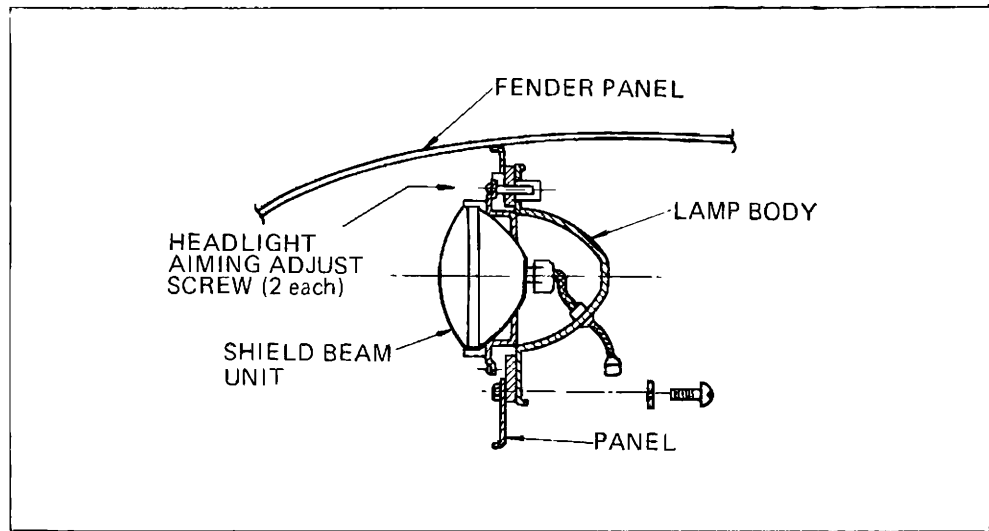
Fig. BE-4 Removing head lamp

Remove four screws from the inside of the wheel opening.

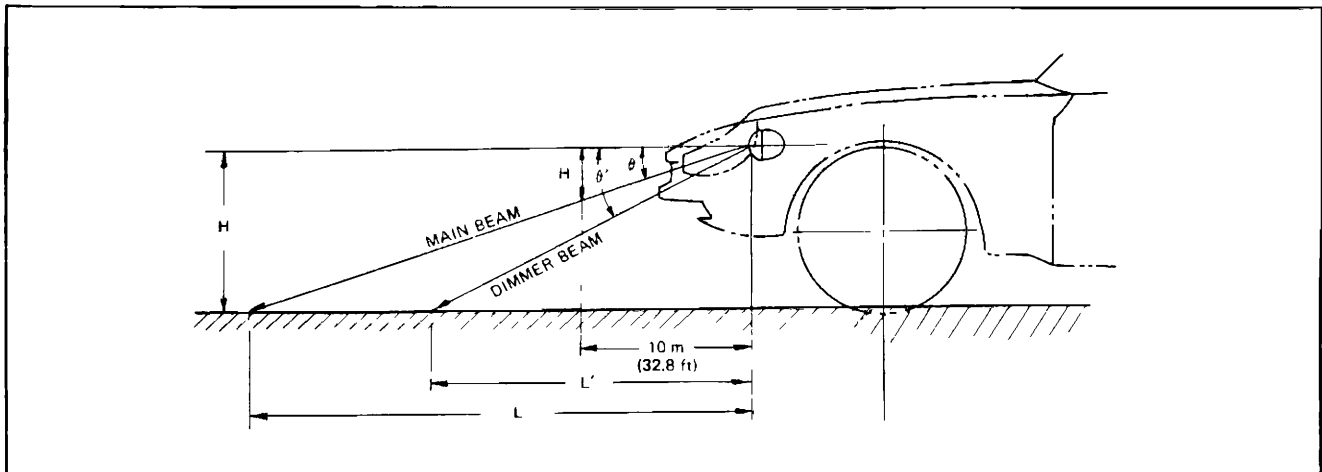
Fig. BE-5 Adjusting headlight aiming

| Dimensions/Angle | Values to which adjusted |
| H | 622.0 mm (24.5 in) |
| $\theta$ | 45' |
| $\theta'$ | 1°35' |
| L | 47.5 m (155.5 ft) |
| L' | 22.5 m (73.8 ft) |
| H' | 130.9 mm (5.15 in) |

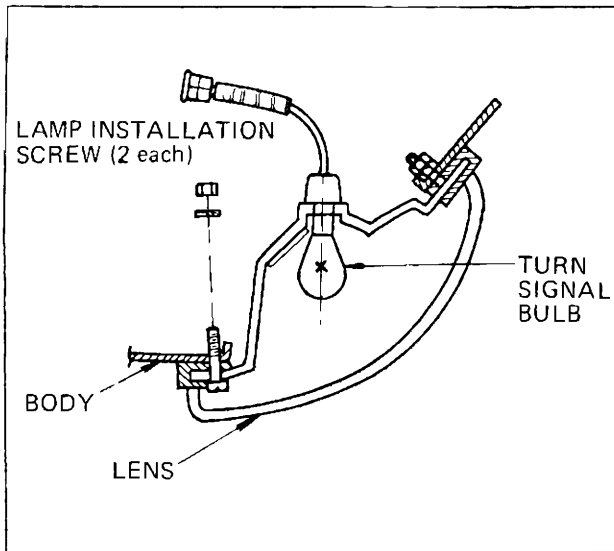
Fig. BE-6 Replacing front parking/turn signal lamp

Turn the socket from the rear side, and remove it.

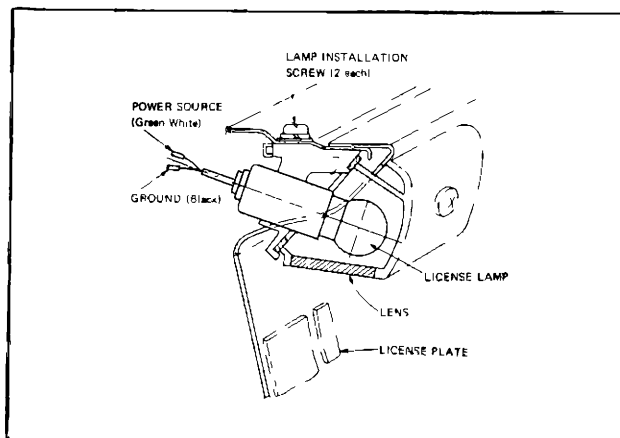
Fig. BE-7 License plate lamp installation

Remove the lamp cover after removing three set screws.

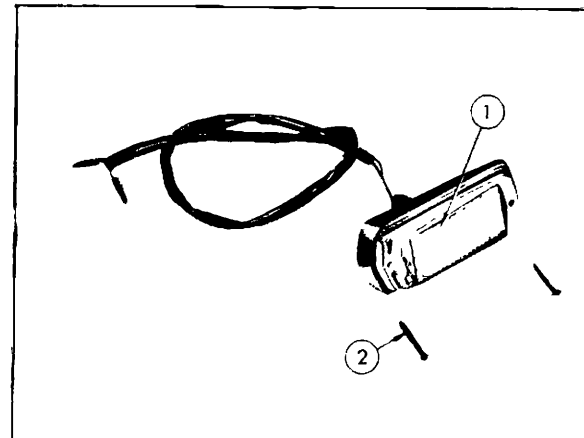
Fig. BE-8 Front side marker lamp

| 1 | Lens | 2 | Set screw |

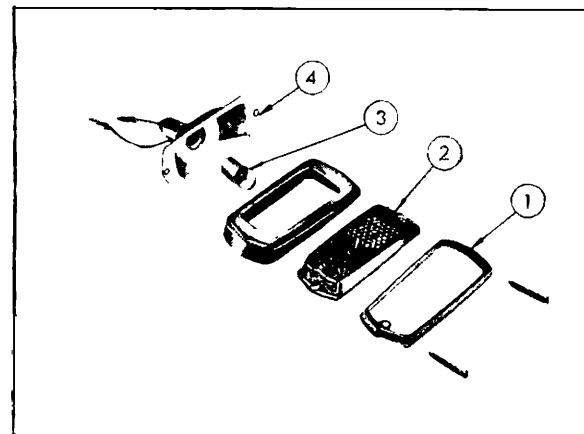
Fig. BE-9 Rear side marker lamp

| 1 | Limb | 3 | Bulb Adapter |
| 2 | Lens (Red) | 4 | Bulb |

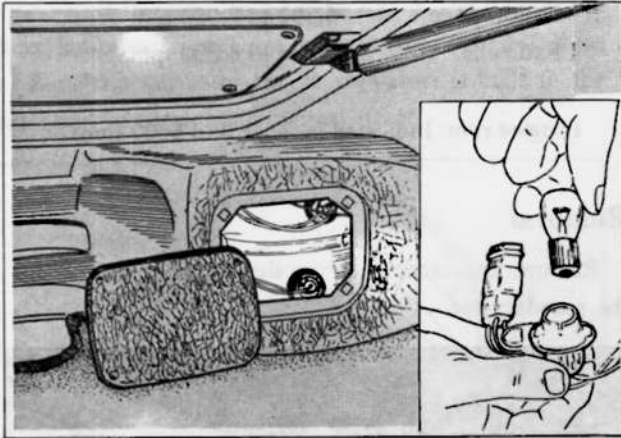
Fig. BE-10 Replacing rear combination lamp bulb

Remove the trim cover (four screws) from the luggage, replace the bulb from the rear side of the socket.

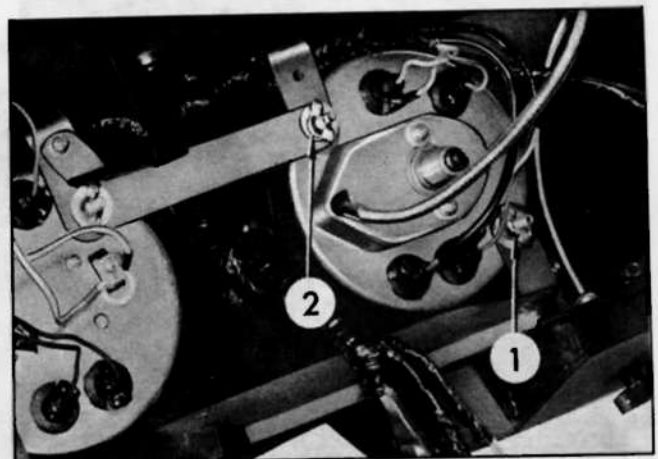
Fig. BE-12 Removing speedometer

Loosen the wing nuts on the meter brackets [① and ② in Figure BE-12 ] on the upper and lower sides of the reverse side of the speedometer, and withdraw the speedometer from the instrument panel.

- Note:** a. When loosening the wing nuts, use a pair of pliers.
- b. In order to facilitate the operation, remove the heater air duct.
- c. See Figure BE-15 for details of the speedometer support bracket and mounting bracket.

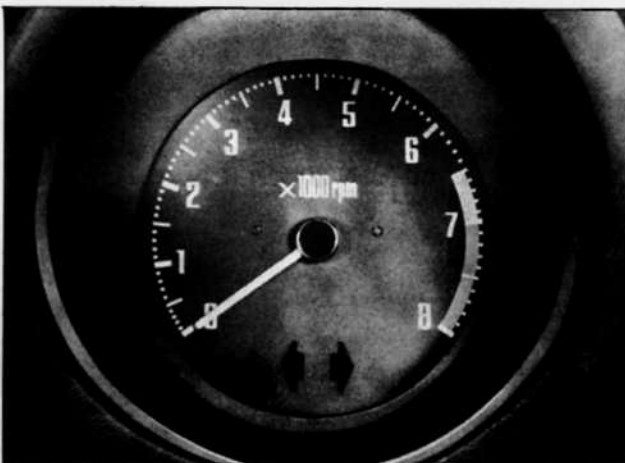
Fig. BE-14 Tachometer

Yellow zone: 6,500 to 7,000 rpm  
Red zone: 7,000 to 8,000 rpm

(Engine rpm: Indicated in range 0 to 8000 rpm)

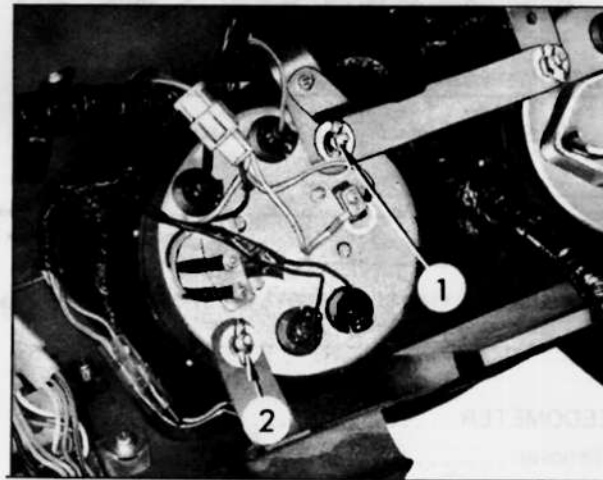
Fig. BE-15

Remove the tachometer in the same manner as the speedometer.

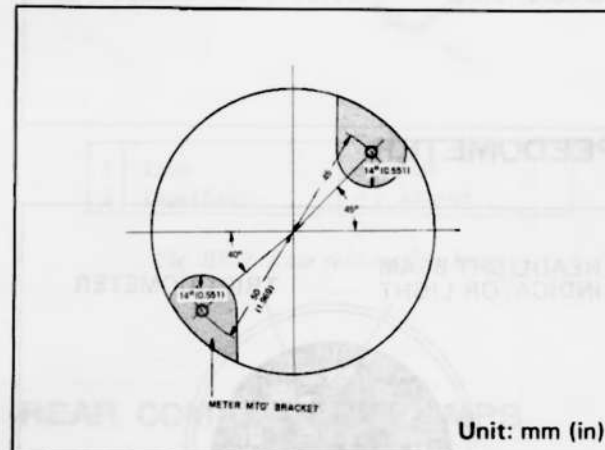
Fig. BE-16 Details of tachometer installation brackets

**Note:** See Figure BE-17 for details of the tachometer support bracket and mounting bracket.

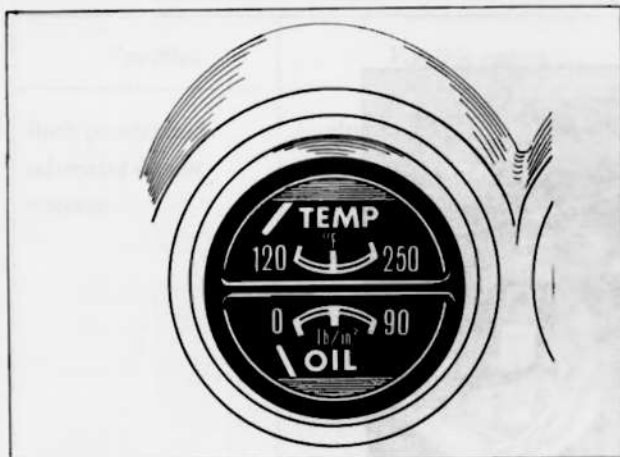
Fig. BE-17 Water temperature gauge and oil pressure gauge

The water temperature gauge and oil pressure gauge are combined. The water temperature gauge indicates water

temperature in range from 120 to 250°F, and oil pressure gauge indicates oil pressure in range from 0 to 140 lb/sq in. A voltage regulator (meter regulator) is built in the meter unit to compensate thermal effect.

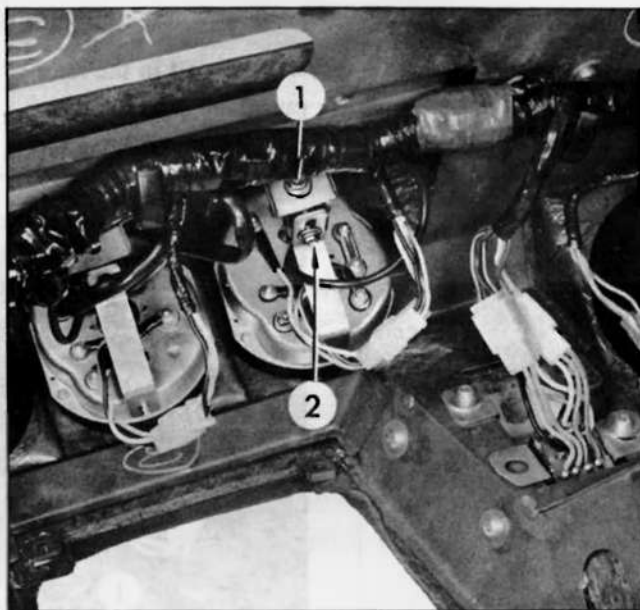
Fig. BE-19 Removing water temperature gauge and oil pressure gauge

1. Remove the center console finisher.
2. Inserting hand into the opening where the center console finisher has been removed, loosen hexagonal cross-headed screws [① and ② in Figure BE-21] use pair of pliers, and remove the unit from the reverse side of the instrument panel.

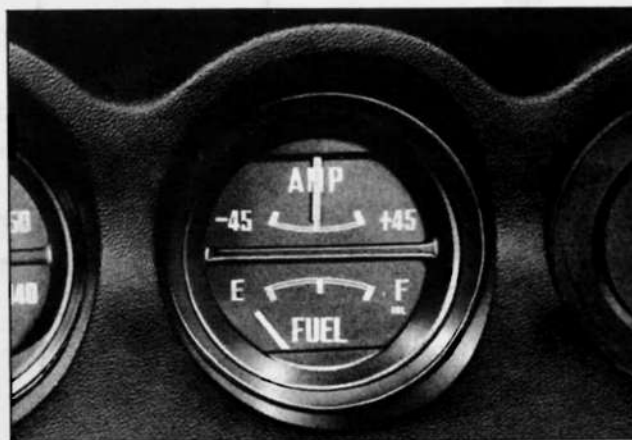
Fig. BE-20 Ammeter and fuel gauge

The ammeter and fuel gauge are combined to a single unit. The ammeter indicates in range from -45 to +45A. "E" and "F" marks on the fuel gauge represent respectively "Empty" [5 liters (18.9 US gal, 122.7 Imp gal)] and "Full" [60 liters (227 US gal, 273 Imp gal)].

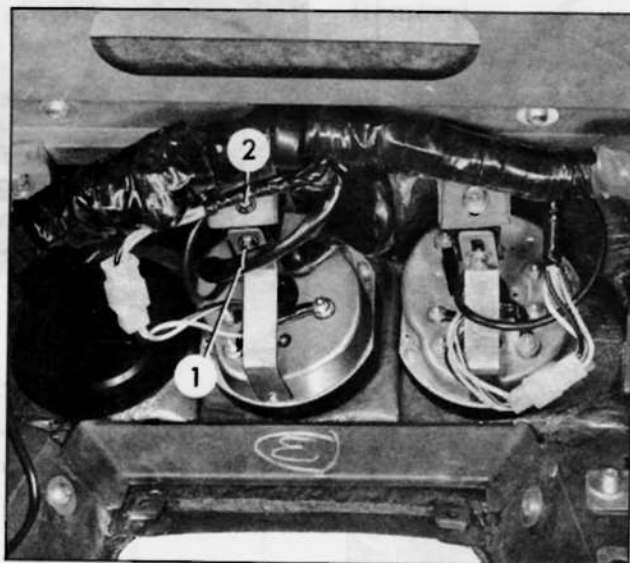
Fig. BE-21 Removing ammeter and fuel gauge

Remove the ammeter and fuel gauge unit in the same manner as for the oil pressure gauge and water temperature gauge. To be more specifically, when removing the

ammeter and fuel gauge unit, remove the meter bracket and remove hexagonal cross-headed screws [① and ② Figure BE-23] from reverse side of the meter.

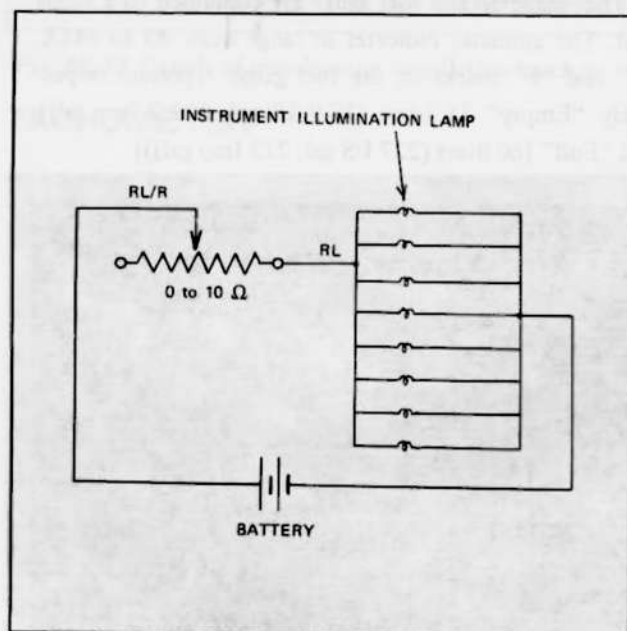
Fig. BE-22 Circuit diagram of illumination control

The illumination control is a variable resistor

(Rheostat) with which the meter illumination can be controlled (none step) to get proper brightness so that meters can be seen clearly.

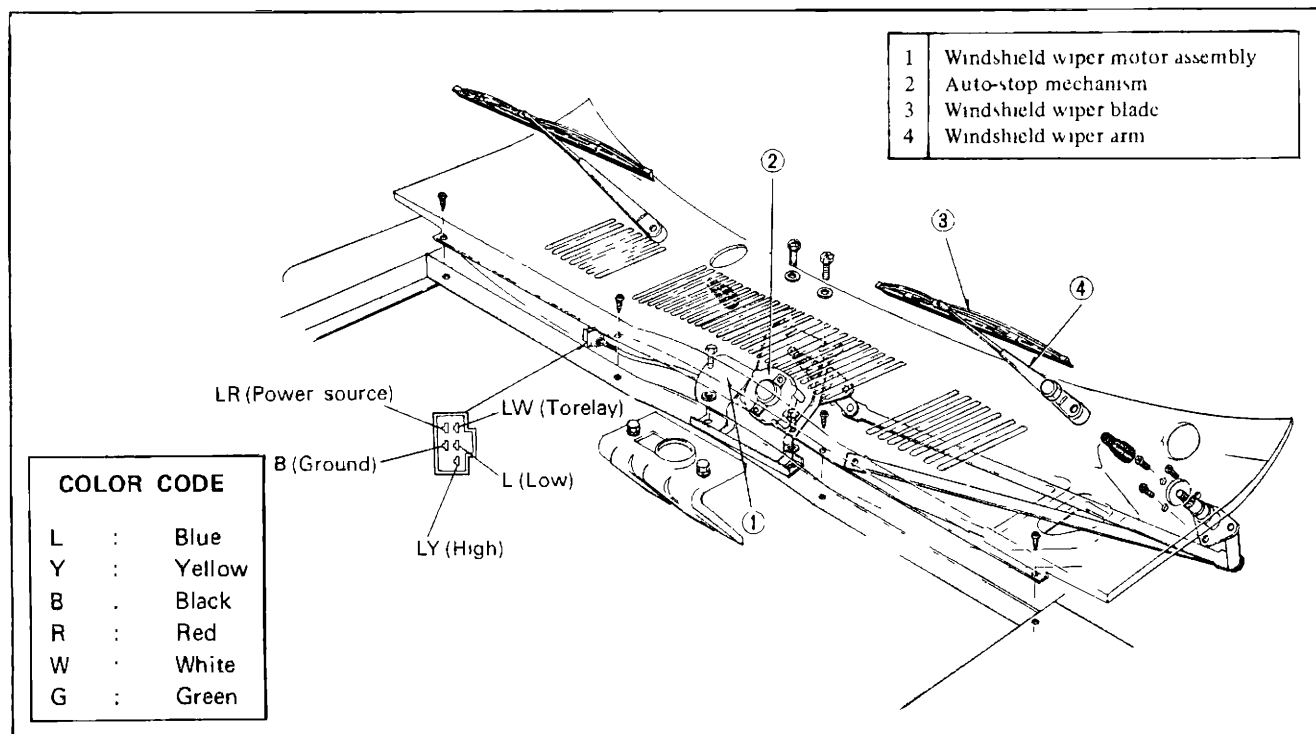
Fig. BE-24 Structure of windshield wiper

| Wiping system | Parallel interlock system (tandem type) | |
| Wiping angle | 86° (Driver side) | 96° (Assistant side) |
| Rise-up angle | 4° 30' (Driver side) | 5° 30' (Assistant side) |
| Blade length | 460 mm (18 in) | |
| Arm installation method | Tapered serration | |

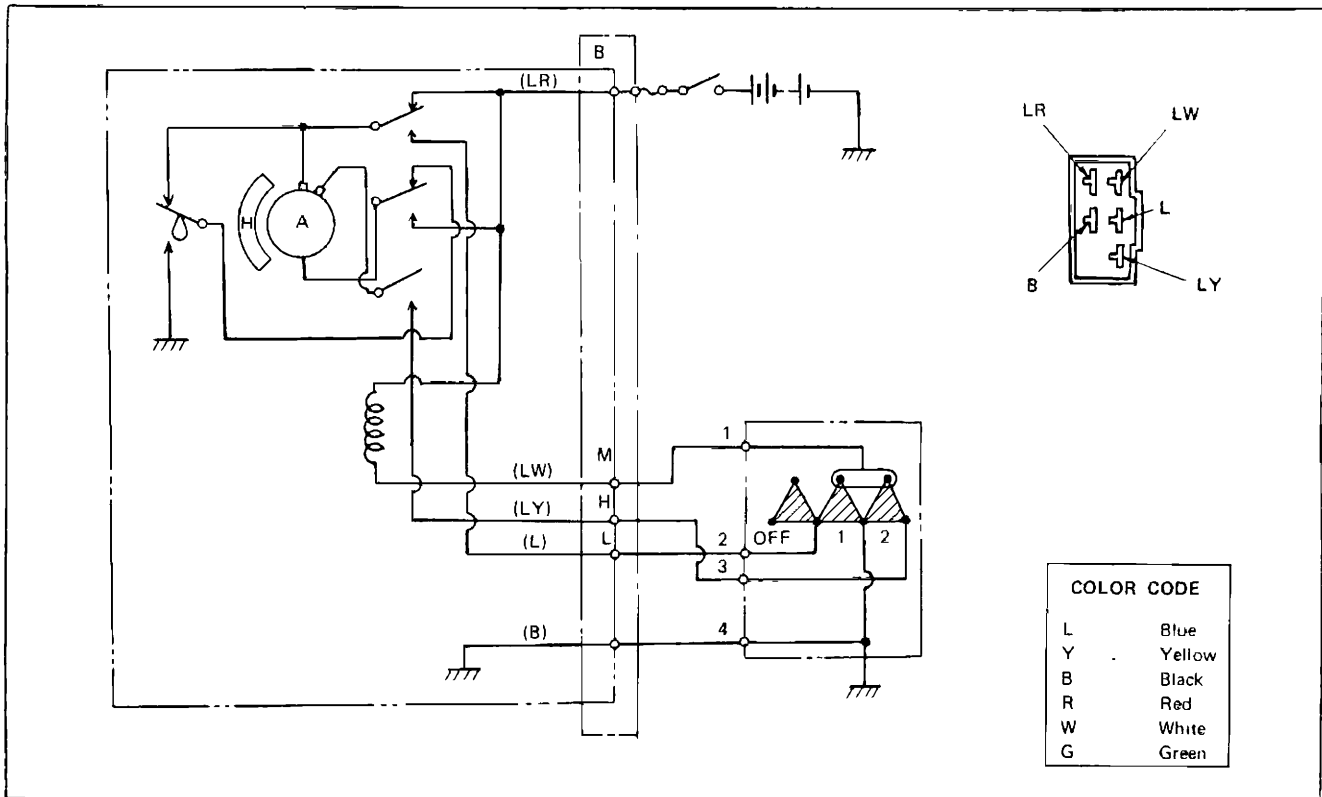
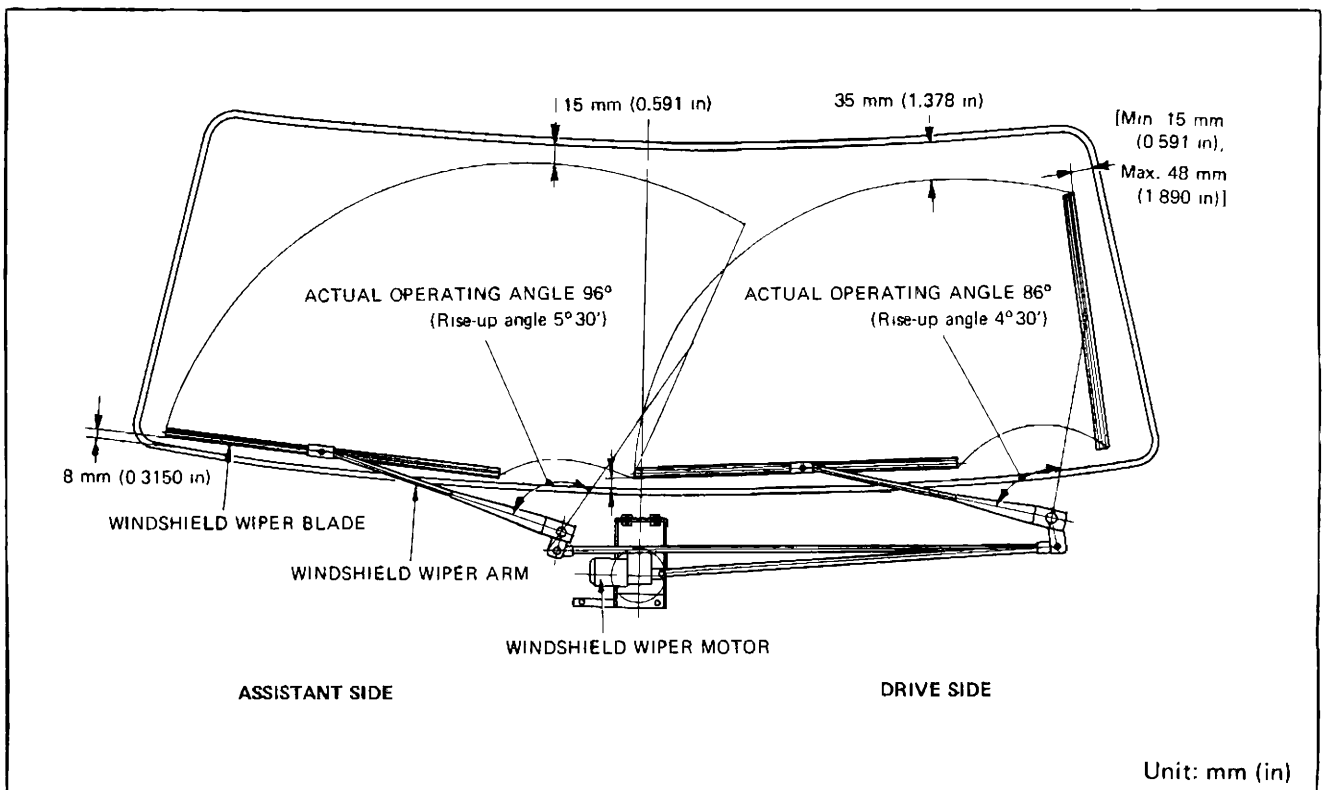
Fig. BE-25 Wiper blade operating range

Install the windshield wiper blade in such a position that the blade comes into contact with the weather strip upper line lightly.

Tighten the windshield wiper blade arm lock nut under 80 to 100 kg-cm (70 to 87 in-lb) tightening torque.

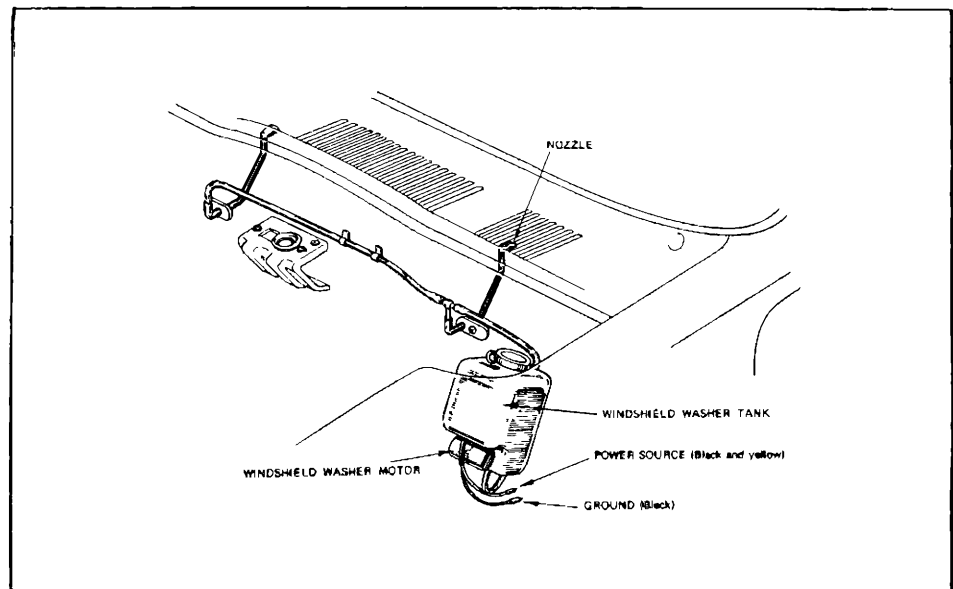
Fig. BE-26 Structural view of windshield washer

Washer tank capacity 1.5 liters (3.96 US gal, 3.30 Imp gal).

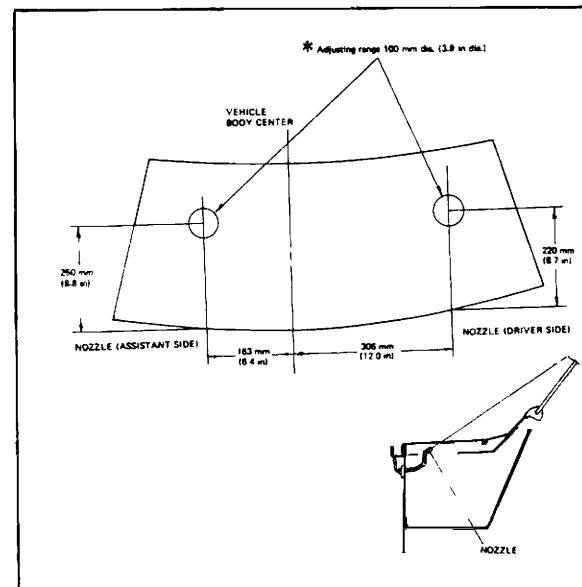
Fig. BE-27 Adjusting washer nozzle

When reassembling washer nozzle or washer fluid is not sprayed properly, adjust the nozzle direction using a pair of pliers so that fluid is sprayed in range indicated by asterisk mark (\*) in Figure BE-31.

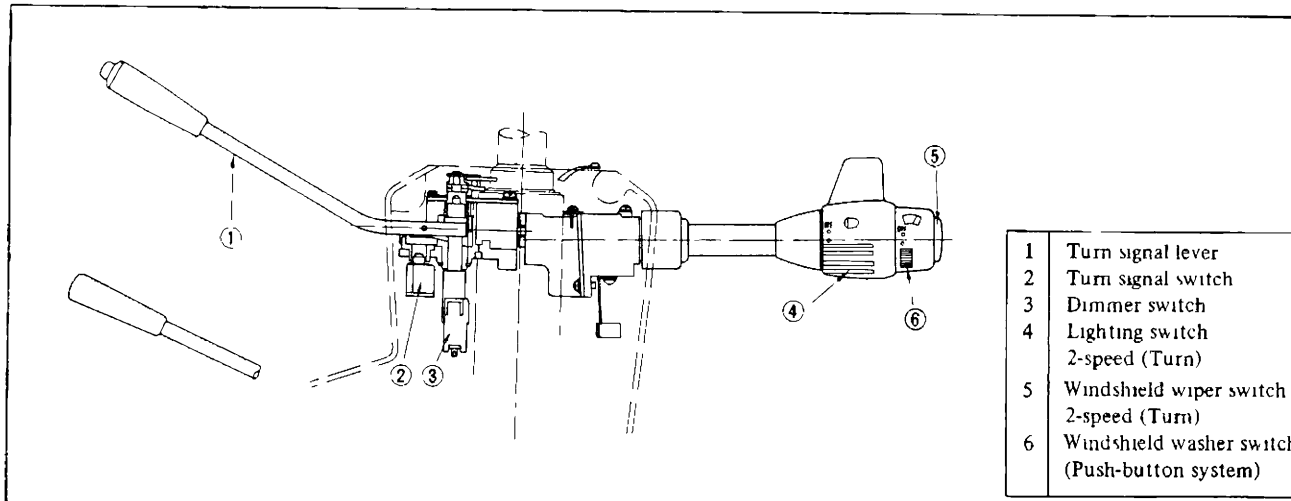
Fig. BE-28 Structural view of combination switch

The combination switch is split into two compartments; one consists of lighting switch, wiper switch,

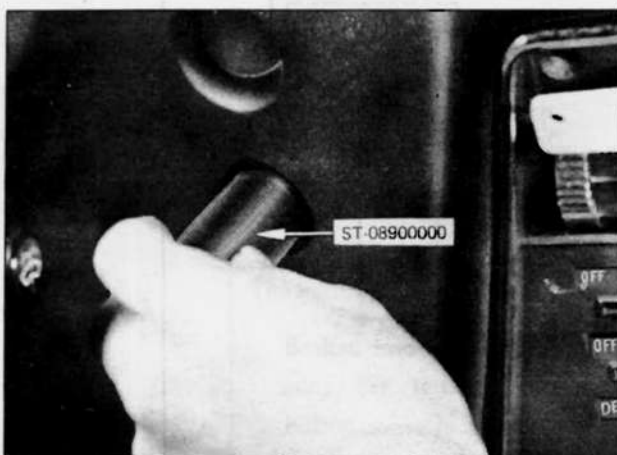
Fig. BE-31

This switch is a tumbler switch. When removing, remove the installation screw from the switch boss portion.

When removing, use the tumbler switch replacer (special tool ST08900000).

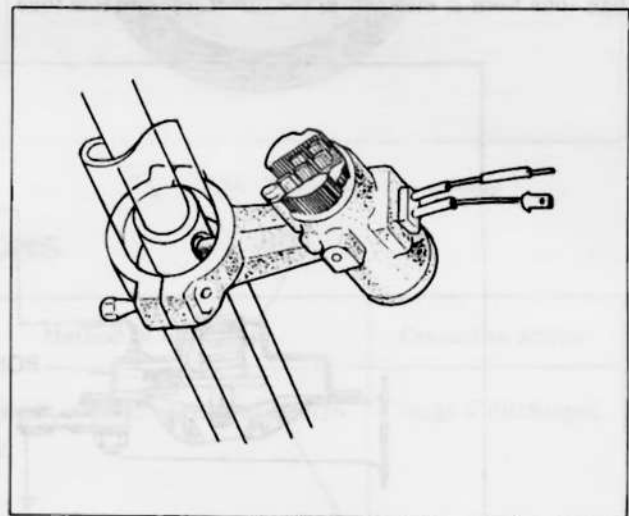
Fig. BE-32 Steering lock

The steering lock is combined with the ignition switch to a single unit which contains warning buzzer micro-switch for reminding the drive to lock the steering. The microswitch is connected to a warning buzzer.

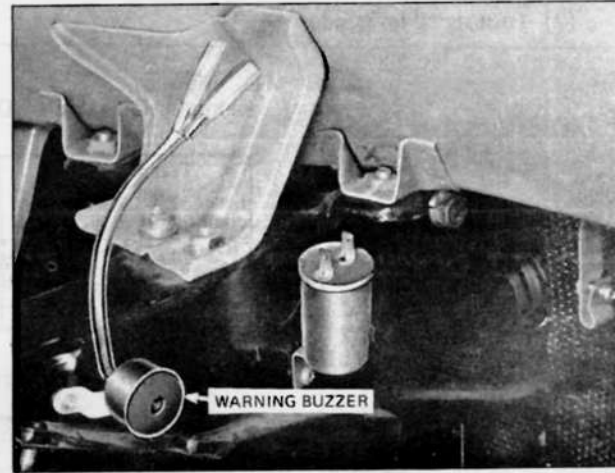
Fig. BE-33 Removing warning buzzer

The warning buzzer is installed on the steering support. When removing the warning buzzer, disconnect steering lock side microswitch cables, and remove two warning buzzer installation screws.

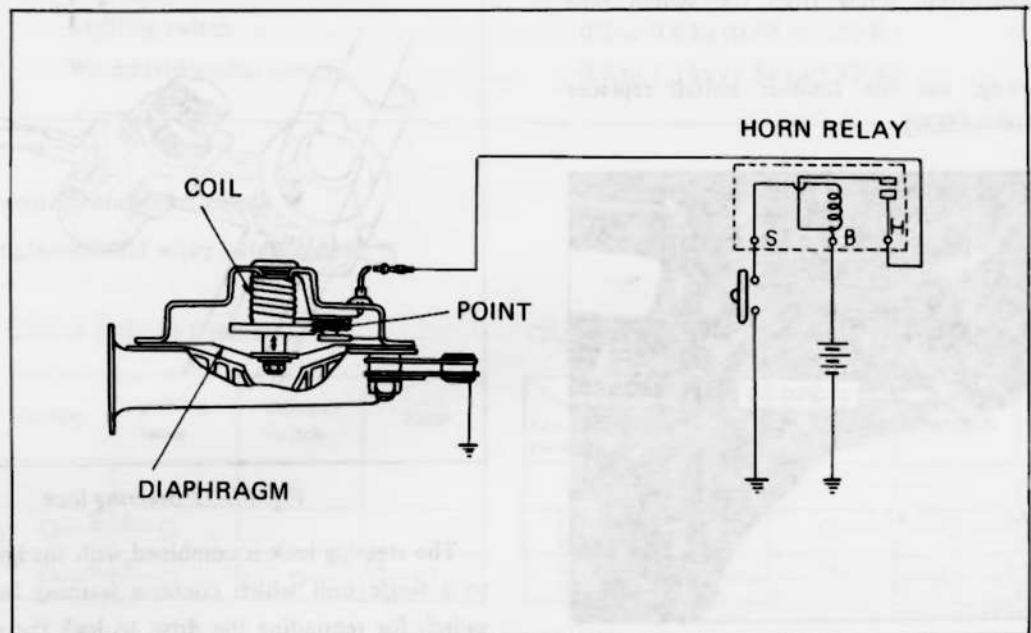
Fig. BE-34 Horn and horn relay circuit diagram

The horn is installed on the top of front crossmember. High tone horn is installed in the driver side and low tone

horn is installed in the assistant side facing toward front. The horn relay is installed on the left side dash side panel.

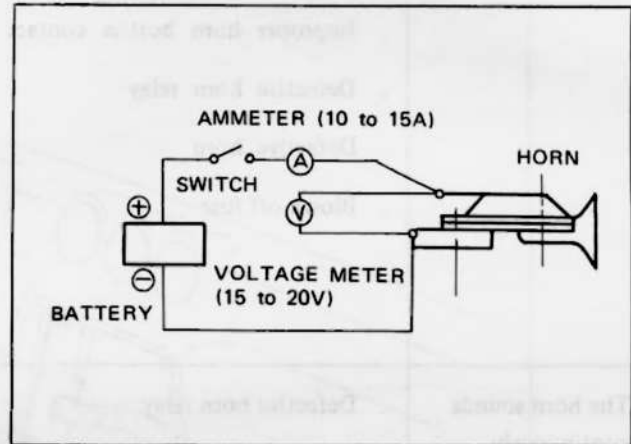
Fig. BE-35 Circuit diagram of horn

1. Apply voltage meter and connect cables as shown in Figure BE-39.
2. Turn on the switch, make sure that the voltmeter indicates 12 to 12.5V, and adjust as described below so that the ammeter indicates approximately 3A.
3. Lock nut in reverse side of the body
  - (1) Turn the lock nut in counterclockwise .....Volume and current increases.
  - (2) Turn the lock nut in clockwise ..... Volume and current reduces.
4. When a proper volume is obtained through the above described method, raise the voltage to 14 or 15V, and further adjust the volume to better sound.
5. A proper sound obtained at range from 12 to 15V is the best adjusting point.  
Lock the nut at that position.

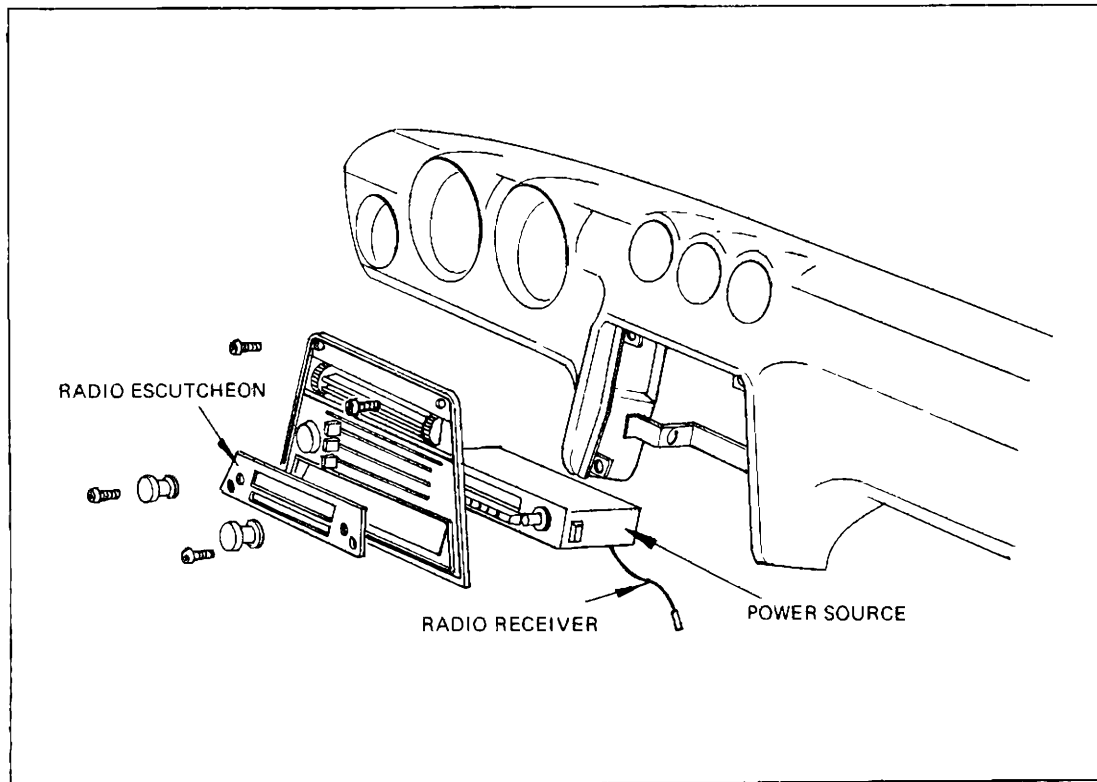
Fig. BE-37 Structural view of radio

The radio receiver proper is a special unit designed for the Model S30 vehicles. The radio receiver unit is fitted flush into the instrument console box.

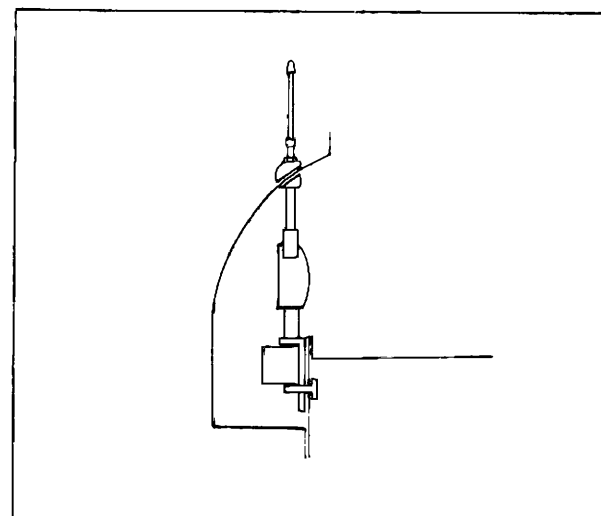
Fig. BE-39 Installing antenna

1. Insert the antenna into the antenna installation hole on the left side rear fender from the passenger compartment side.
2. Install the antenna mounting bracket on the body side.
3. Install the antenna upper unit from the outside of the rear fender.

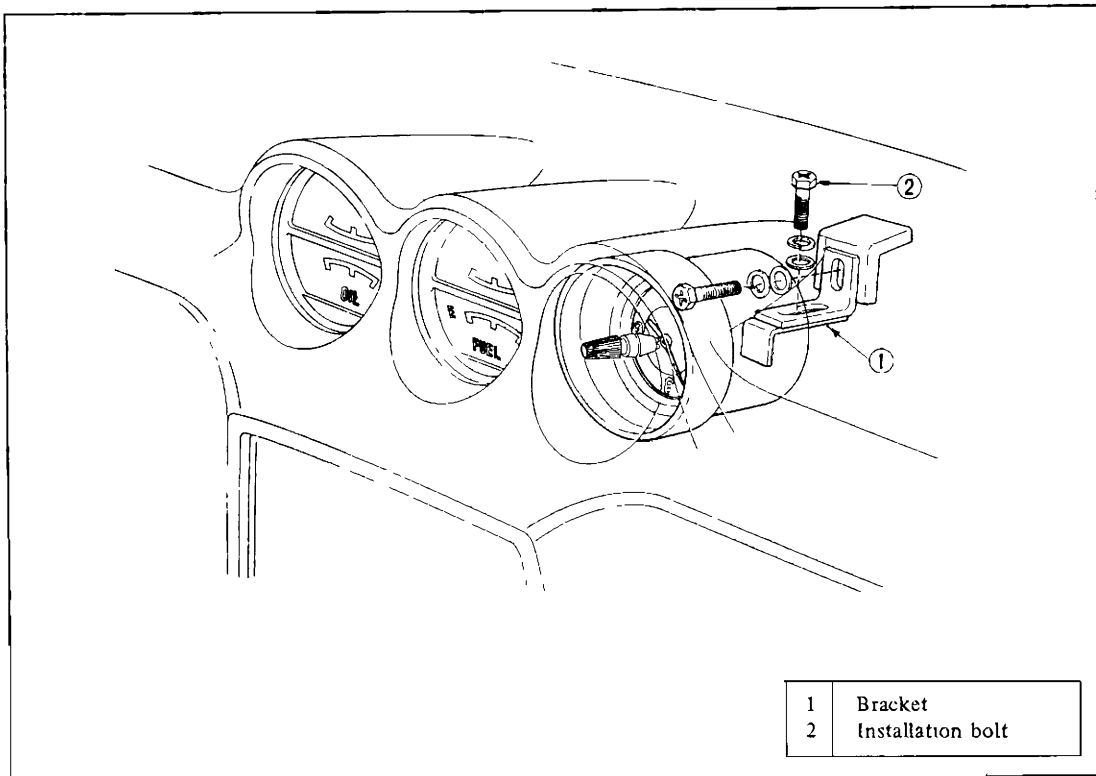
Fig. BE-41 Installing clock

1. Remove the center console finisher.
2. Remove the radio mask, and install the clock thereon.
3. Secure the radio bracket on the L-shape bracket in the instrument panel side with screws.

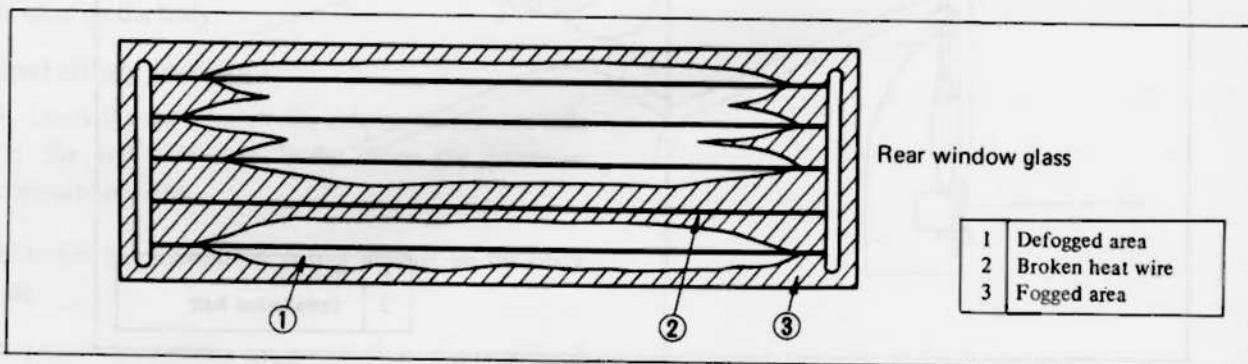
Fig. BE-44 Defogging pattern

1. How to locate a broken heat wire and a break
  - (1) Method 1 - Start the engine and turn on the rear window defroster system. If the area around a specific heat wire is not defogged, that line is broken.

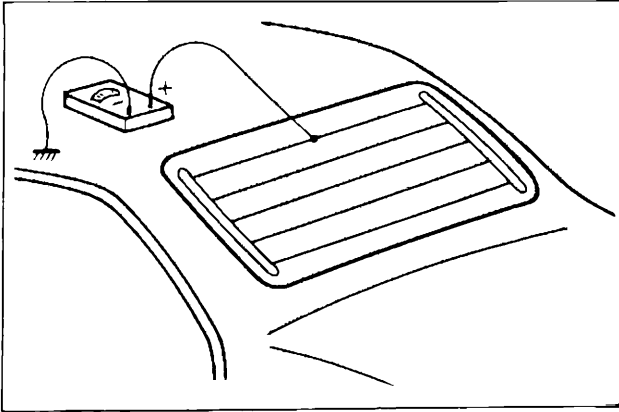
Fig. BE-45 Checking for broken heat wire with d-c voltmeter

(2) Method 2 — Start the engine and turn on the window defroster system. With a d-c voltmeter setup shown in Figure BE-45, check each heat wire for discontinuity. If the meter indicates 12 volts or 0 on a specific wire, that line is broken. (Normal indication. 6 volts)

A break in that line can then be detected by moving the positive lead of meter along the line until an abrupt variation in the meter indication is encountered.

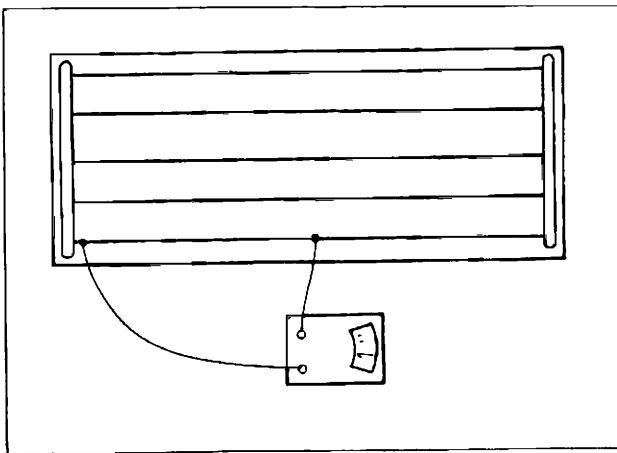
Fig. BE-46 Checking for broken heat wire with ohmmeter

(3) Method 3 With an ohmmeter setup shown in Figure BE-46, locate one lead on each end of a heat wire and the other in the middle section of that wire. If the meter registers, on a specific grid line, a value twice as much on any other line, that line is broken.

A break in that line can then be located by an abrupt variation in the meter indication as the test lead moves along the broken heat wire.

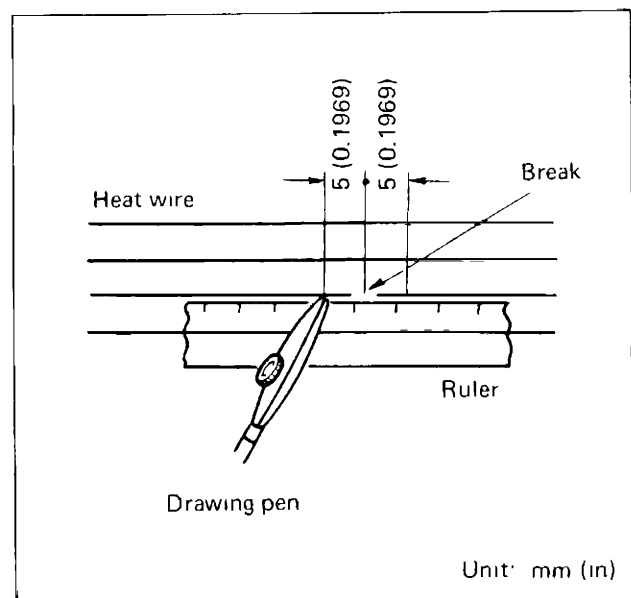
Fig. BE-47 Locating ruler in position

- Place ruler on glass along broken line to be repaired as shown in Figure BE-47. Deposition of conductive silver composition to break line with drawing pen. Slightly overlap existing heat wire either side [5 mm (0.1969 in) preferable] of the break.

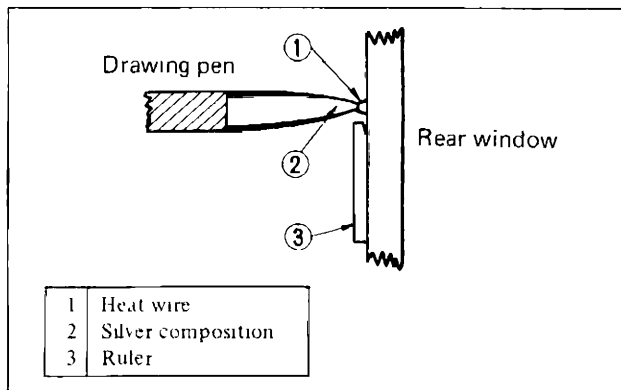
Fig. BE-48 Depositing silver composition in place

- Wipe clean broken heat wire and its surrounding area with a cloth dampened in alcohol.
- Apply a small amount of conductive silver composition to the tip of drawing pen.
