# SERVICE MANUAL

DATSUN 240Z  
MODEL S30 SERIES

## SECTION ST

### STEERING

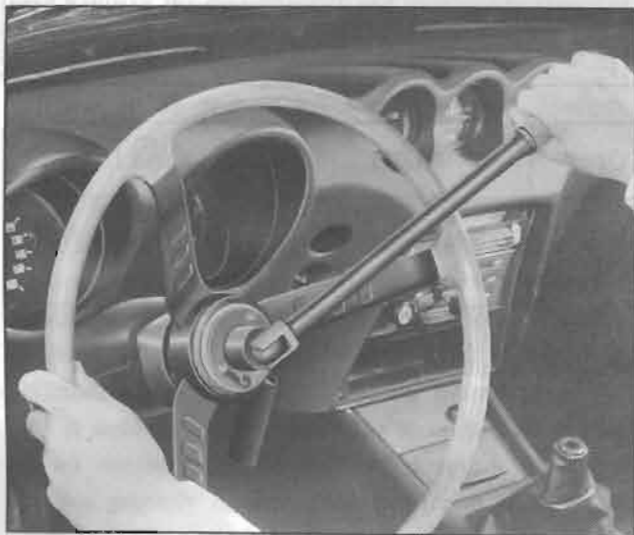
*Fig. ST-3 Removing steering wheel*

1. Remove the horn button by pulling rearward. Remove the steering wheel after removing the steering wheel nut.

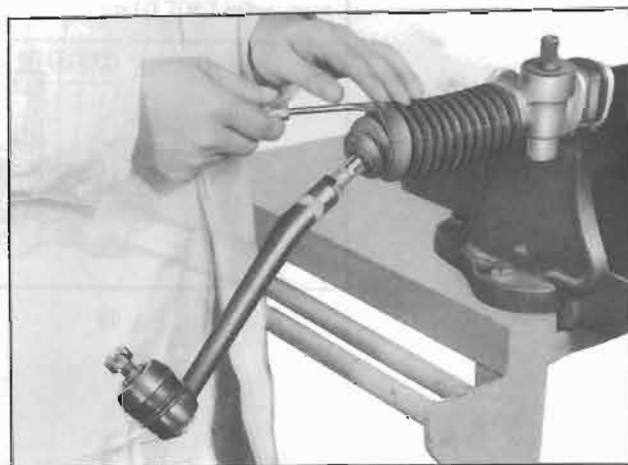
*Fig. ST-16 Removing dust cover clamp*

1. Disconnect the steering lower joint from the rack-and-pinion assembly.
2. Clamp the rack-and-pinion assembly in a vise by using patches on the steering gear housing to avoid scarring.
3. Remove the dust cover clamp and boot clamp from the steering gear boot. (Both left and right.)

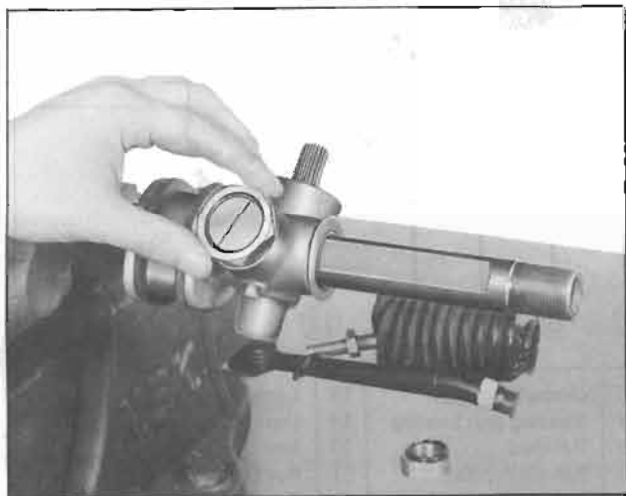
*Fig. ST-18 Removing side rod outer socket*

6. Loosen the side rod lock nut and disconnect the side rod outer socket assembly from the side rod bar.

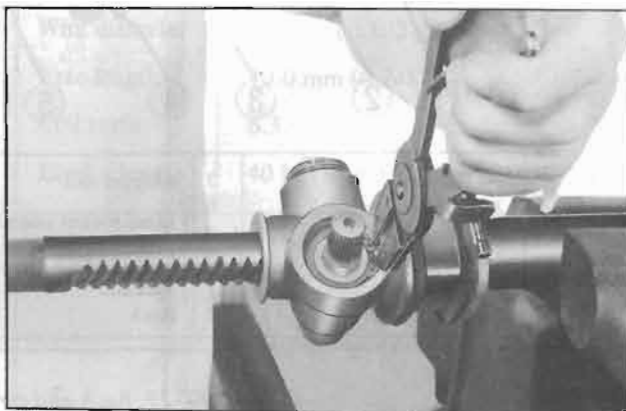
*Fig. ST-21 Removing snap ring*

9. Remove the snap ring and draw out the steering pinion assembly.

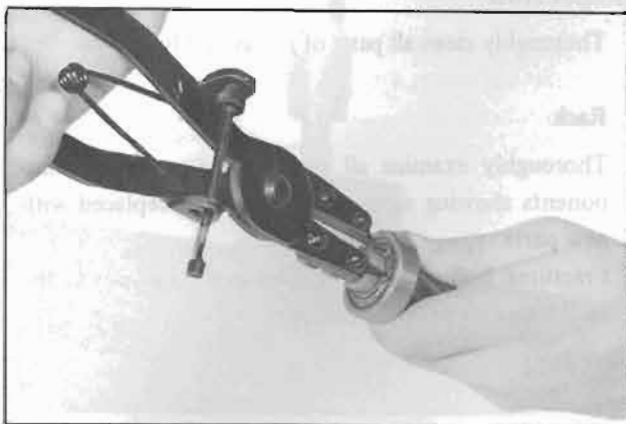
*Fig. ST-22 Removing snap ring*

10. Remove the snap ring and draw out the bearing from the pinion.

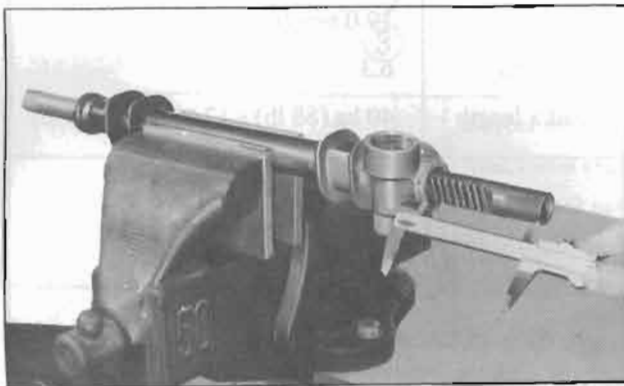
Fig. ST-26 Measuring protruding portion of rack

3. Clamp the steering gear housing in a vise.
4. Evenly apply recommended multipurpose grease to teeth and friction surfaces of the rack, and lubricate the gear housing from the pinion housing side.
5. Make sure that the rack protrudes by the same amount from both ends of the housing [96 mm (3.78 in)] and that rack teeth are directed toward the pinion shaft.

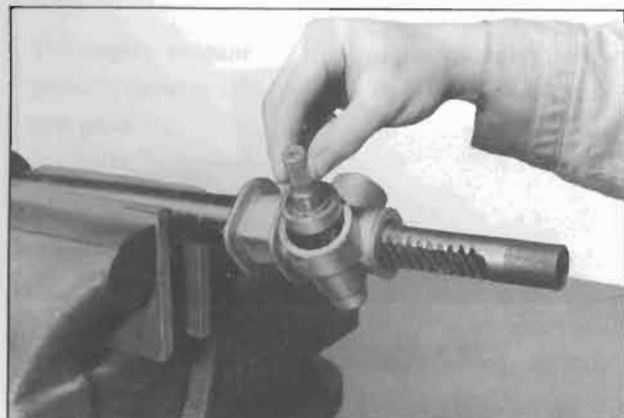
Fig. ST-27 Inserting pinion

6. Evenly apply recommended multipurpose grease to the pinion teeth, end bushing, and pinion bearing.
7. Mesh the teeth of the pinion to those of the rack, and insert the pinion without damaging the bushing.

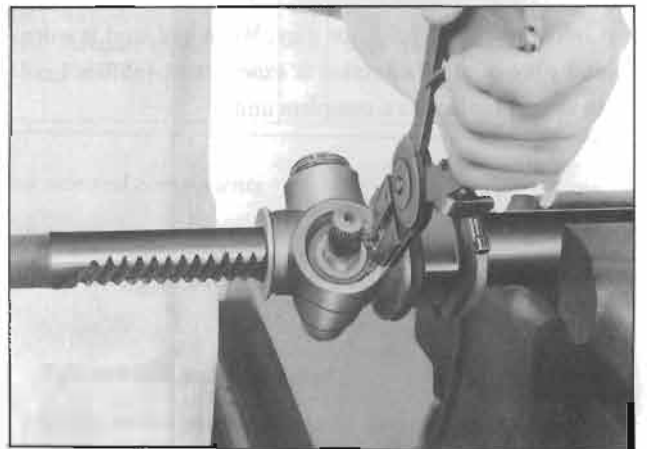
Fig. ST-29 Fitting snap ring

9. Fit the snap ring, holding the bearing outer race in place.

**Note:** Carefully fit the snap ring to the housing groove. Use the tightest snap ring among the variations.

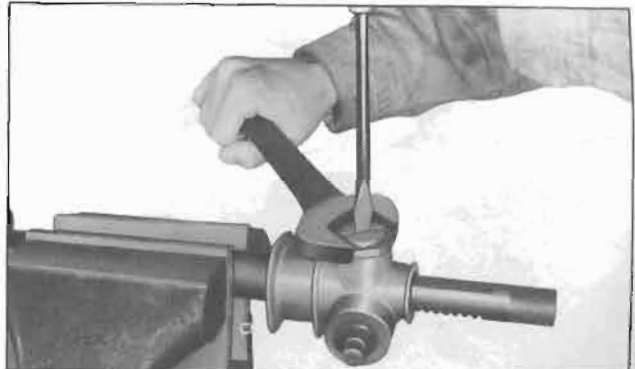
*Fig. ST-33 Locking retainer lock nut*

14. Fully tighten the adjusting screw and back off 20 to 25 degrees. Lock this screw with the lock nut.

Retainer floating play: 0.09 mm (0.0035 in)  
Lock nut tightening torque: 4 to 6 kg-m  
(28.9 to 43.4 ft-lb)

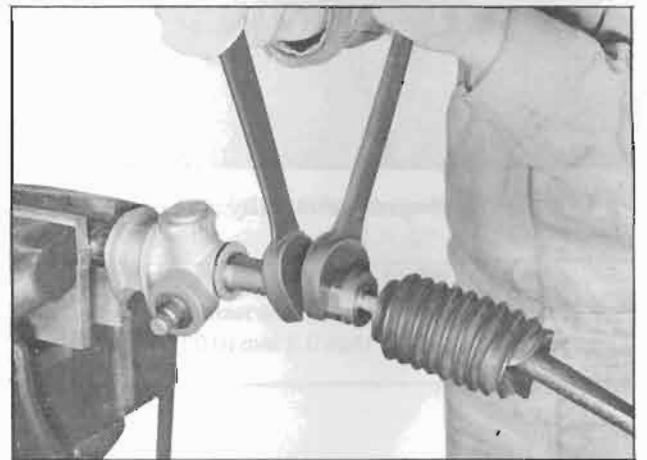
Fig. ST-38 Locking the stopper nut

21. Tighten the inner socket portion until the ball seat reaches the rack end, and lock with the stopper nut.

7 to 9 kg-m (50.6 to 65.1 ft-lb)

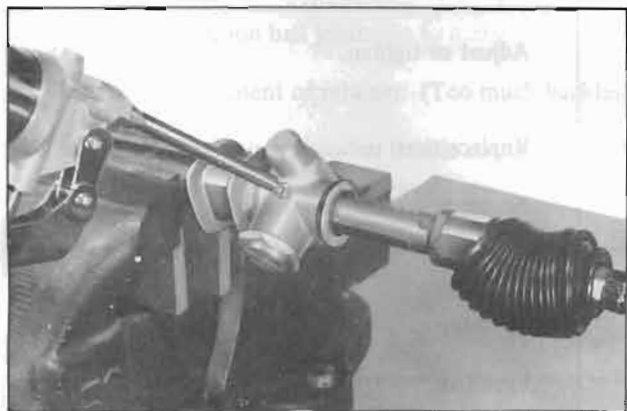
Fig. ST-40 Supplying the grease

23. Install a grease nipple at both ends of the rack-and-pinion housing, and apply recommended multipurpose grease to each joint.

Note: Lubrication of the rack ends is made so that a small quantity of new grease appears at the boot grease outlet hole, and lubrication of the pinion housing is made so that a small amount of grease appears between the rack and housing.
