# SERVICE MANUAL

DATSUN 260Z  
MODEL S30 SERIES

### COOLING SYSTEM

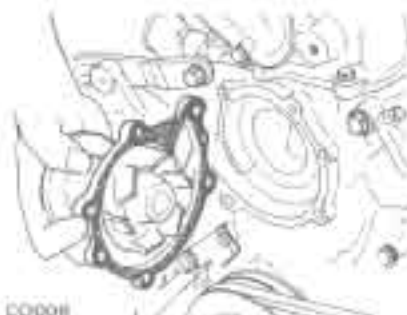
1. Drain coolant into a clean container.
2. Loosen bolts retaining fan shroud to radiator and remove shroud.
3. Loosen belt, then remove fan blade and pulley from hub.
4. Remove pump assembly and gasket from front cover.

Fig. CO-3 Removing water pump

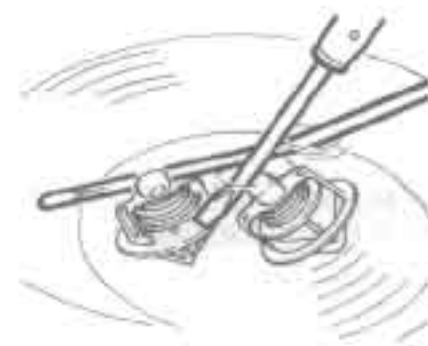
CO011

1. Submerge thermostat in hot water 5°C (9°F) above the temperature specified in the following table.
2. After preparing for the marked screwdriver at about 8 mm (0.315 in) from the tip, inspect the lift height of valve by inserting it.
3. Now, place thermostat in water 5°C (9°F) below the specified temperature.

Fig. CO-7 Inspecting thermostat

| | Standard | For cold areas | For tropical areas |
|---|---|---|---|
| Valve opening temperature | 82°C (180°F) | 88°C (190°F) | 76.5°C (170°F) |
| Max. valve lift | above 8 mm at 95°C (0.315 in at 203°F) | above 8 mm at 100°C (0.315 in at 212°F) | above 8 mm at 90°C (0.315 in at 194°F) |

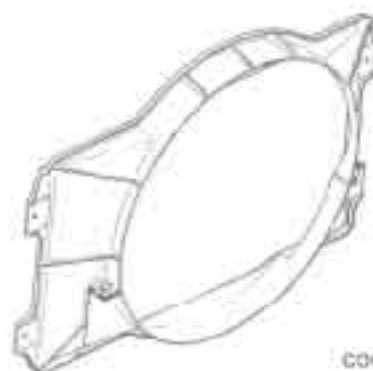
CO036

Fig. CO-9 Radiator shroud  
(for the model equipped  
with air conditioner)

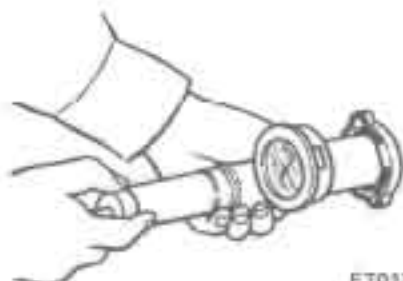
ET012

Radiator cap should be checked for working pressure at regular tune up intervals. First, check rubber seal on

cap for tears, cracks or deterioration after cleaning it. Then, install radiator cap on a tester. If cap does not hold or will not release at the specified pressure, replace cap.

Fig. CO-10 Testing radiator cap

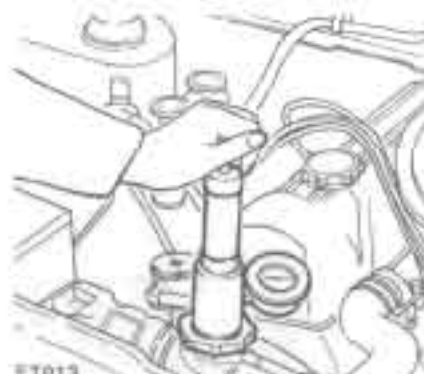
ET013

Fig. CO-11 Testing cooling system  
pressure

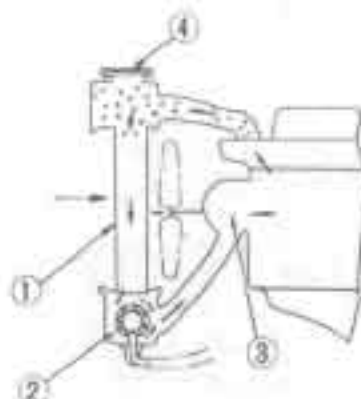
CO038

1. Radiator
2. Oil cooler
3. Water pump
4. Cap for water supply

Fig. CO-12 Structural view of cooling system
