Power Assisted System (Power Steering)

## 1. General Description S601001

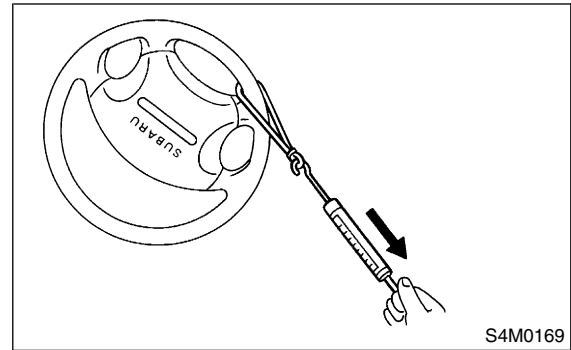
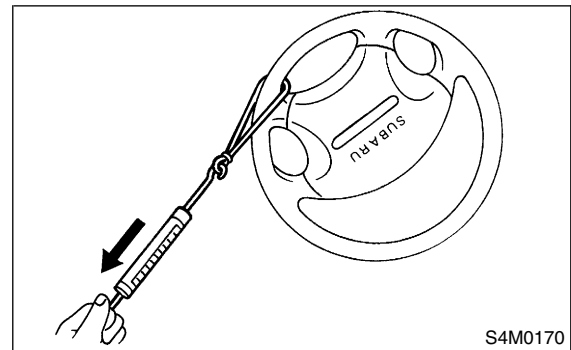
Measurement of steering effort is as shown in the figures.
