22. Rear Side Marker Light Bulb

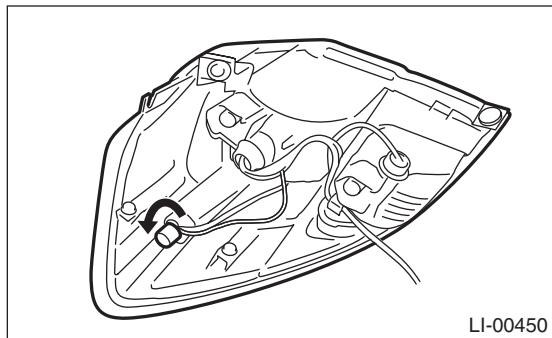
- 1) Remove the rear combination light assembly. <Ref. to LI-23, WAGON MODEL, REMOVAL, Rear Combination Light Assembly.>
- 2) Turn the socket and remove the bulb.
