## 27. Roof Trim

### A: REMOVAL

#### 1. SEDAN MODEL

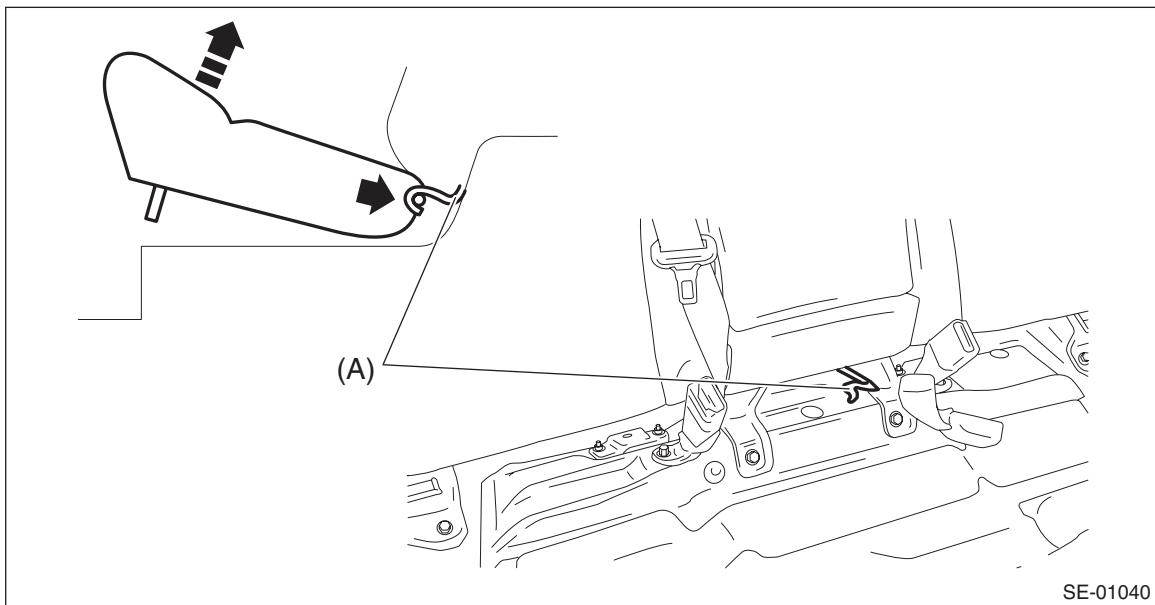
(2) Remove the hook (A) by pushing it back while lifting the front side of the seat cushion, and remove the seat cushion.

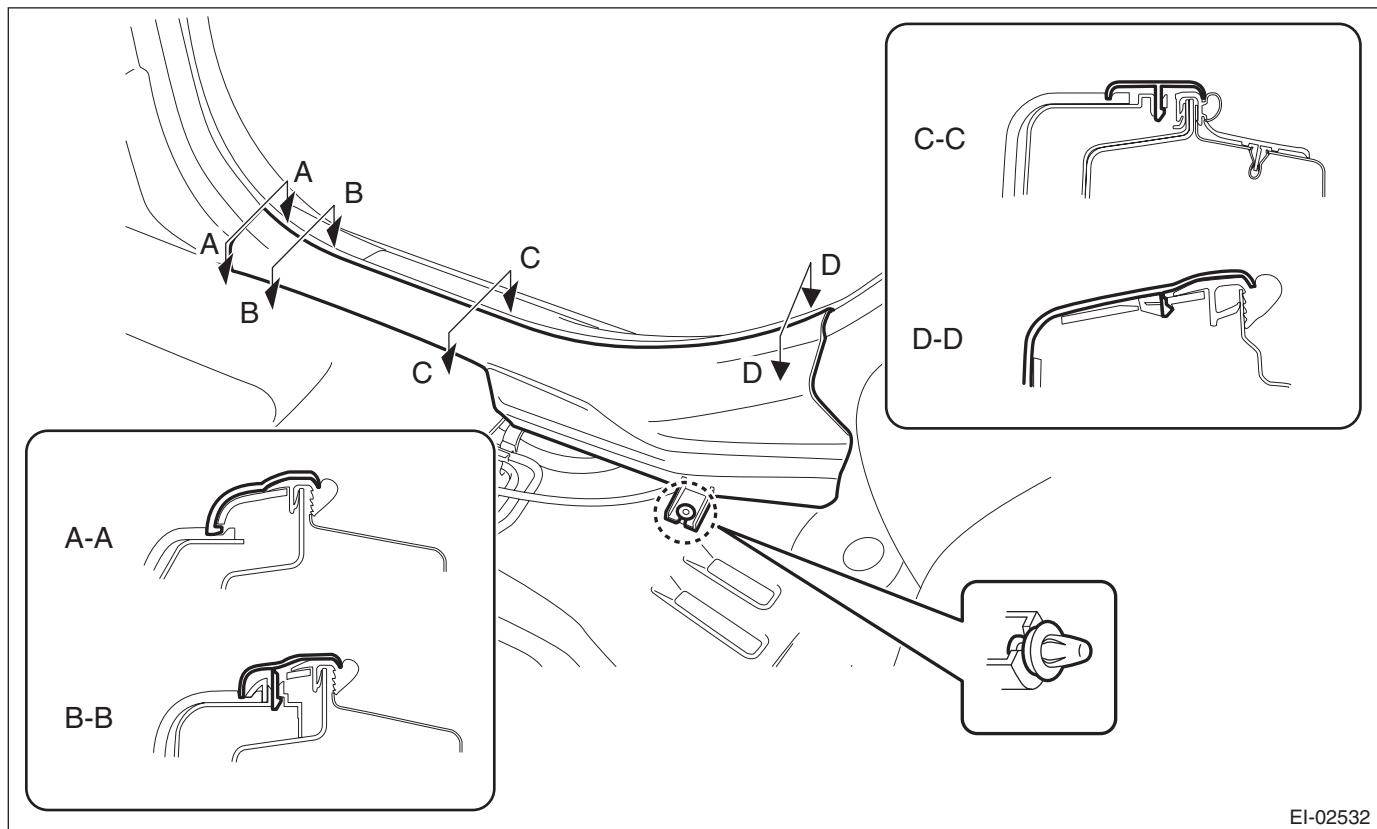
2) Release the clips and claws, and then remove the left and right side sill covers-rear INN.

To release the claws of the side sill cover INN, the following steps are recommended.

1. Take out the weather strip from under the side sill cover INN.
2. Turn over the floor mat and release the claw (C-C and D-D) by accessing from behind the side sill cover INN.

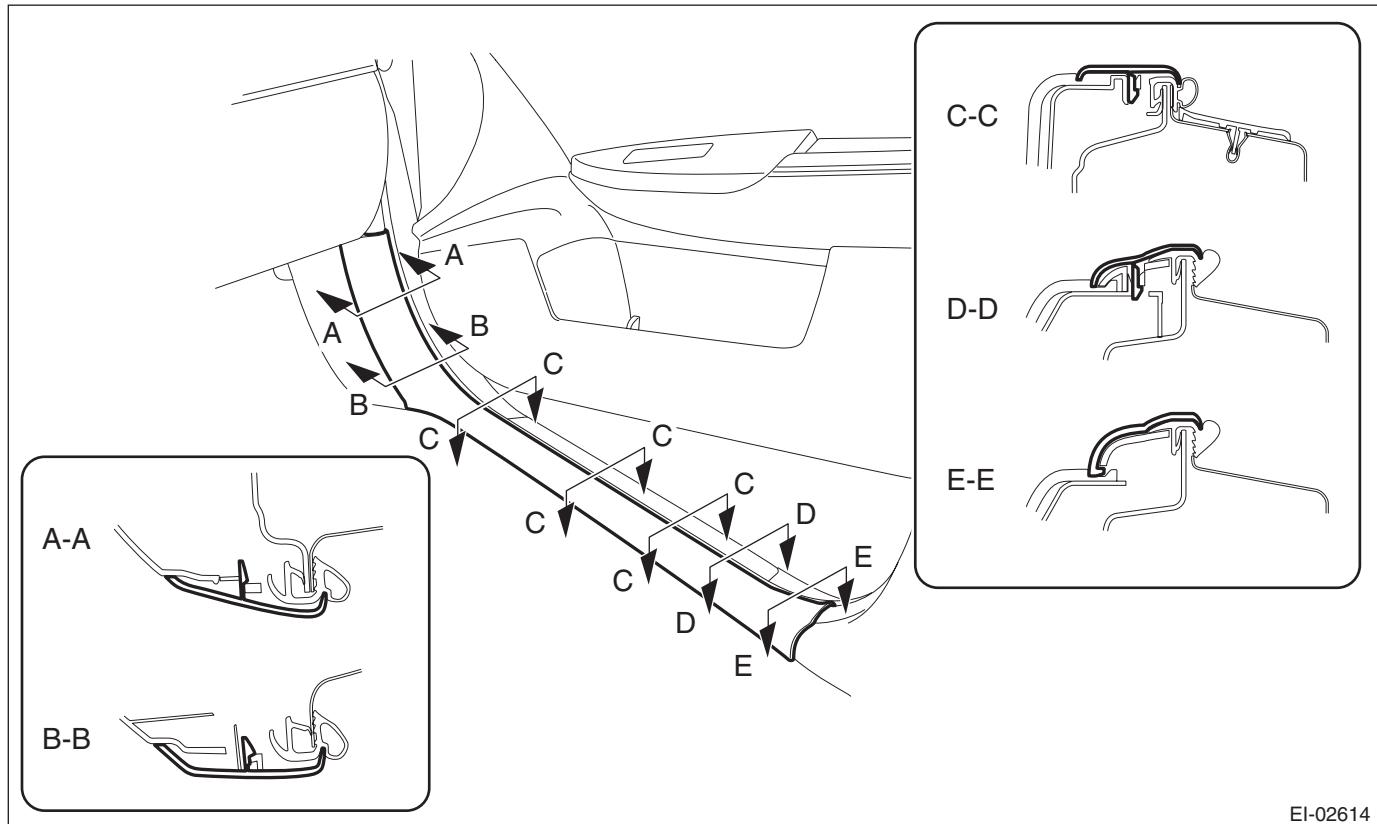
EI-02614

3) Release the claws, and then remove the left and right side sill cover-front INN.

To release the claws of the side sill cover INN, the following steps are recommended.

1. Take out the weather strip from under the side sill cover INN.
2. Turn over the floor mat and release the claw (C-C) by accessing from behind the side sill cover INN.

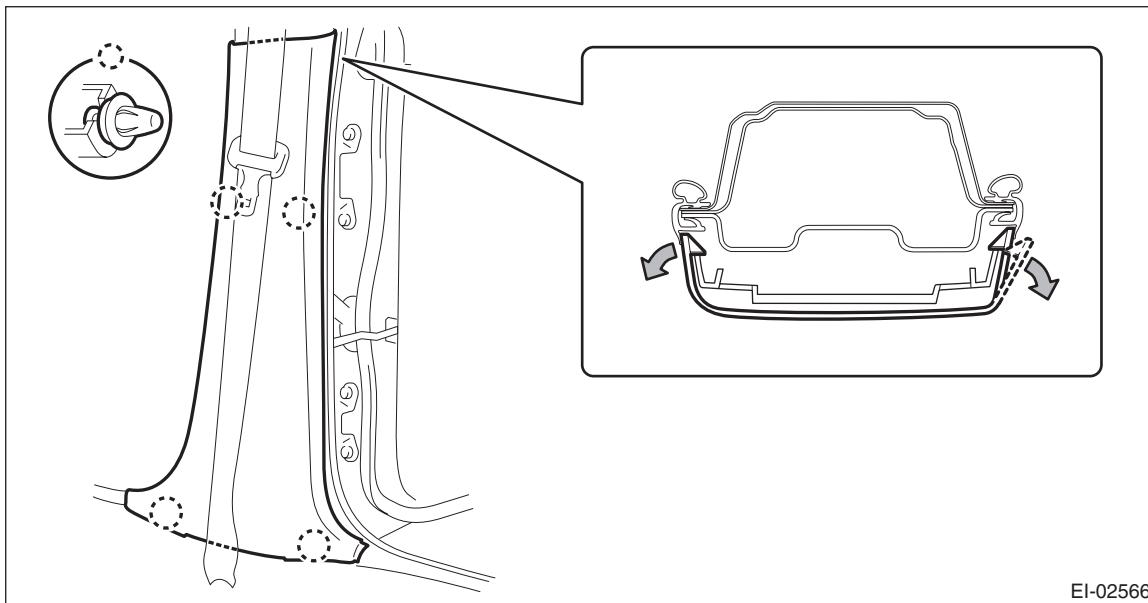
4) Remove the left and right center pillar trim LWR.

(1) Release the clip by pulling the center pillar trim LWR toward you.

(2) Expand the claws of center pillar trim LWR outward and remove it from the center pillar trim UPR.

**Do not expand the center pillar trim LWR excessively. Doing so may damage the trim.**

First release the claw located to the rear of the vehicle.

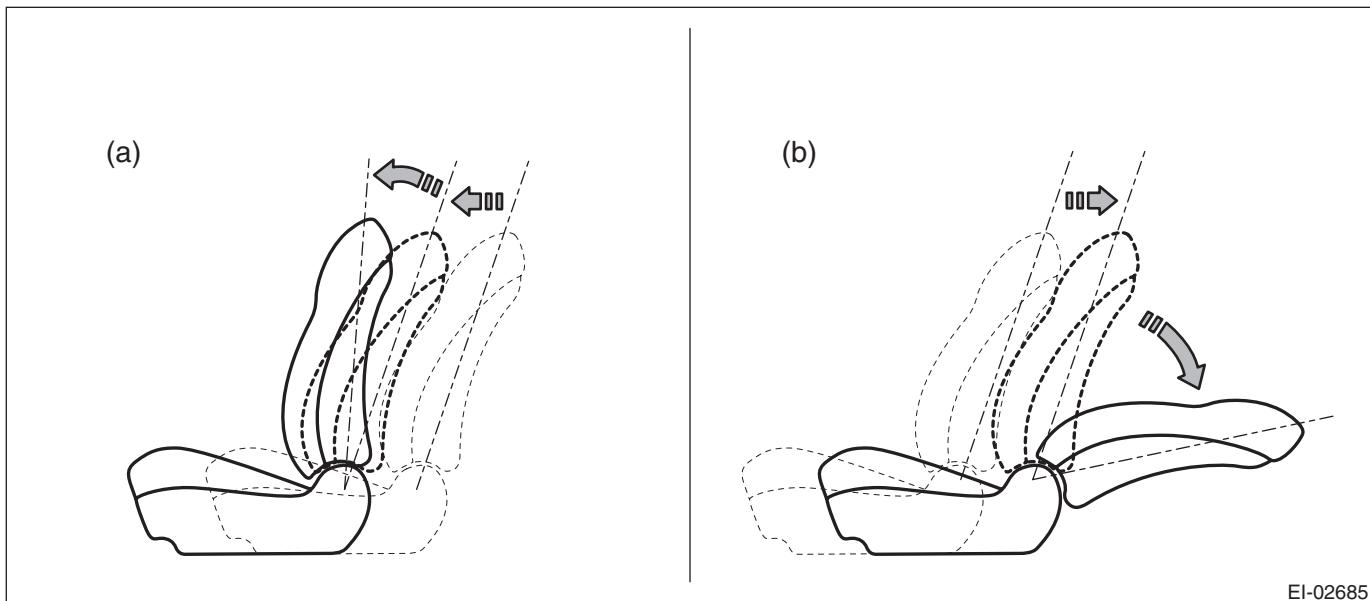
EI-02685

(2) Tilt the driver's seat backrest forward and move the seat to the front most position. (a)  
 (3) Tilt the passenger's seat backrest rearward and move the seat to the rearmost position. (b)

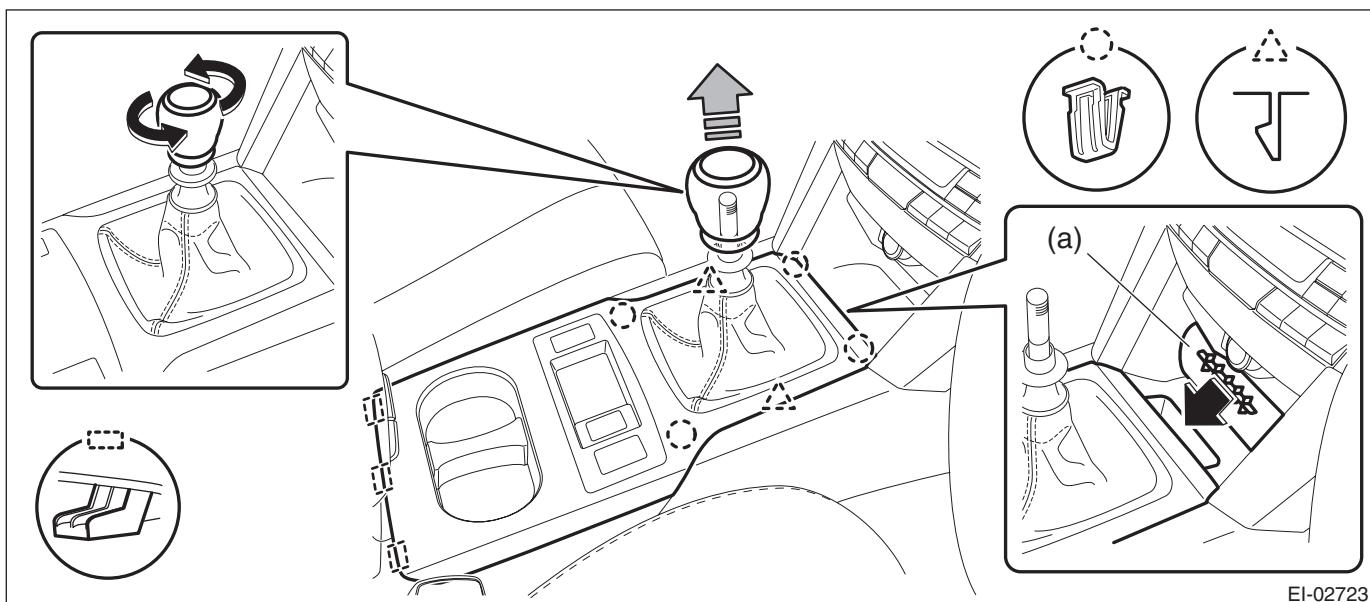
EI-02723

- MT model
  1. Remove the shift knob.
  2. Release the clips and claws, then pull up the console front cover assembly.

Turn over the front center pocket mat (a) and pull up the console front cover from the slit.

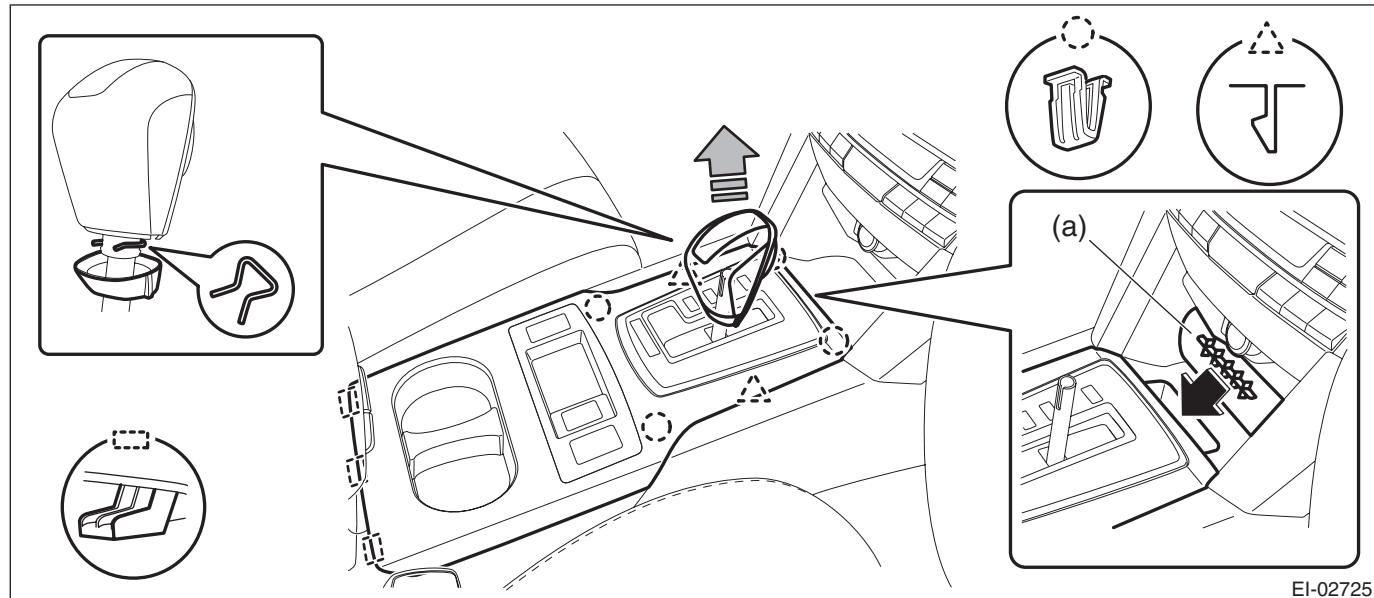
1. Remove the select lever knob.
  - a. Lower the cover grip AT.
  - b. Remove the clamp grip pin, then remove the select lever knob.
2. Release the clips and claws, then pull up the console front cover assembly.

Turn over the front center pocket mat (a) and pull up the console front cover from the slit.

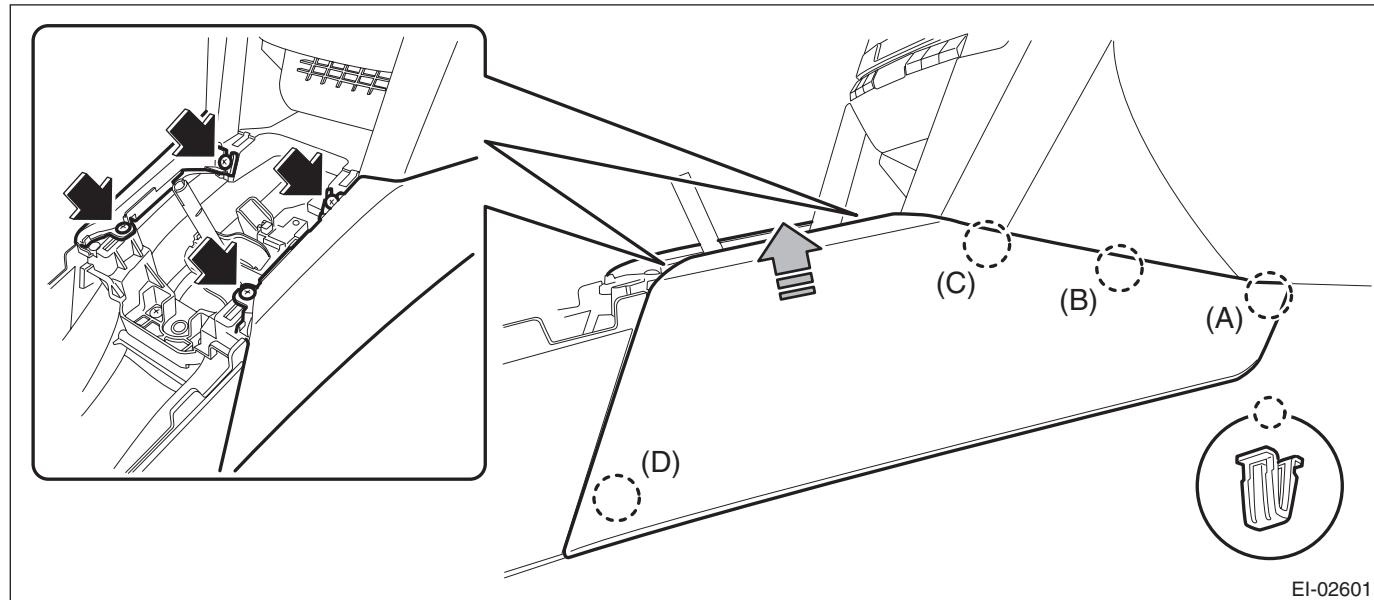
3. Disconnect the harness connector and remove the console front cover assembly.
- 9) Remove the left and right console front side cover assembly.
  - (1) Remove the screws and release the clips (A) to (D) in order.
  - (2) Remove the console front side cover assembly by pulling it up.

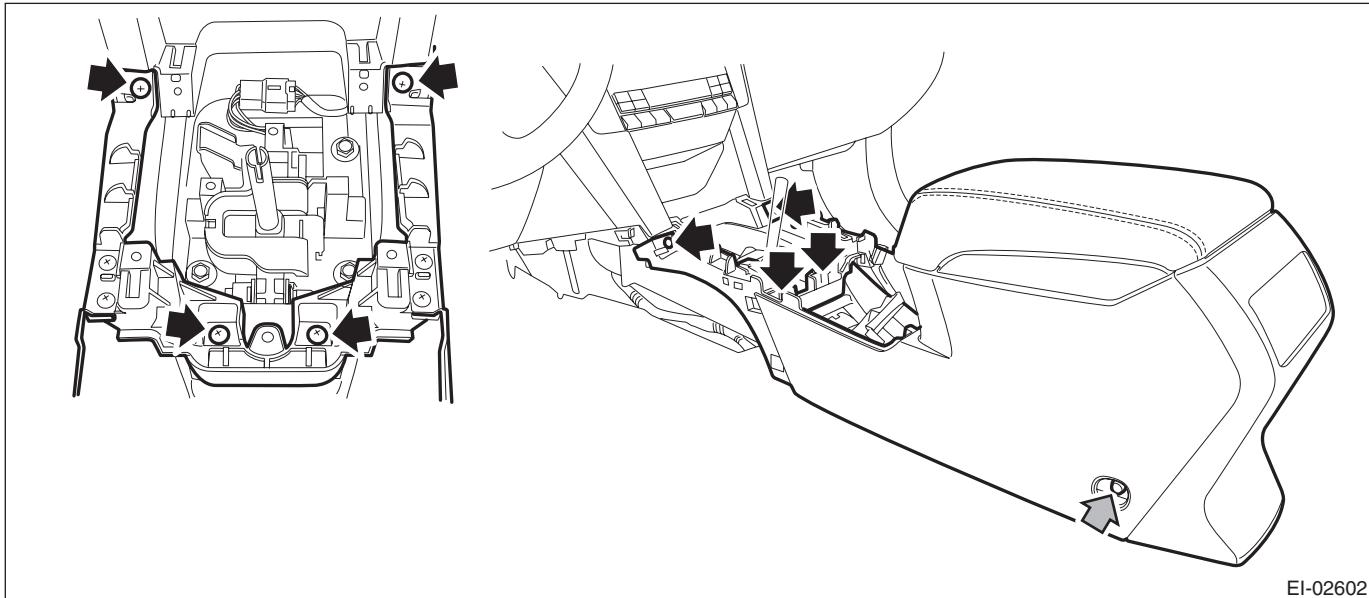
(1) Move the seat, and remove the bolts after detaching the left and right caps.

(2) Remove the screws, disconnect the harness connector and remove the console box assembly.

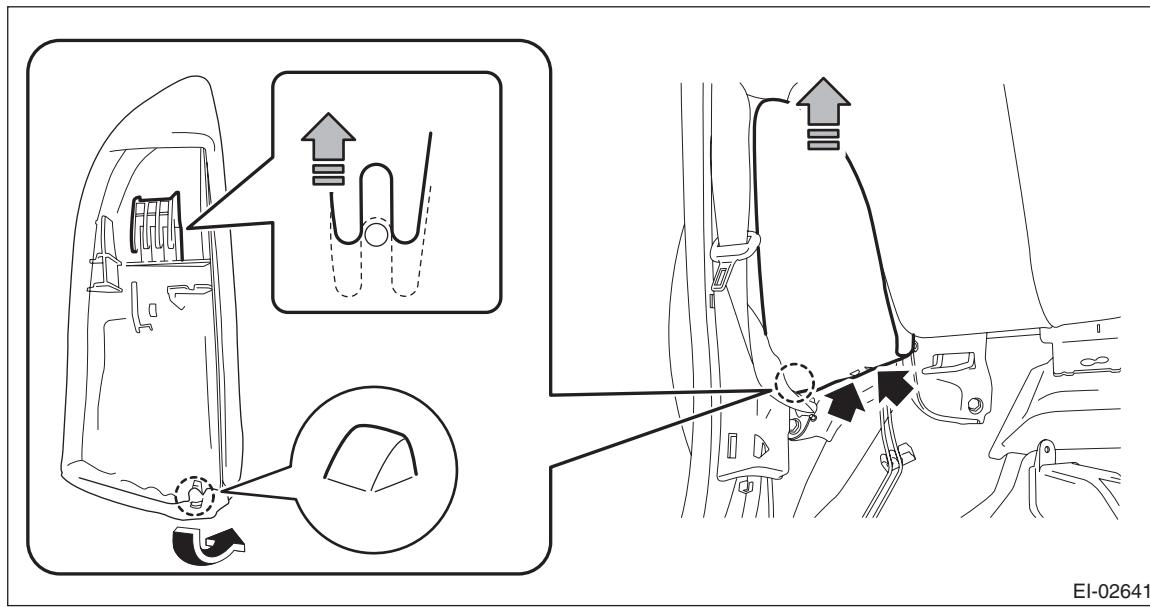
(1) Remove the backrest side pad.

a) Remove the screws.

b) Turn over the bottom end of the backrest side pad in the forward direction so that the claws are released.

c) Remove the backrest side pad by pulling it up.

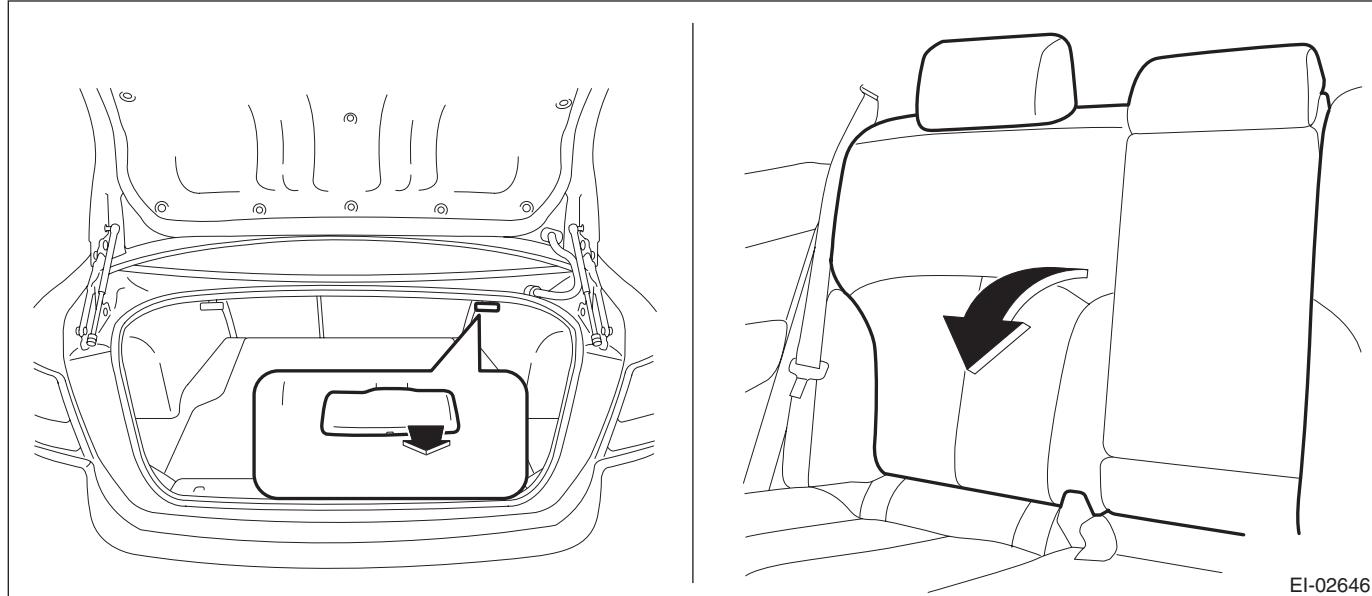
(2) Pull the release lever in the trunk room, and then tilt the backrest forward.

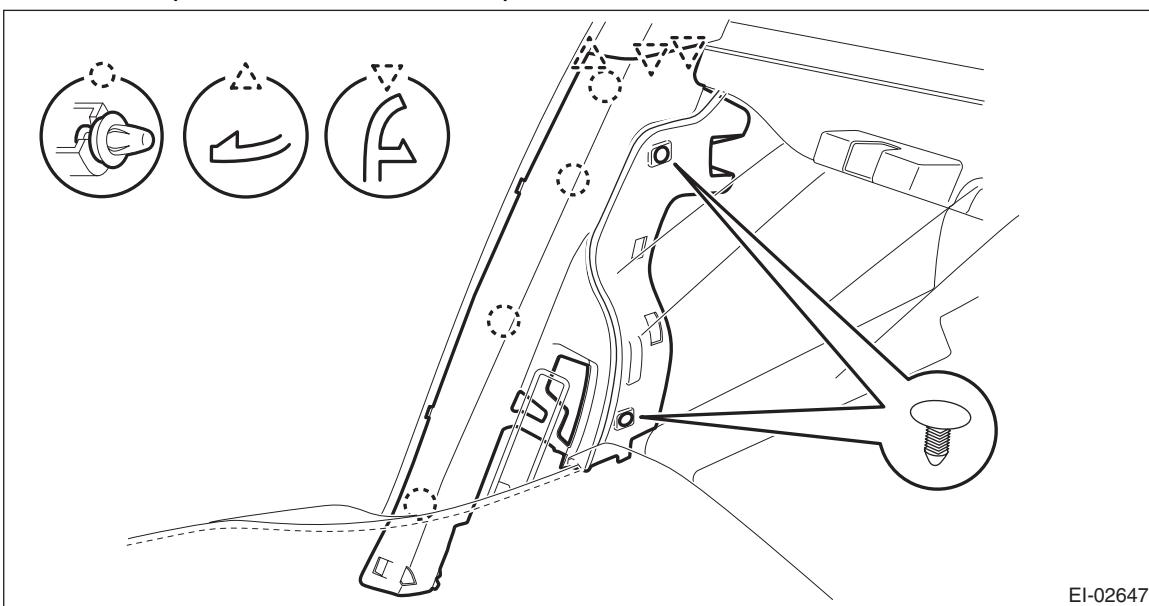
(3) Release the clips of the trunk trim panel assembly-side.

(4) Remove the clips, and remove the rear quarter trim LWR.

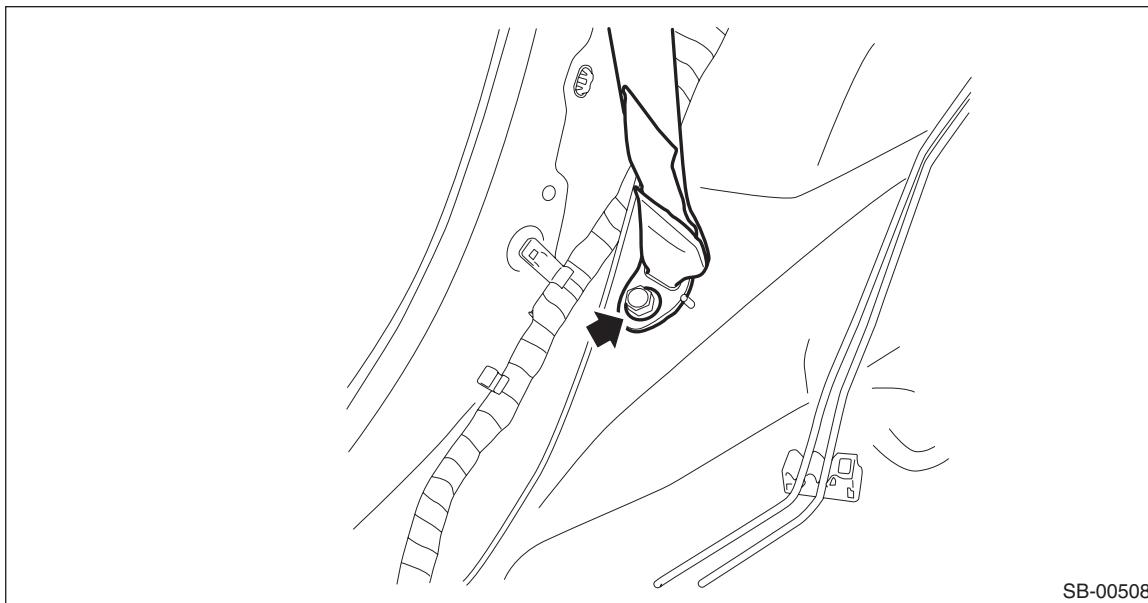
(1) Remove the lower anchor bolt of the outer belt assembly.

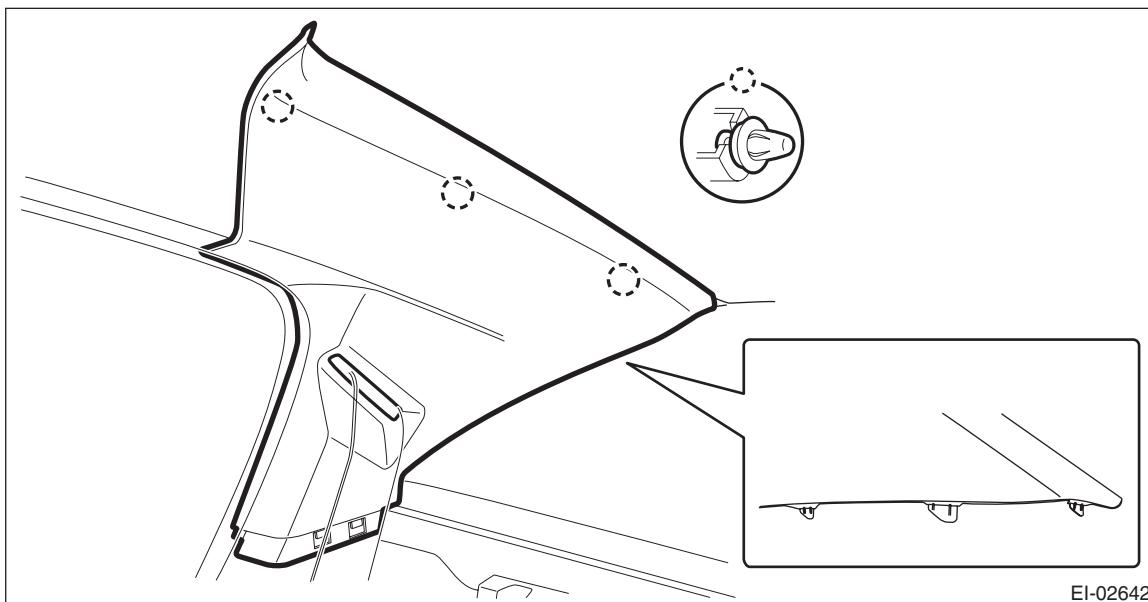
(2) Release the clips, and remove the rear quarter trim UPR.

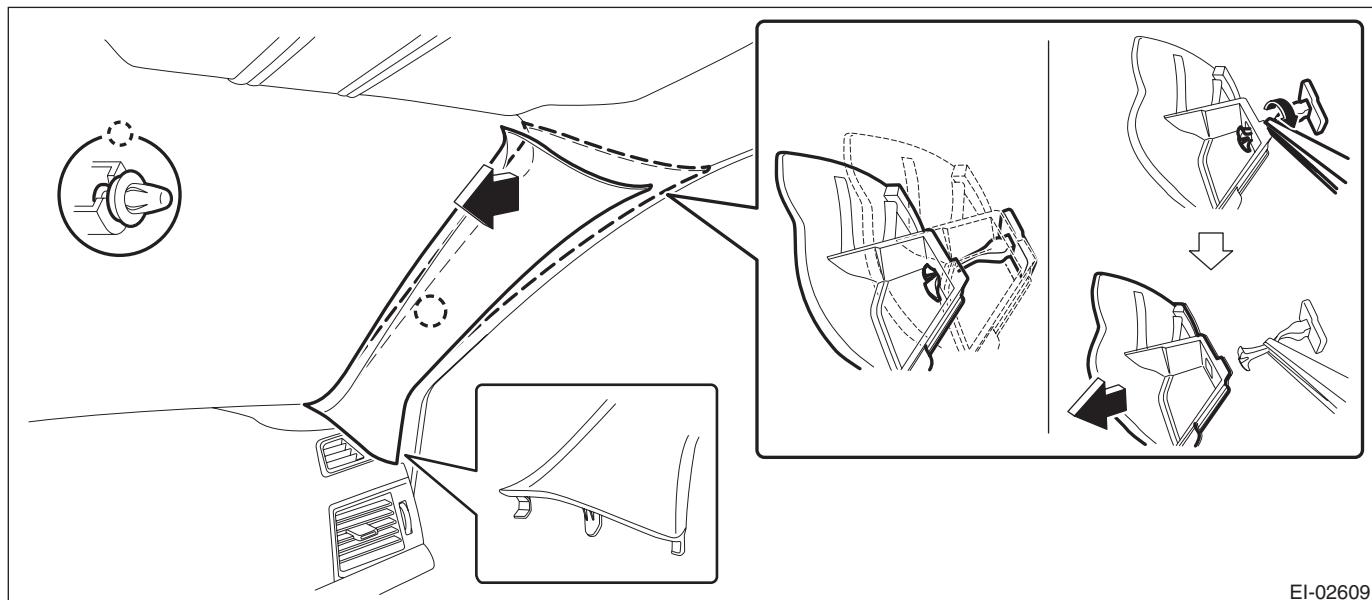
(1) Pull the upper part of the front pillar trim towards the center of the vehicle.

(2) Insert long-nose pliers into the top part of the trim, grip the clip with the pliers and twist 90° in that position.

(3) Holding the clip twisted as in the previous step, remove the front pillar trim from the clip.

(4) Remove the clip and the front pillar trim.

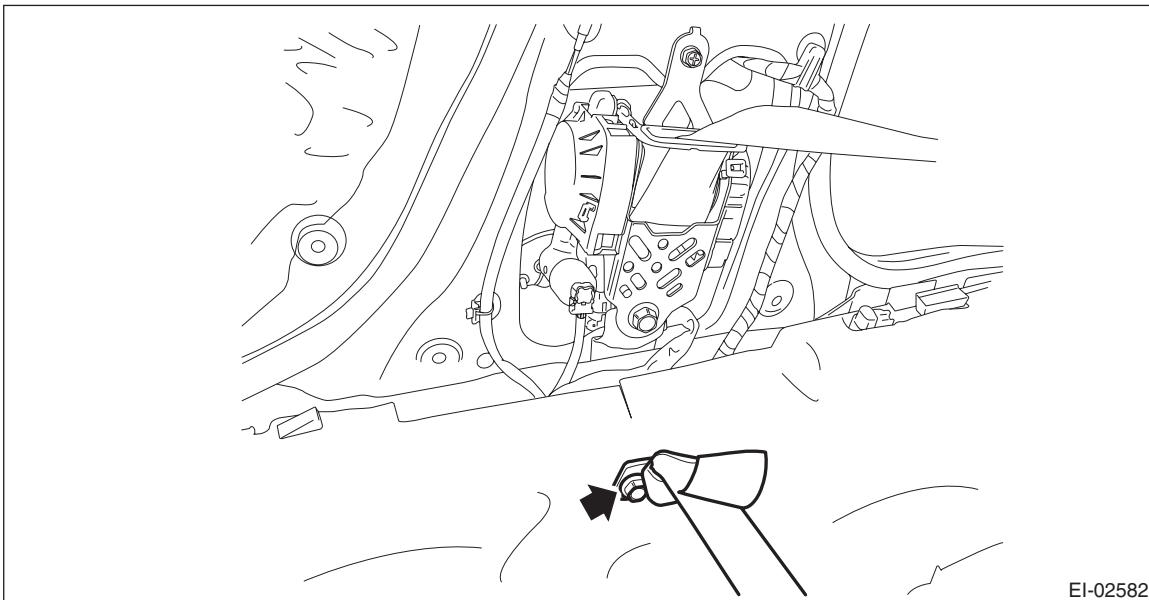
(1) Remove the seat belt lower anchor bolt.

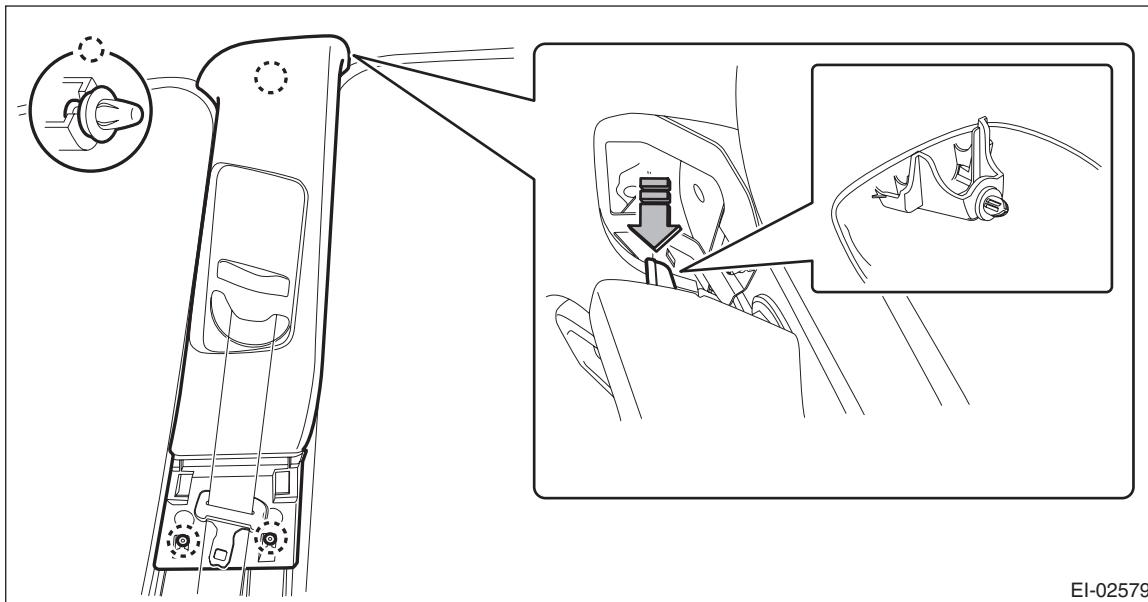
(2) Release the clip by pulling the lower part of the trim toward you.

(3) Remove the clip by pulling the upper part of the trim toward you, and while lowering the entire trim, remove the center pillar trim UPR.

**Do not reuse the upper clips of the center pillar trim UPR. Once the clip is removed, its holding force is reduced. Be sure to replace it with a new clip.**

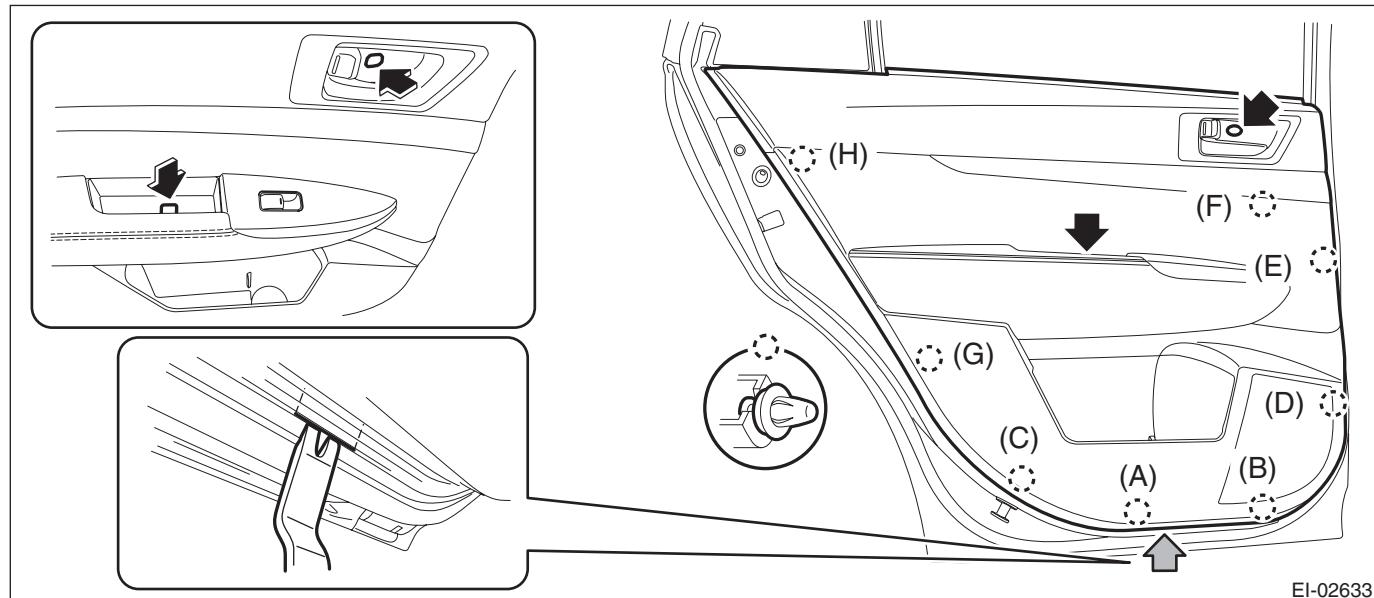
(1) Open the cover and remove the screw.

(2) Remove the clips in the order of (A) to (H) and remove the door trim from the door panel.

**When removing the door trim, be sure to remove the clips in the correct order. Forcibly removing clips may damage the door panel assembly.**

Insert a plastic clip remover into the slit at the bottom of the door trim, to lift the door trim.

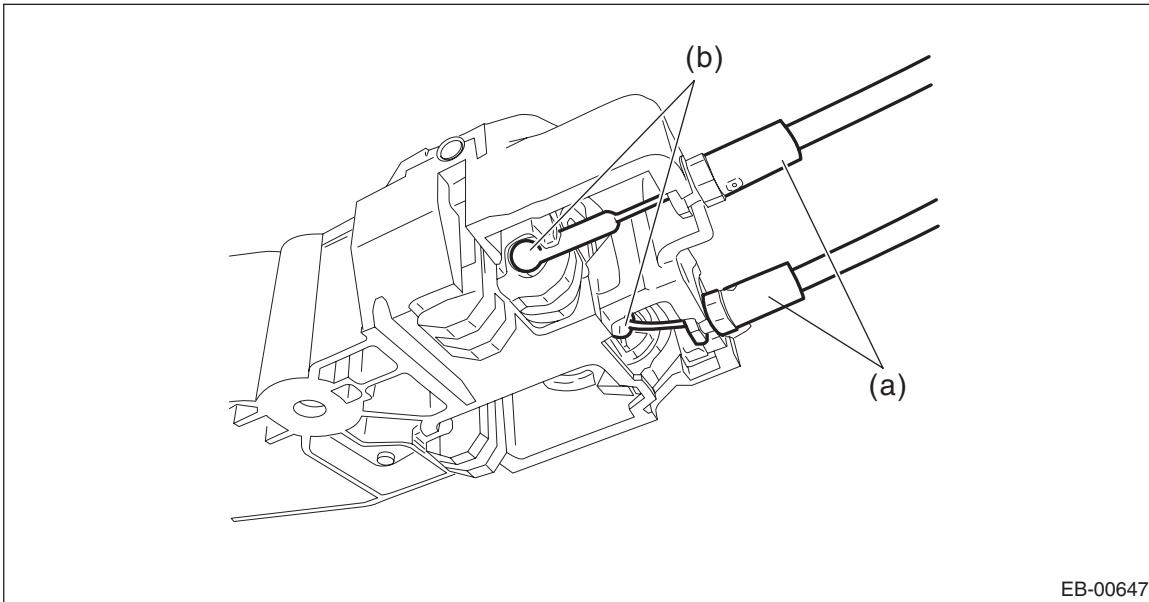
(3) Remove the cables (a) and (b) from the cable holder of inner remote.

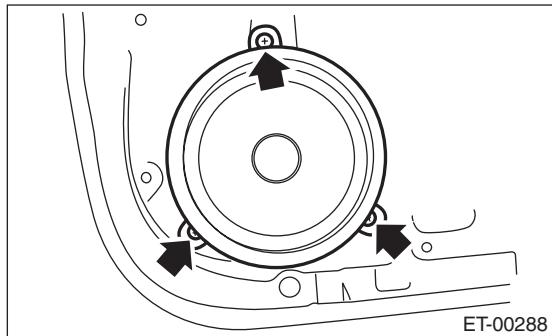
(1) Remove the screws.

(2) Disconnect the harness connector and remove the rear door speaker.

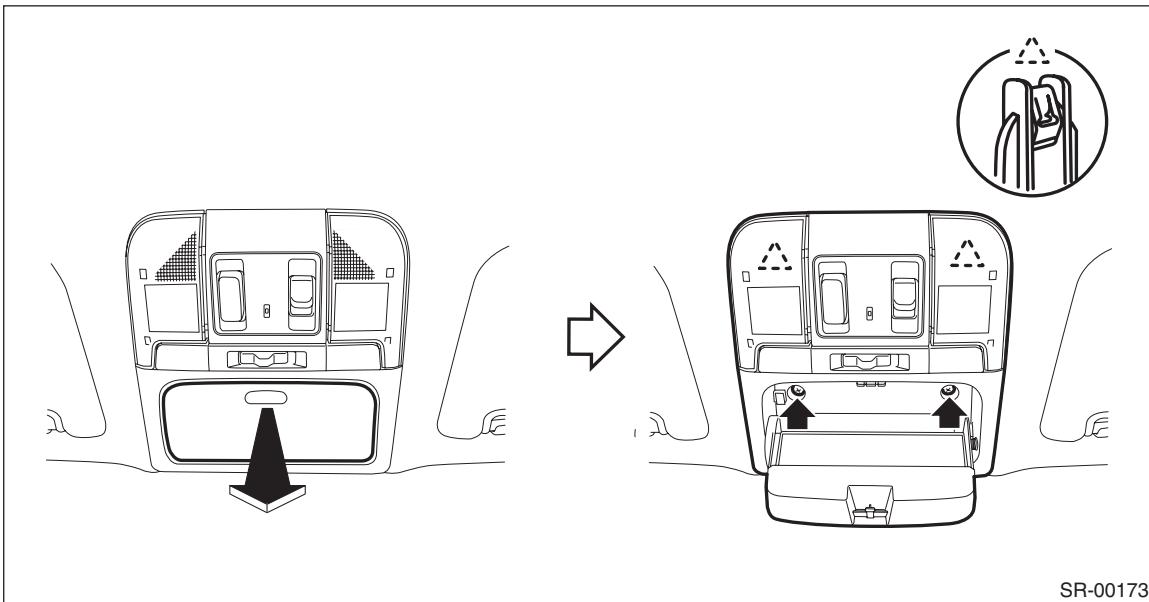
(1) Push and open the rear end of the overhead console lid, and remove the screws.

(2) Disconnect the connector and remove the overhead console assembly.

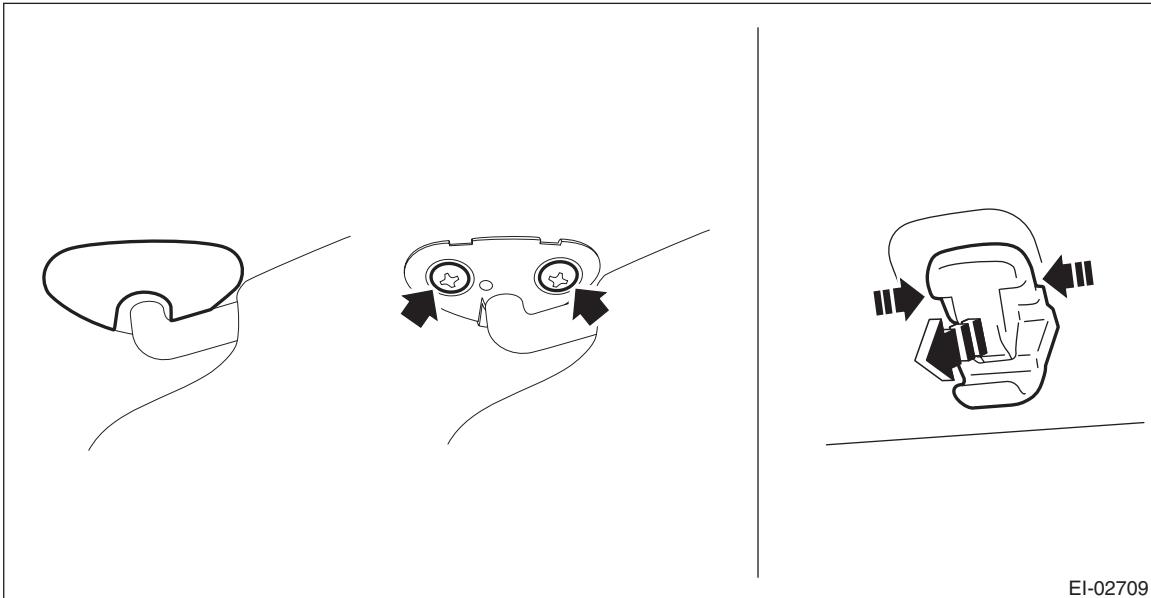
- (1) Remove the cover, loosen the screws, and remove the sun visor assembly.
- (2) Press the both sides of the sun visor hook using a flat tip screwdriver.
- (3) Remove the sun visor hook by pulling toward you.

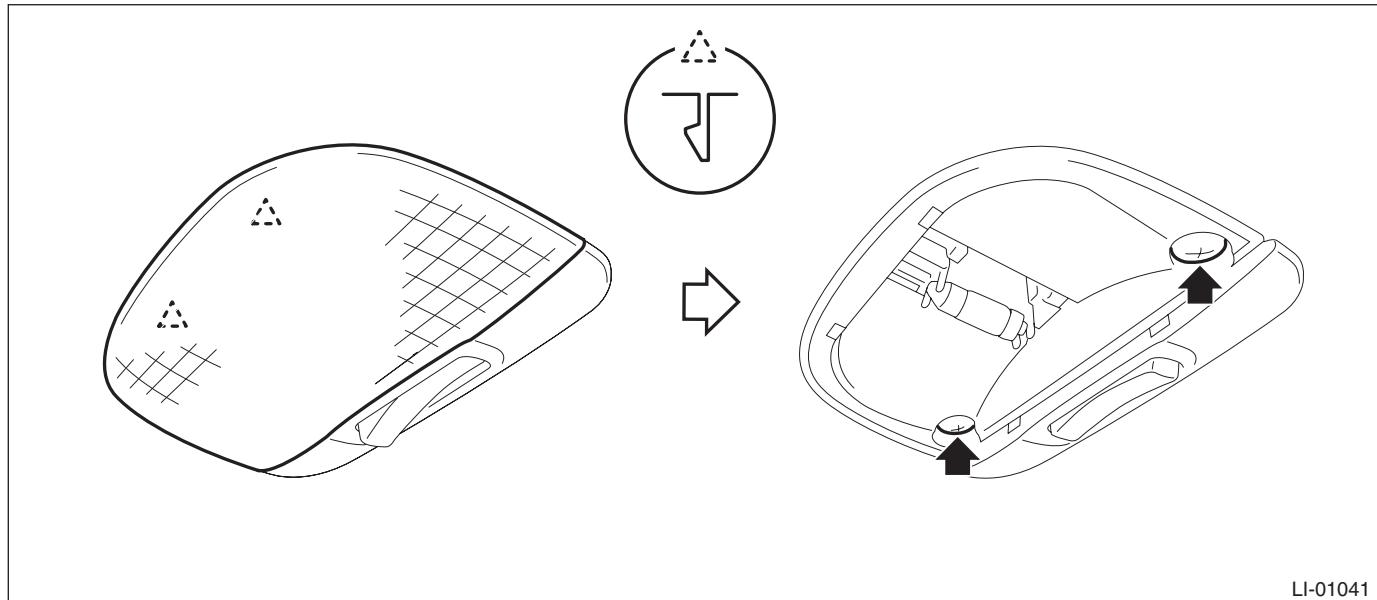
- (1) Release the claws and remove the cover.
- (2) Remove the two screws.

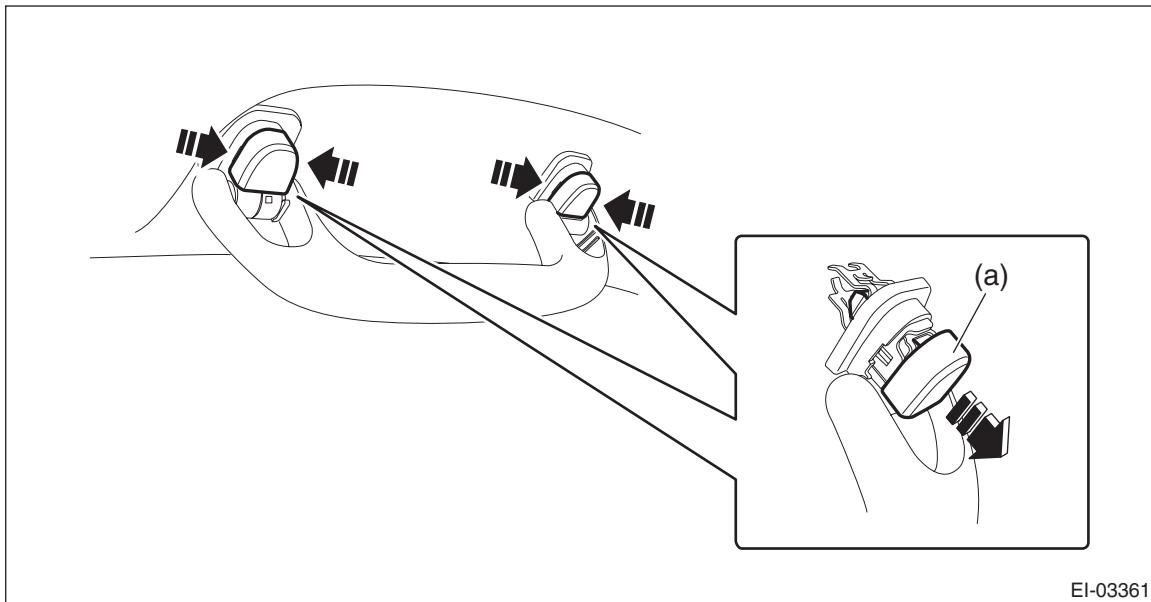
(1) Remove the cap (a) by pulling the both sides of the cap (a) using a flat tip screwdriver wrapped with a protection tape.

(2) Pull the assist grip toward you (to the vehicle center) and remove the metal clip from the bracket.

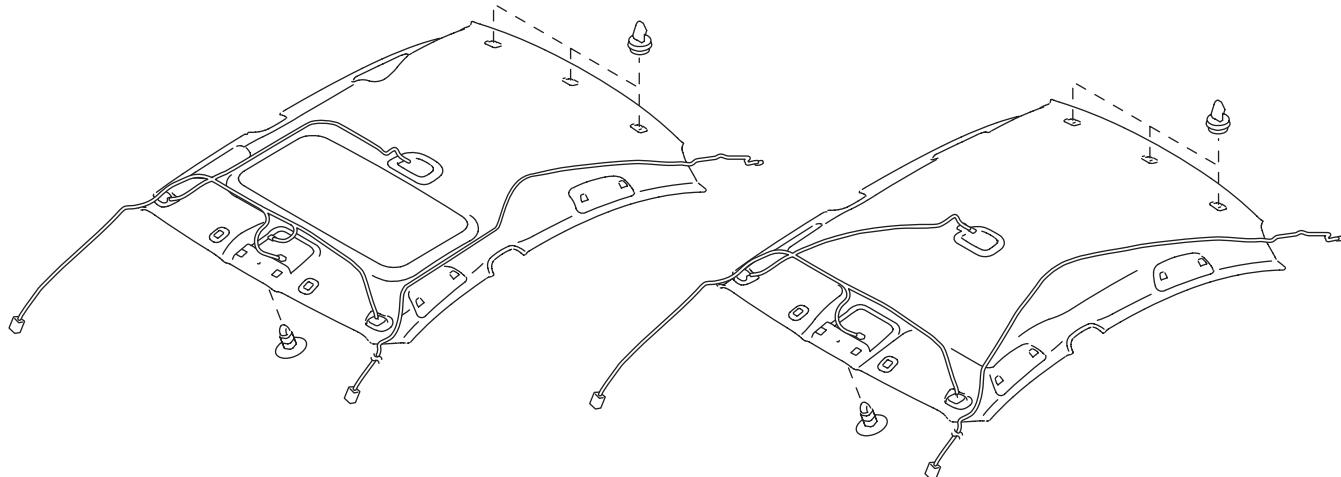
EI-02873

(1) Remove the clips, and then remove the roof trim.

(2) Remove the feeder cord and roof cord from the roof trim.

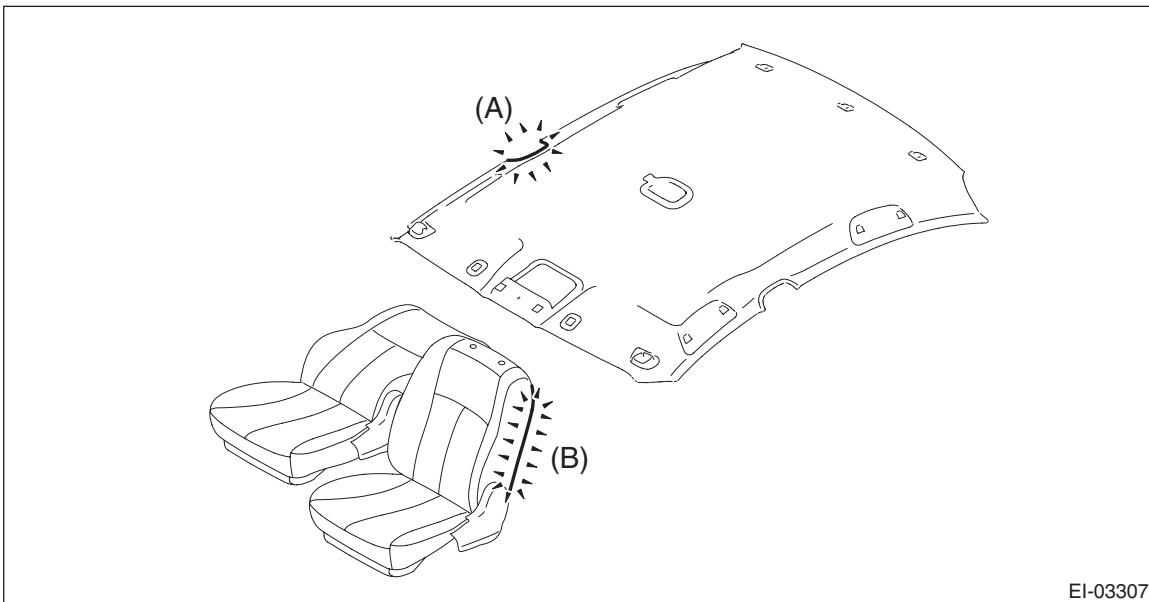
EI-03307

a) Align the center pillar (A) of roof trim with a corner (B) of the driver's seat and turn the roof trim obliquely.

b) While holding the roof trim assembly in the condition in step a), take it out from the driver's side rear door opening.

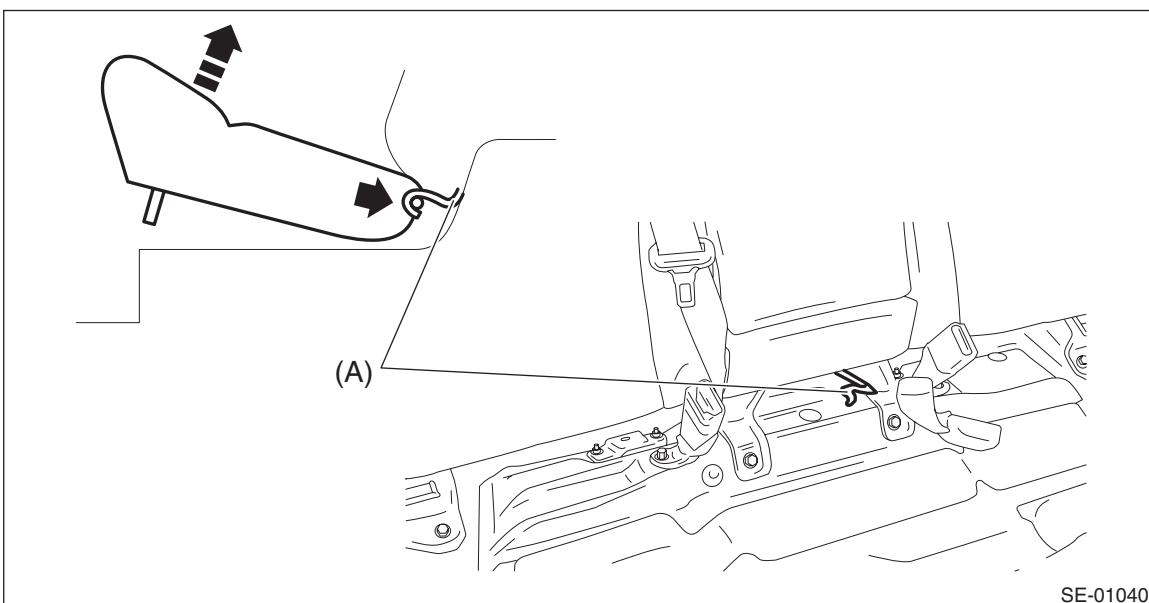
(2) Remove the hook (A) by pushing it back while lifting the front side of the seat cushion, and remove the seat cushion.

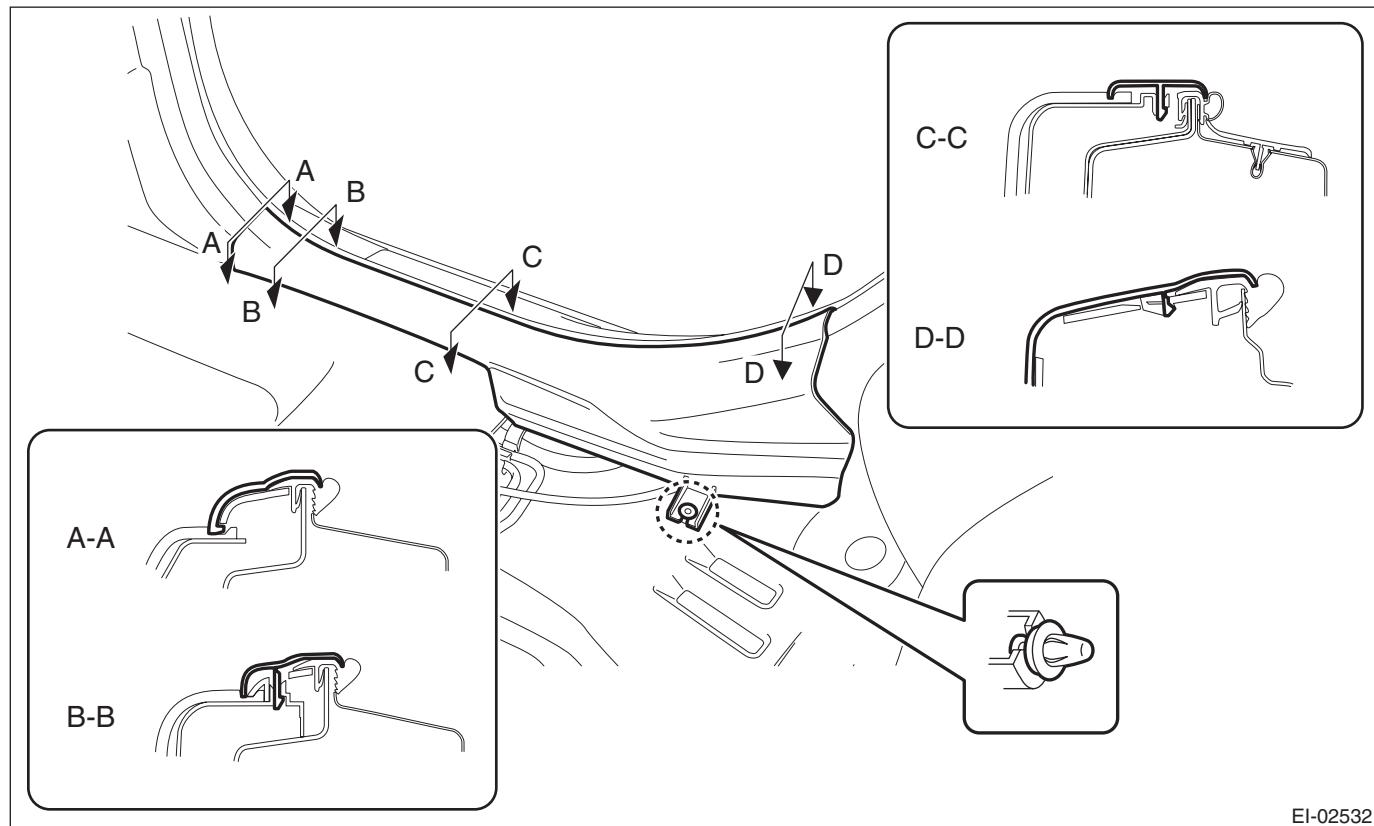
EI-02532

3) Release the clips and claws, and then remove the left and right side sill covers-rear INN.

To release the claws of the side sill cover INN, the following steps are recommended.

1. Take out the weather strip from under the side sill cover INN.
2. Turn over the floor mat and release the claw (C-C and D-D) by accessing from behind the side sill cover INN.
- 3) Tilt the backrest forward and release the clips of the backrest backside mat.
