## 27. Roof Trim

### A: REMOVAL

#### 1. SEDAN MODEL

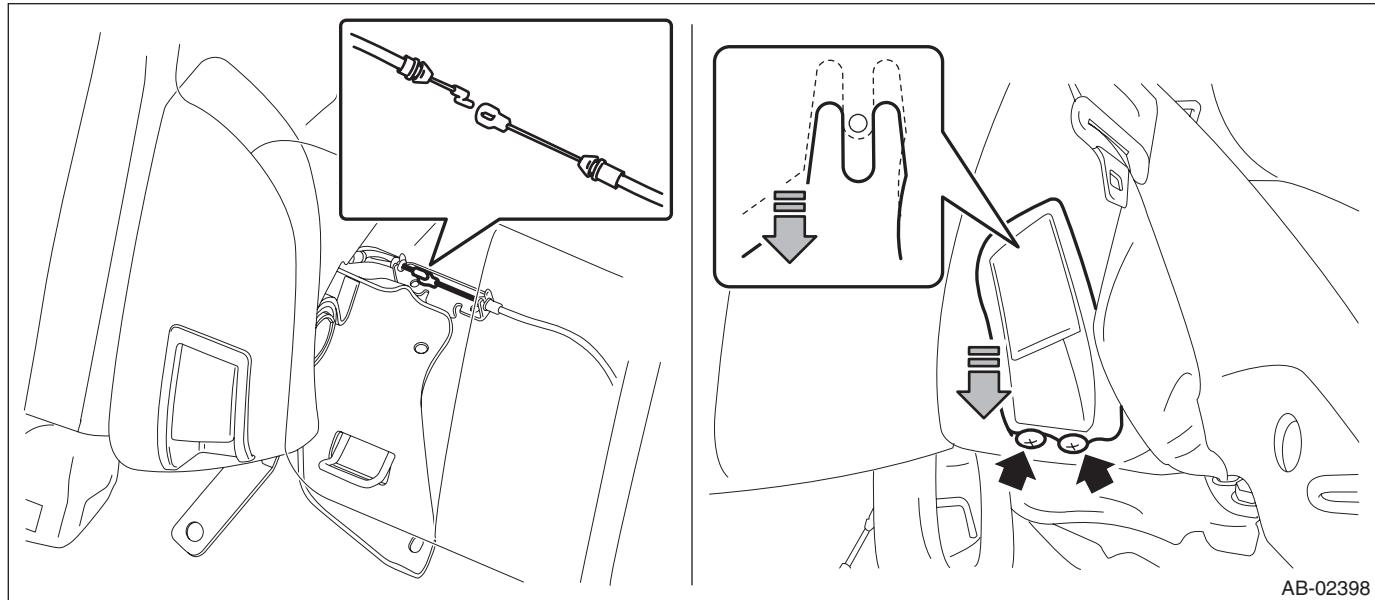
- 5) Remove the left and right backrest side pad assembly. (On the side where airbag sensor is removed)
  - (1) Disconnect the backrest cable and reclining lever cable.
  - (2) Remove the screws and remove the reclining lever assembly by pulling it downward.

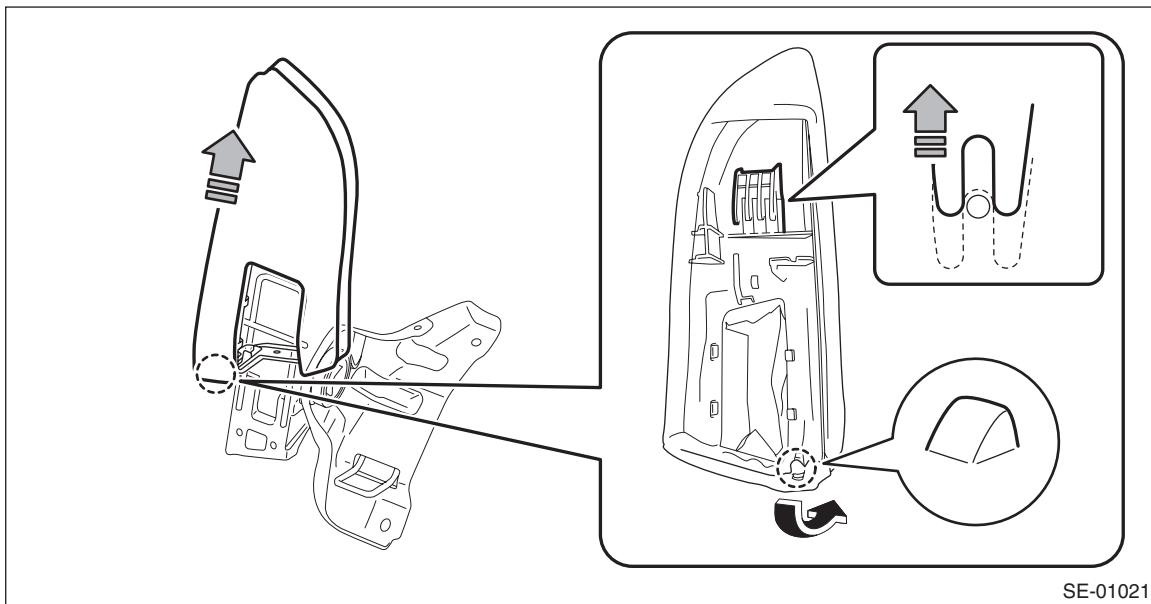
- (3) Turn over the bottom end of the backrest side pad in the forward direction so that the claws are released.
- (4) Remove the backrest side pad by pulling it up.

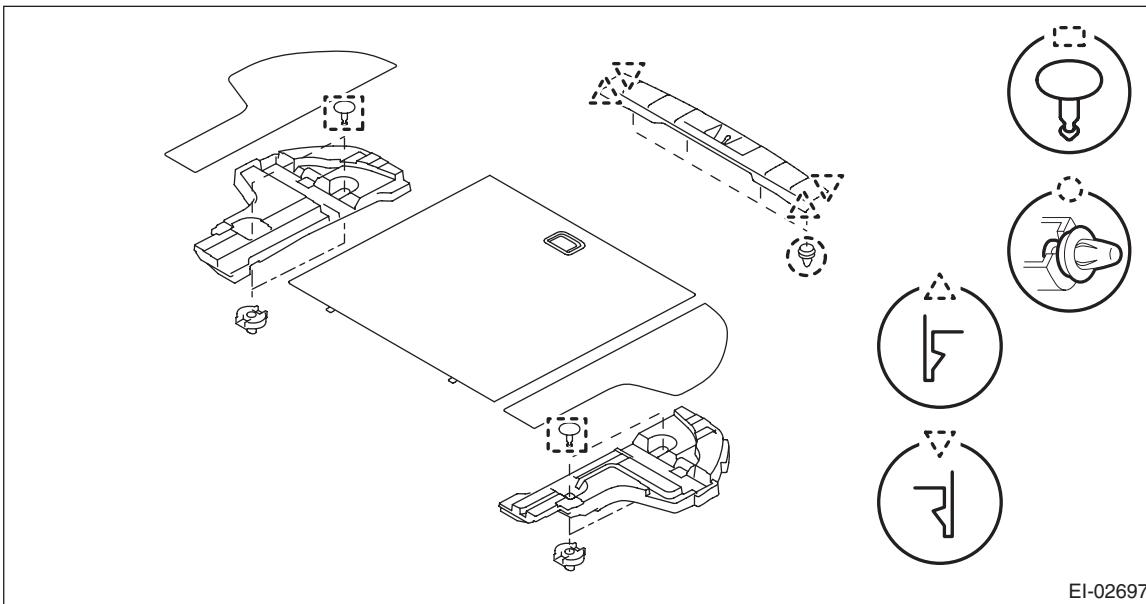
6) Remove the clips, and remove the luggage floor box and rear floor edge cover.

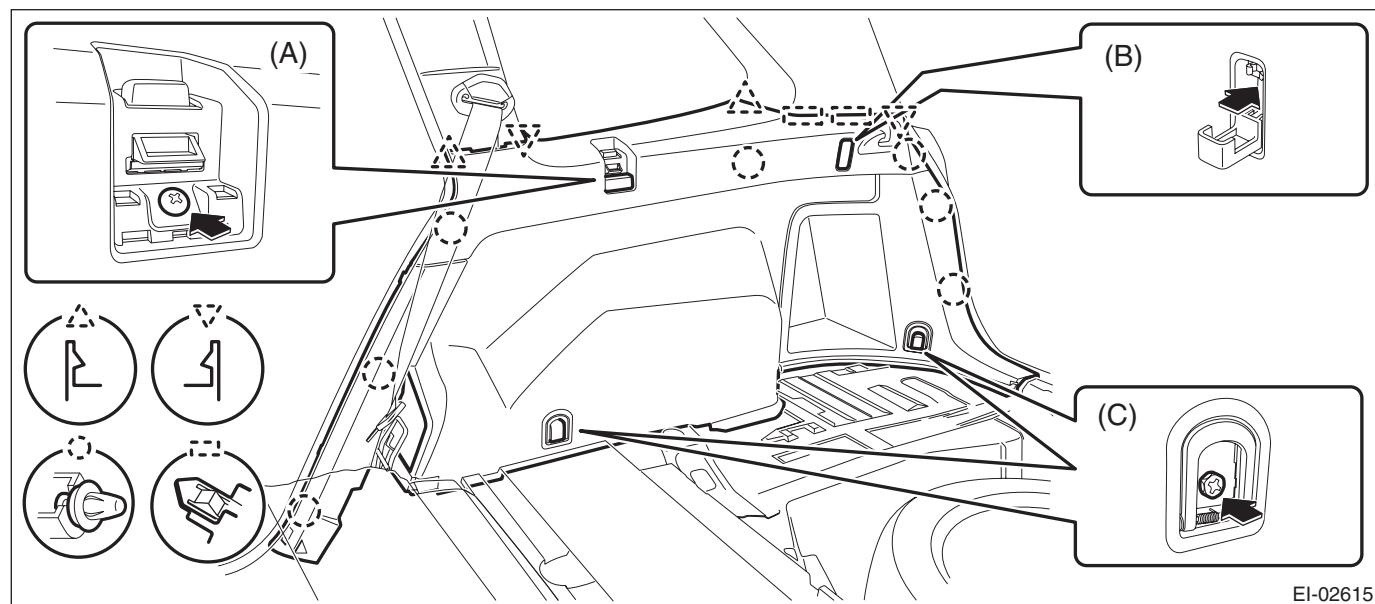
- (1) Remove the caps, screws, and bolts. (A), (C)
- (2) Take out the hook and remove the screw inside. (B)
- (3) Remove the clips, and remove the rear quarter trim LWR.

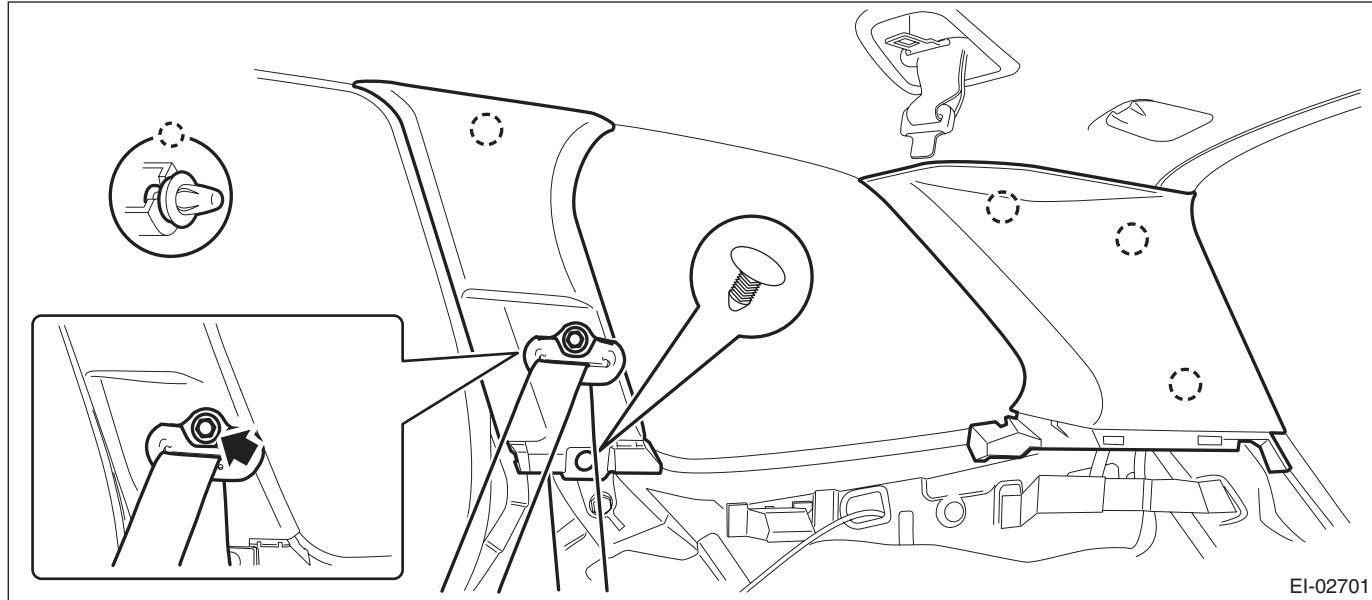
- (1) Open the cap and remove the bolt to remove the seat belt anchor.
- (2) Remove the clips, and remove the rear quarter trim UPR-front.
- (3) Remove the clips, and remove the rear quarter trim UPR-rear.

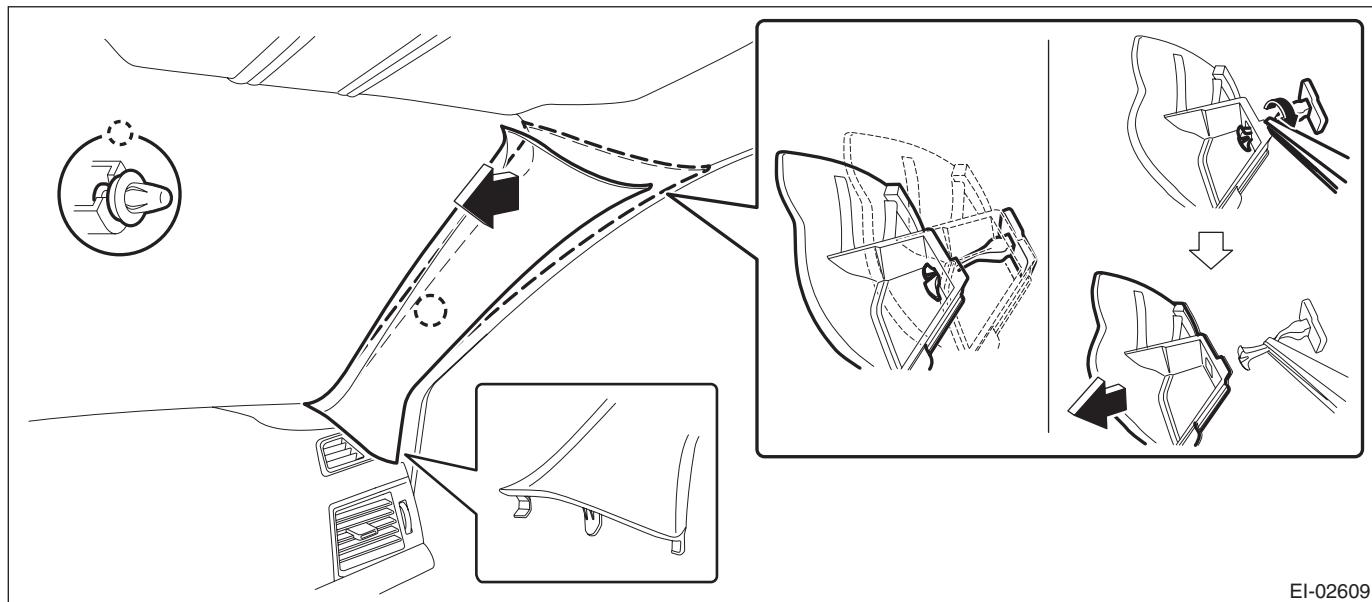
- (1) Pull the upper part of the front pillar trim towards the center of the vehicle.
- (2) Insert long-nose pliers into the top part of the trim, grip the clip with the pliers and twist 90° in that position.

- (3) Holding the clip twisted as in the previous step, remove the front pillar trim from the clip.
- (4) Remove the clip and the front pillar trim.

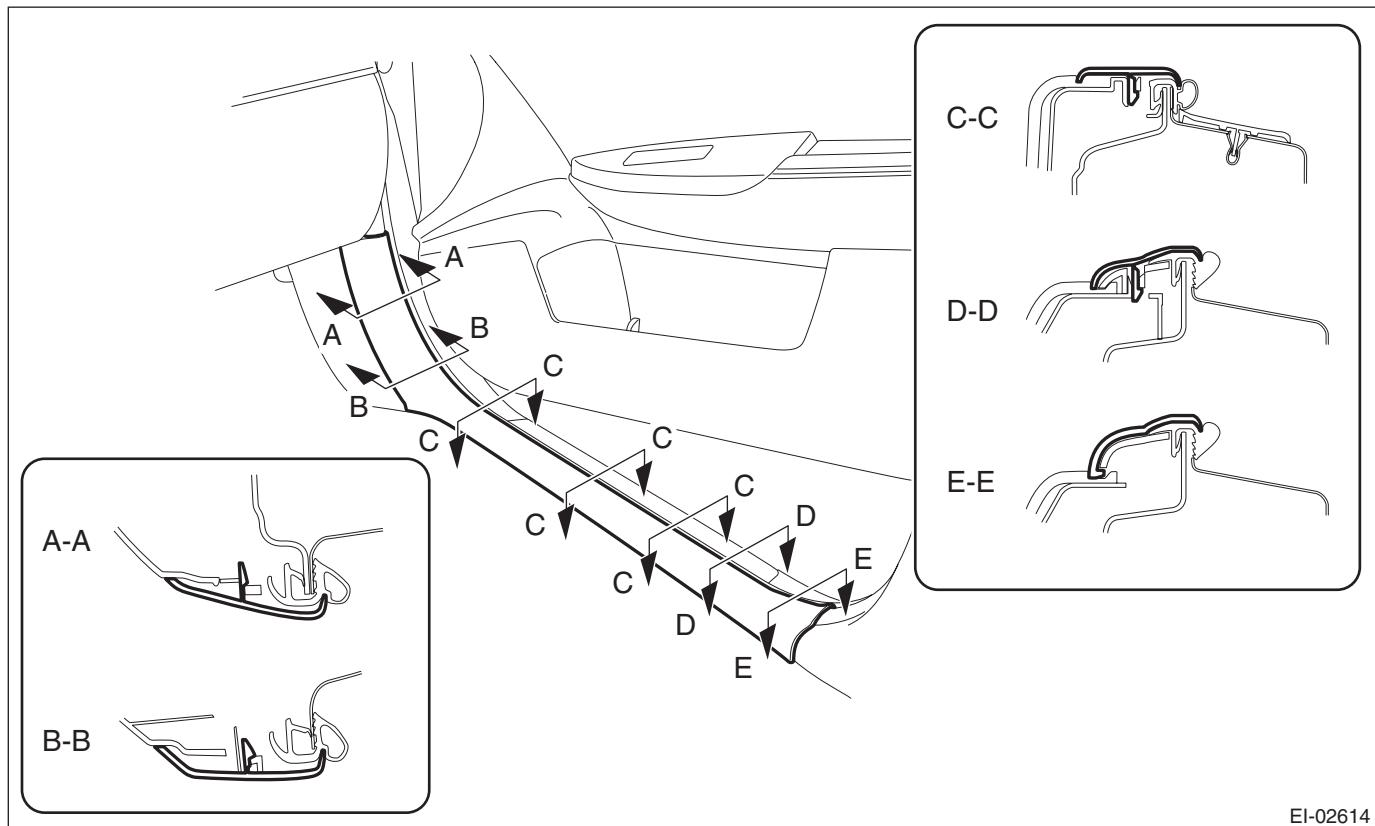
EI-02614

10) Release the claws, and then remove the left and right side sill cover-front INN.

1. Take out the weather strip from under the side sill cover INN.
2. Turn over the floor mat and release the claw (C-C) by accessing from behind the side sill cover INN.

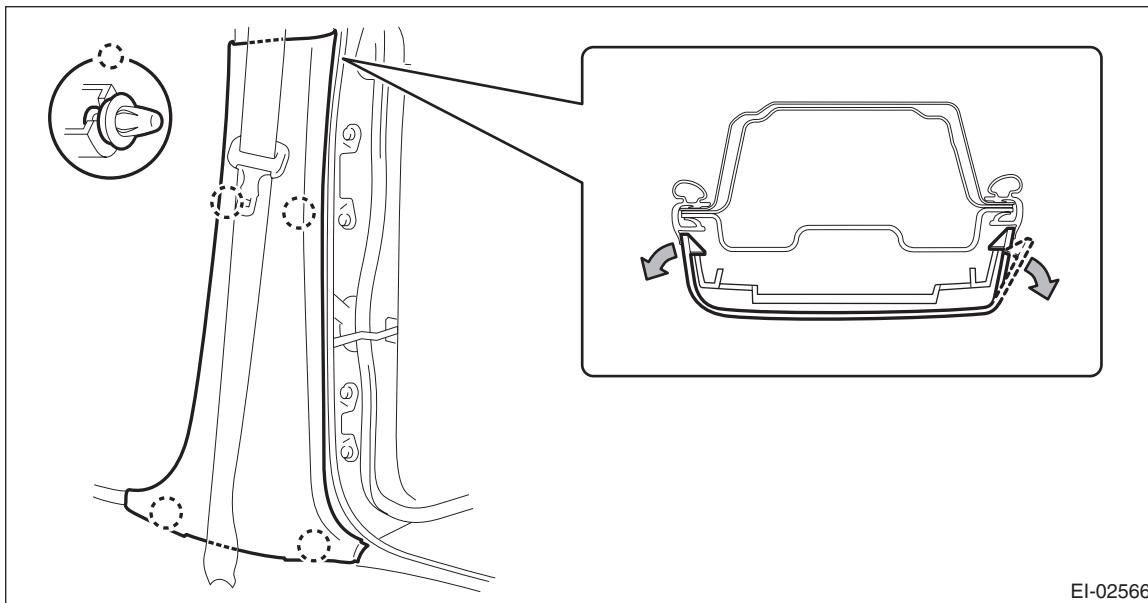
(1) Release the clip by pulling the center pillar trim LWR toward you.

(2) Expand the claws of center pillar trim LWR outward and remove it from the center pillar trim UPR.

First release the claw located to the rear of the vehicle.

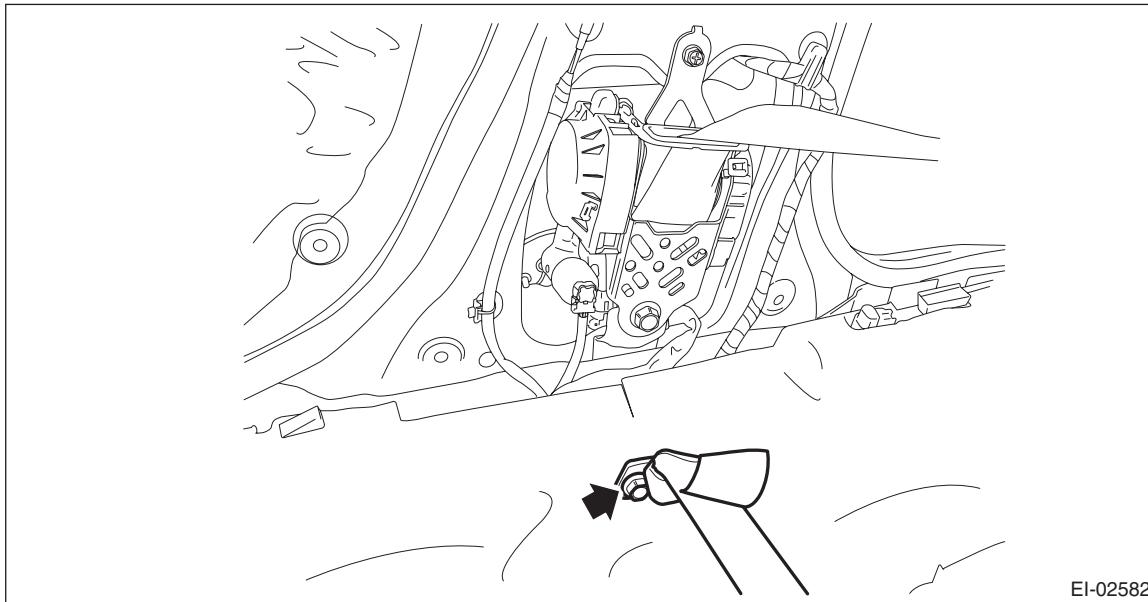
(1) Remove the seat belt lower anchor bolt.

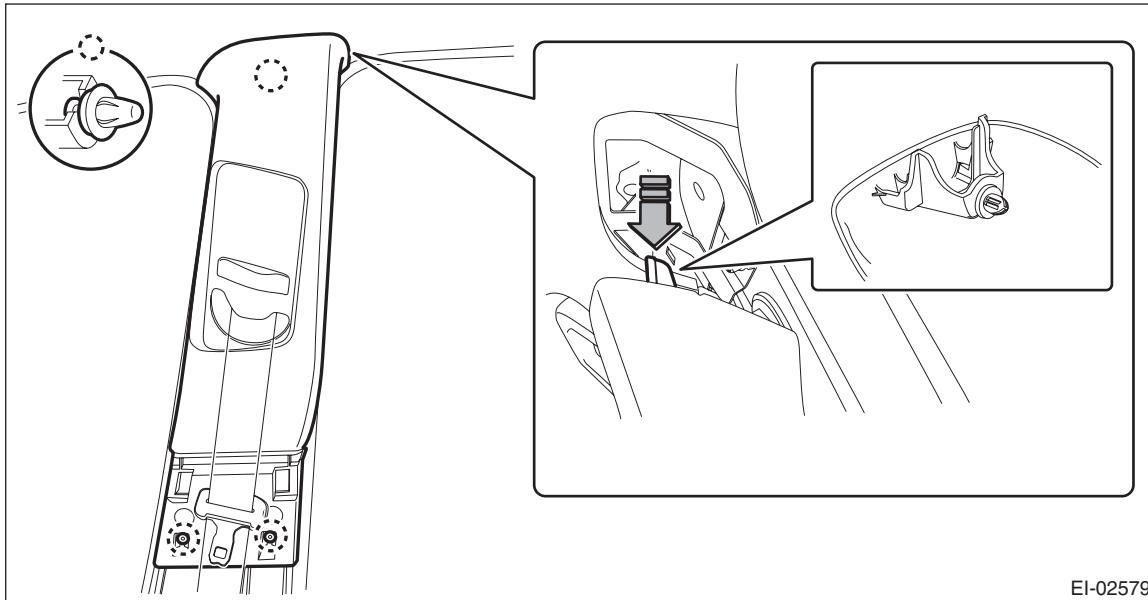
EI-02579

(2) Release the clip by pulling the lower part of the trim toward you.

(3) Remove the clip by pulling the upper part of the trim toward you, and while lowering the entire trim, remove the center pillar trim UPR.

**Do not reuse the upper clips of the center pillar trim UPR. Once the clip is removed, its holding force is reduced. Be sure to replace it with a new clip.**

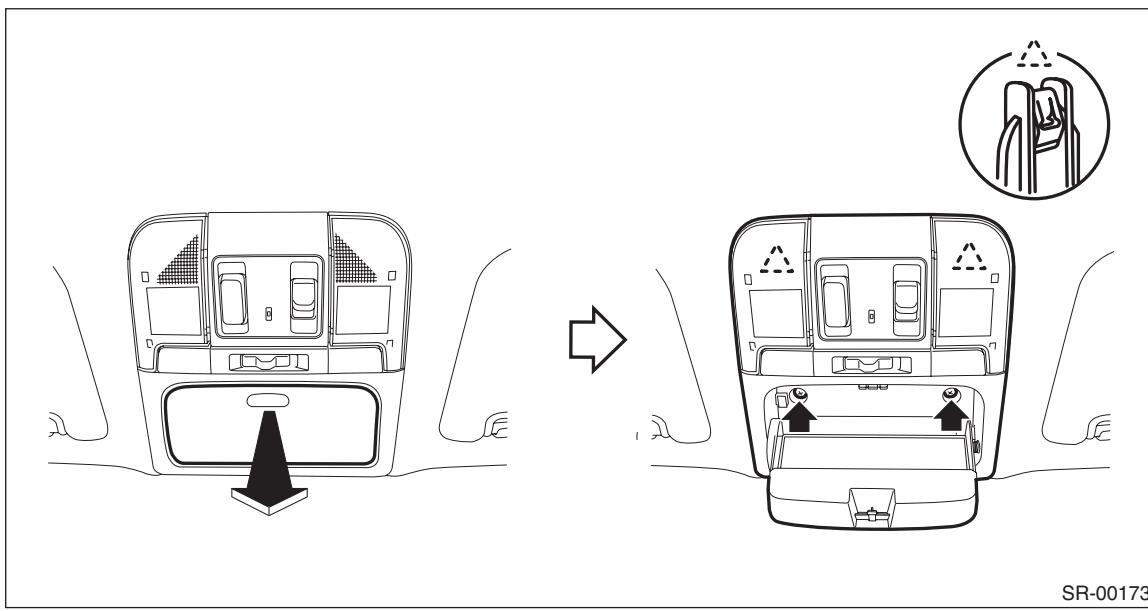
SR-00173

(1) Push and open the rear end of the overhead console lid, and remove the screws.

(2) Disconnect the connector and remove the overhead console assembly.

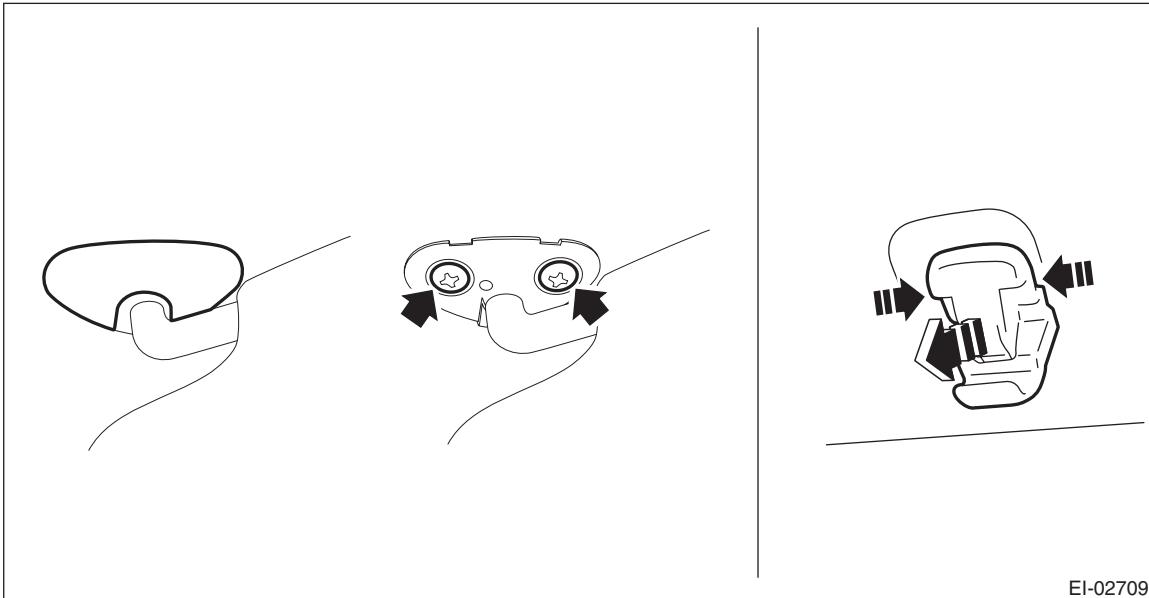
- (1) Remove the cover, loosen the screws, and remove the sun visor assembly.
- (2) Press the both sides of the sun visor hook using a flat tip screwdriver.
- (3) Remove the sun visor hook by pulling toward you.

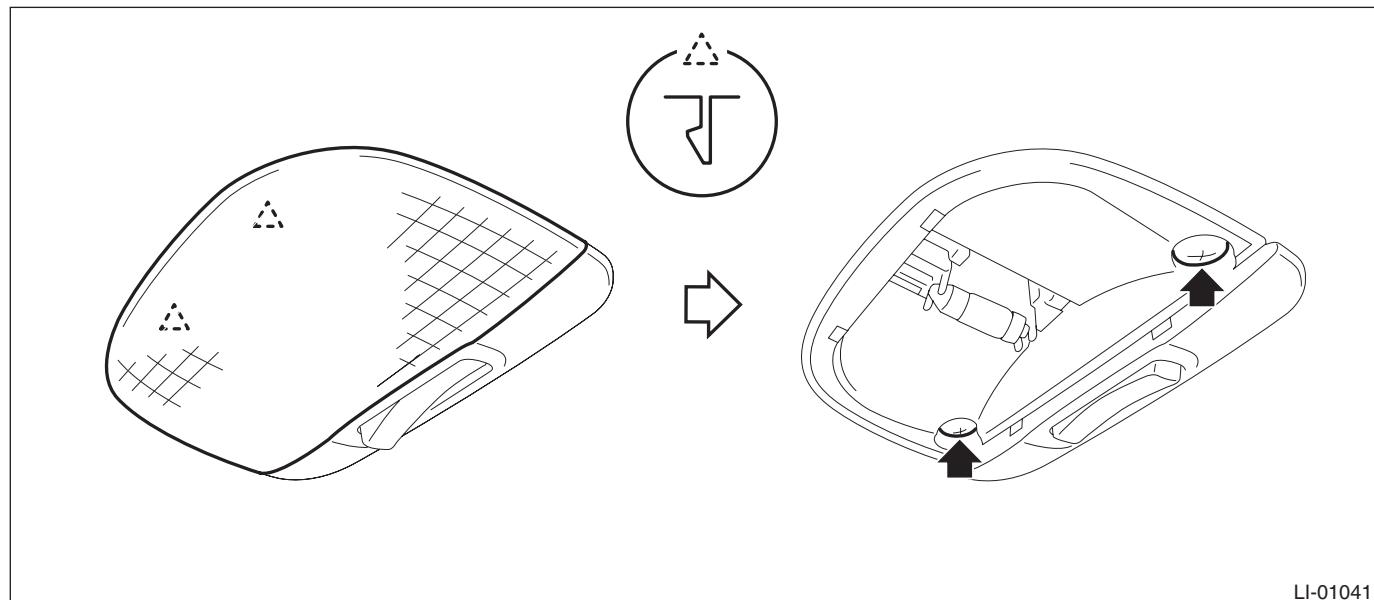
- (1) Release the claws and remove the cover.
- (2) Remove the two screws.

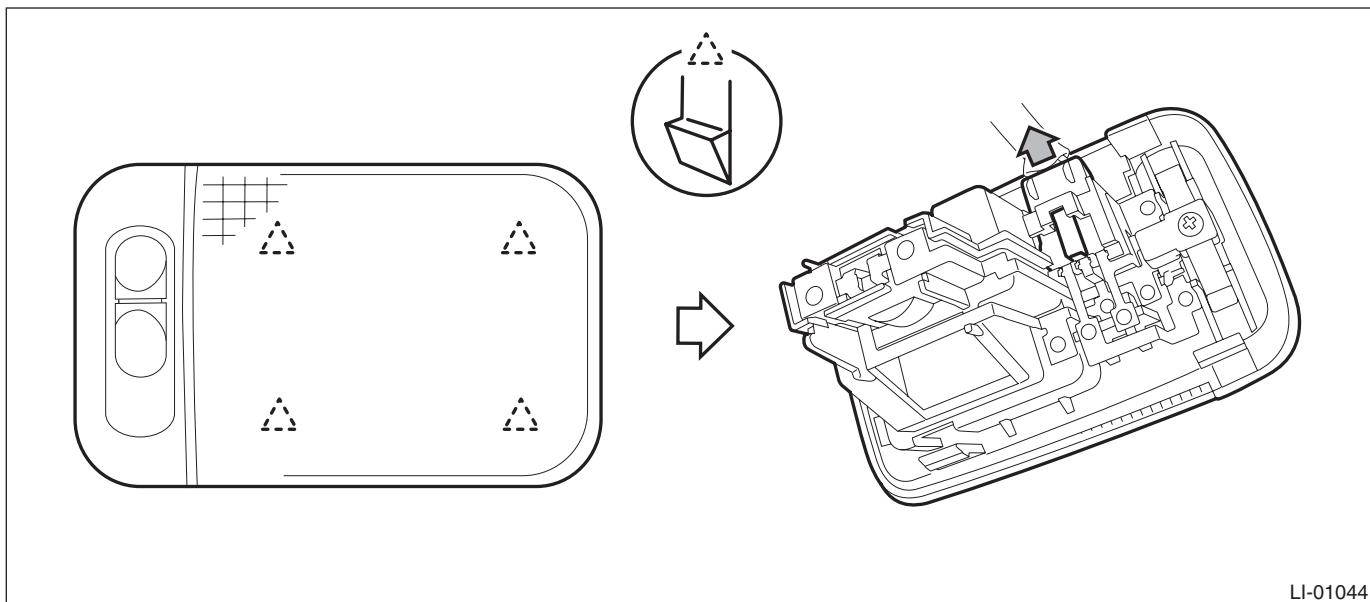
LI-01044

- (1) Release the claws and remove the luggage room light main body.
- (2) Disconnect the connector and remove the luggage room light.

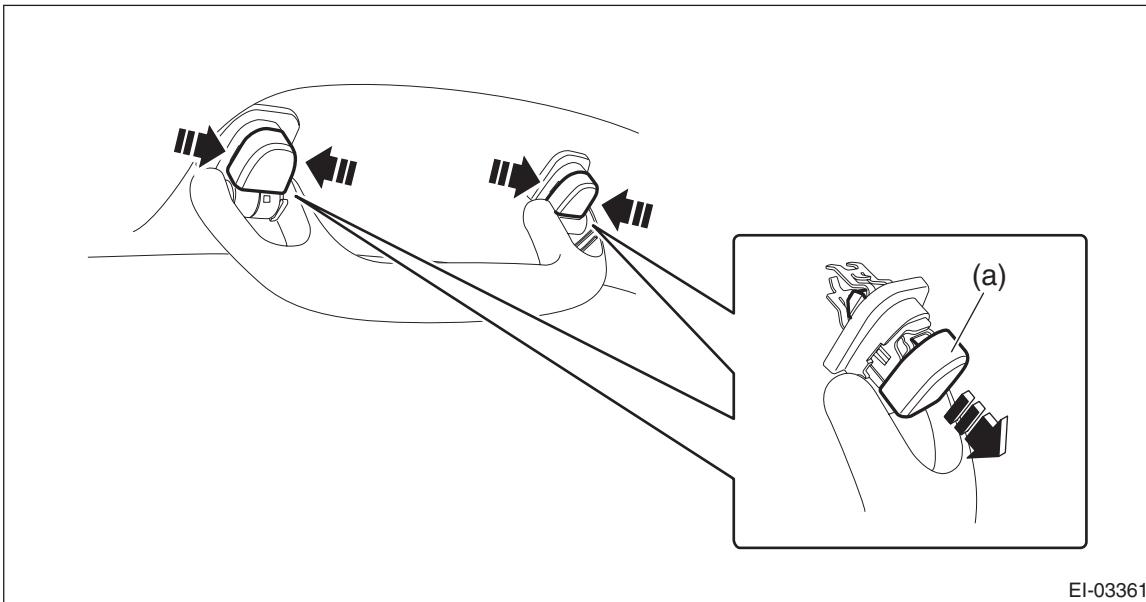
EI-03361

- (1) Remove the cap (a) by pulling the both sides of the cap (a) using a flat tip screwdriver wrapped with a protection tape.
- (2) Pull the assist grip toward you (to the vehicle center) and remove the metal clip from the bracket.

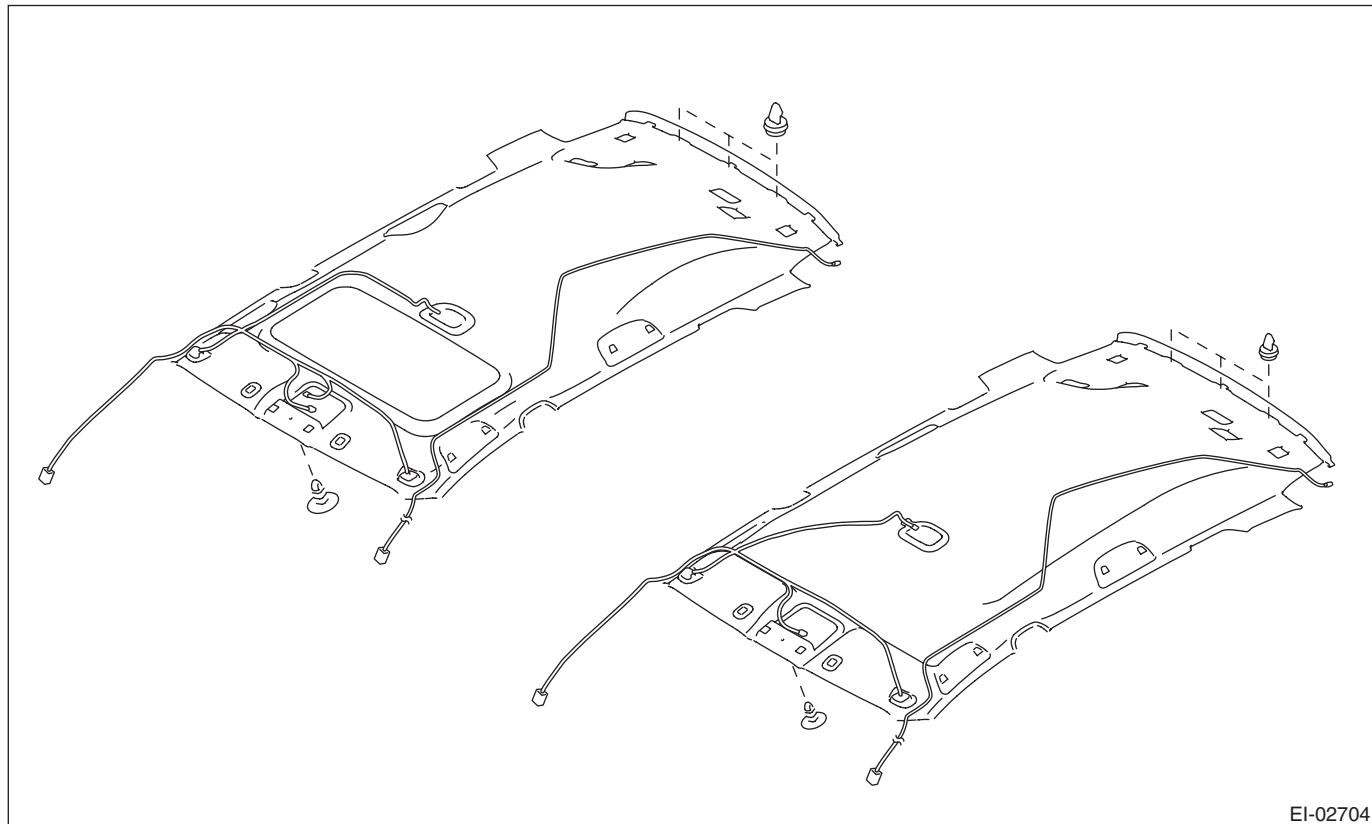
- 19) Disconnect the roof harness connector at the front pillar RH.
- 20) Remove the roof trim assembly.
  - (1) Release the clips and remove the feeder cord and roof cord from the roof trim.
  - (2) Take out the roof trim assembly from the rear gate opening to outside.

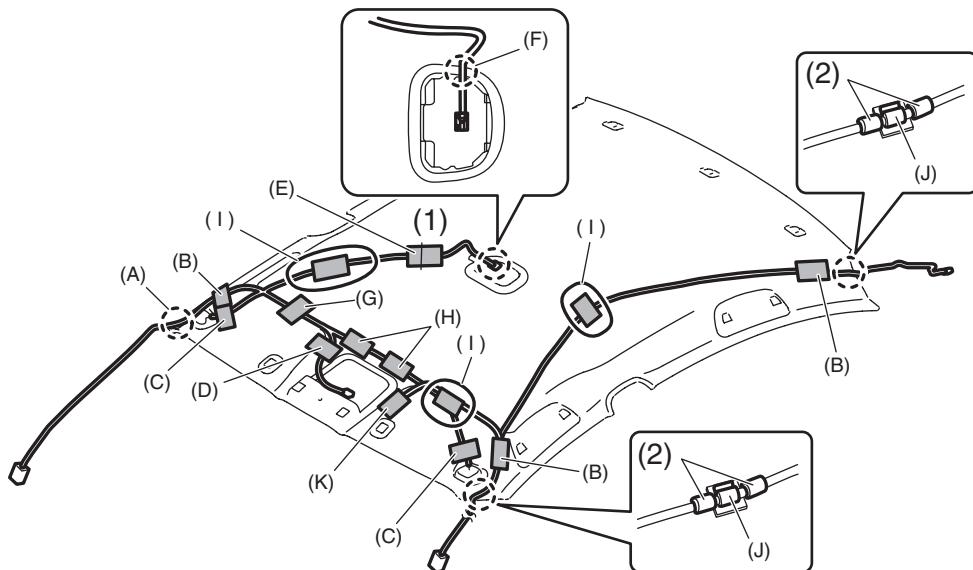
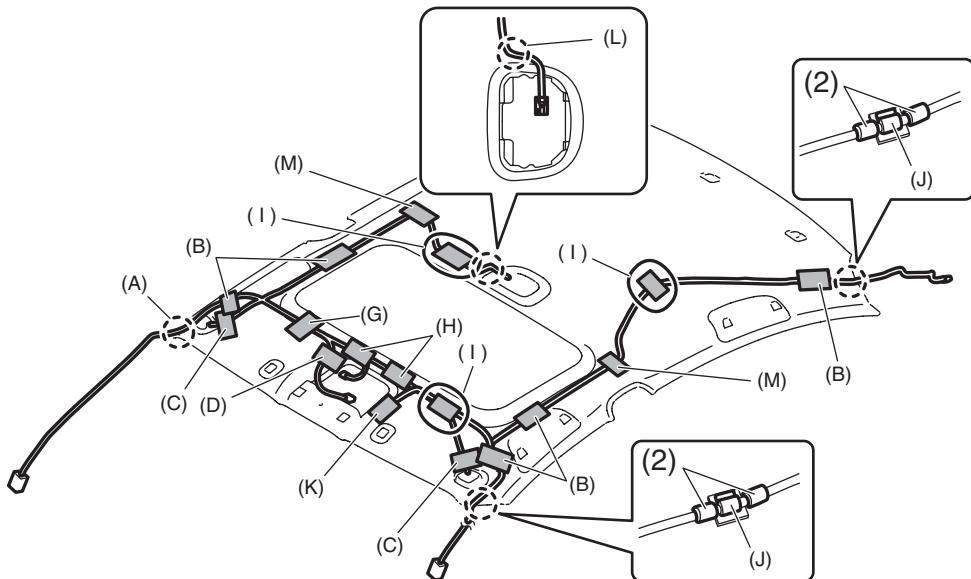
(1) Mark-off line

(2) Polyurethane tape

(A) Align the marking (white) center of cord with the clamp to secure.	(F) Place the marking (white) cord center to adjust the excess.	(J) Place the clamp between the polyurethane tapes (2) to secure.
(B) Affix with tape while avoiding the assist grip surface.	(G) Align with the center of sun visor, and affix with tape.	(K) Affix the prewire connector with tape.
(C) Adjust the excess cord to $60\pm10$ mm ( $2.4\pm0.4$ in) from the hole edge, and affix with tape.	(H) Affix the rear left and right of the hole with tape.	(L) Pass the marking (white) of cord under the clamp.
(D) Affix right after the cord branching point with tape.	(I) Adjust the excess cord at (I) position and affix with tape.	(M) Affix the cord at the pad rear end with tape.
(E) Affix with tape while aligning with the mark-off line.

- 1) Attach the feeder cord and roof cord to the roof trim.

Route each cord carefully. The cord may interfere, thus preventing normal deployment of the curtain airbag when necessary.

Use the tape (service parts) by cutting into 80 mm × 50 mm (3.2 in × 2.0 in).

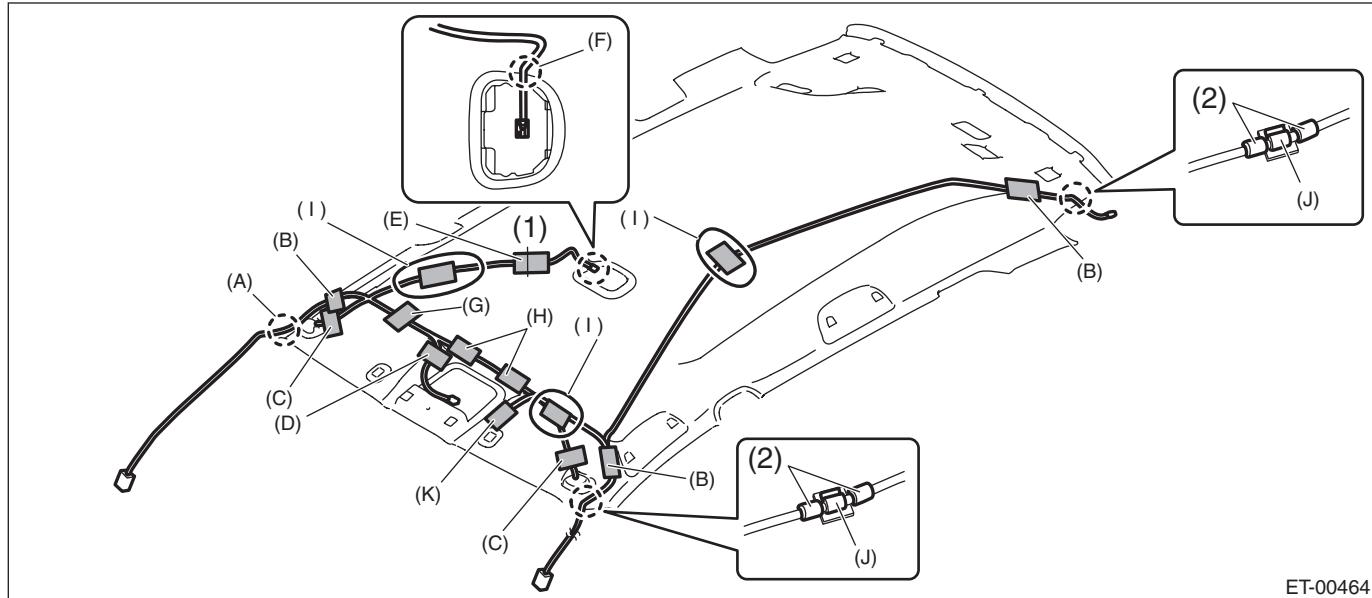
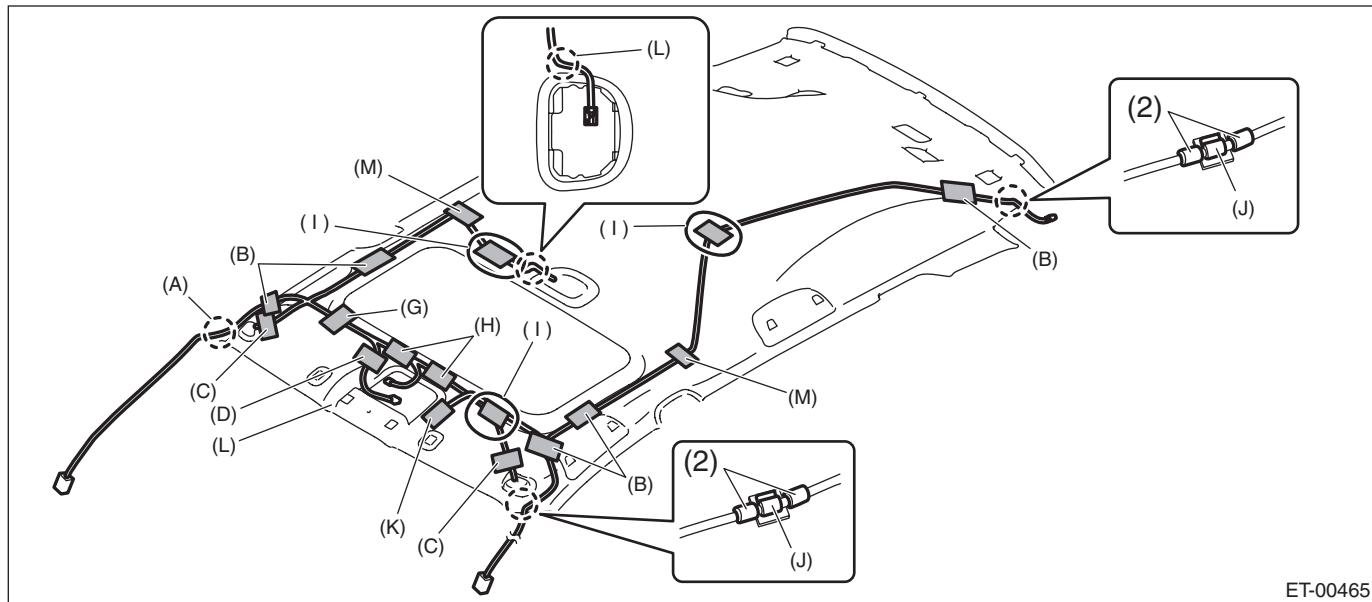
(1) Mark-off line

(2) Polyurethane tape

(A) Align the marking (white) center of cord with the clamp to secure.	(F) Place the marking (white) cord center to adjust the excess.	(J) Place the clamp between the polyurethane tapes (2) to secure.
(B) Affix with tape while avoiding the assist grip surface.	(G) Align with the center of sun visor, and affix with tape.	(K) Affix the prewire connector with tape.
(C) Adjust the excess cord to $60\pm10$ mm ( $2.4\pm0.4$ in) from the hole edge, and affix with tape.	(H) Affix the rear left and right of the hole with tape.	(L) Pass the marking (white) of cord under the clamp.
(D) Affix right after the cord branching point with tape.	(I) Adjust the excess cord at (I) position and affix with tape.	(M) Affix the cord at the pad rear end with tape.
(E) Affix with tape while aligning with the mark-off line.
