### 24.Extension Case

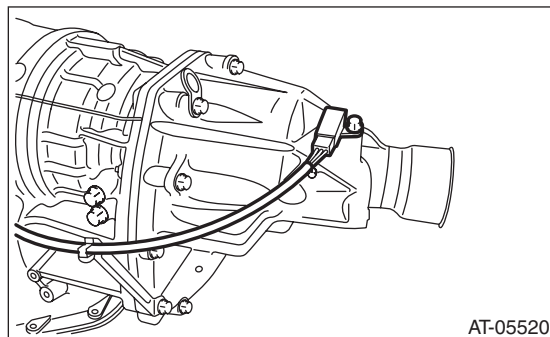
- 1) Remove the transmission assembly. <Ref. to 5AT-36, REMOVAL, Automatic Transmission Assembly.>
- 2) Disconnect the rear vehicle speed sensor connector.

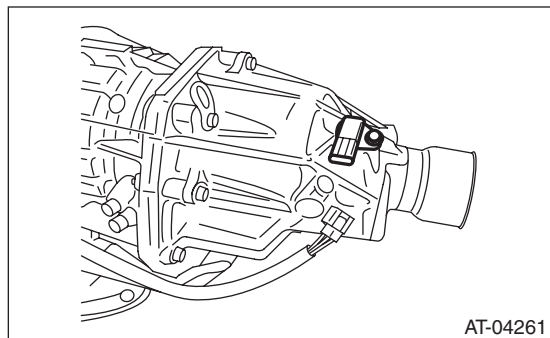
- 3) Remove the rear vehicle speed sensor.

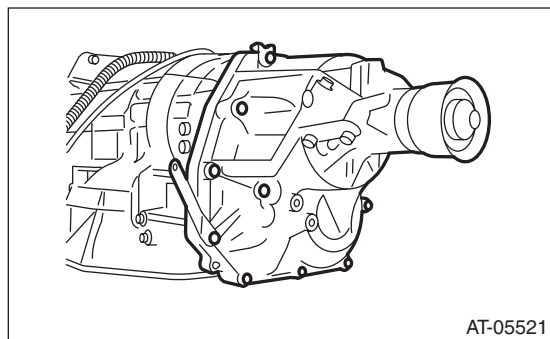
- 4) Remove the extension case.

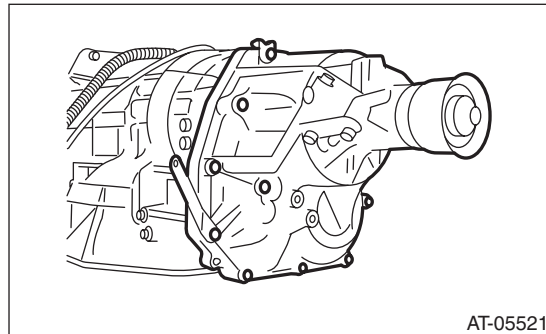
- 1) Attach the selected reduction driven gear shim to end surface of reduction driven gear with vase-line. <Ref. to 5AT-70, ADJUSTMENT, Reduction Driven Gear.>
- 2) Install the extension case.

Use a new gasket.

**Tightening torque:**

**25 N·m (2.5 kgf-m, 18.4 ft-lb)**

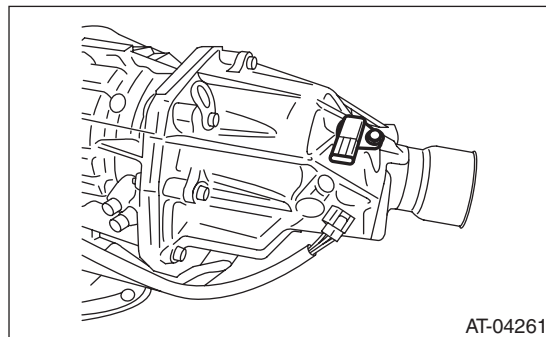
- 3) Install the rear vehicle speed sensor.

Use new O-rings.

**Tightening torque:**

**7 N·m (0.7 kgf-m, 5.2 ft-lb)**

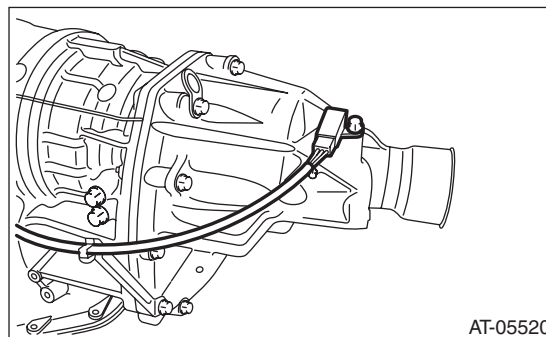
- 4) Connect the rear vehicle speed sensor connector.

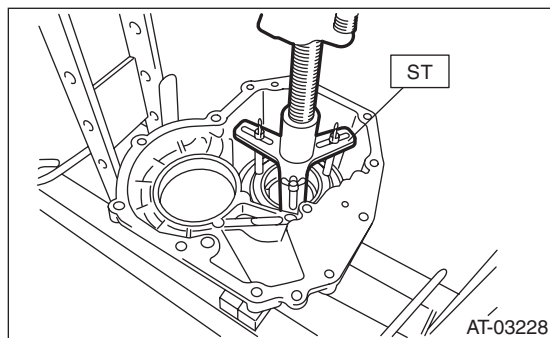
2) Remove the snap ring using the ST and press.  
ST 18762AA000 COMPRESSOR SPECIAL TOOL

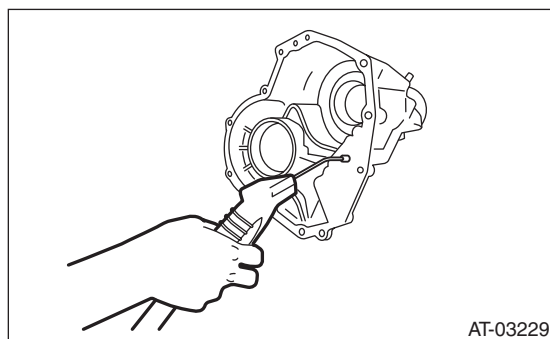
3) Supply compressed air to remove the clutch piston.

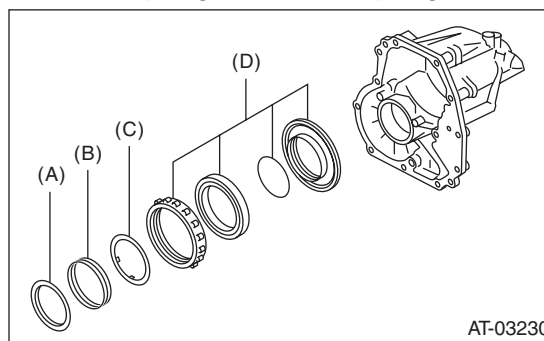
3) Insert the transfer clutch assembly, spring retainer, return spring and clutch spring retainer.

(A) Clutch spring retainer

(B) Return spring

(C) Spring retainer

(D) Transfer clutch piston ASSY

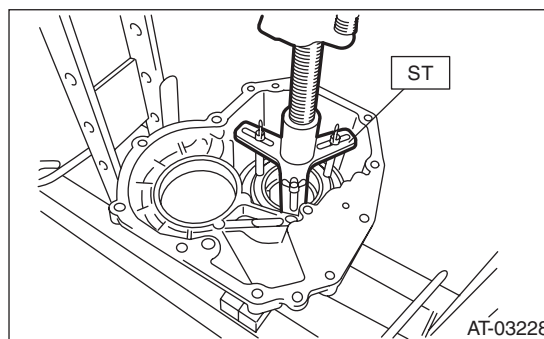
4) Using the ST and compressor, install the snap ring.

ST 18762AA000 COMPRESSOR SPECIAL TOOL
