I86(A), I87(B), O2(C)  
Certification ECU

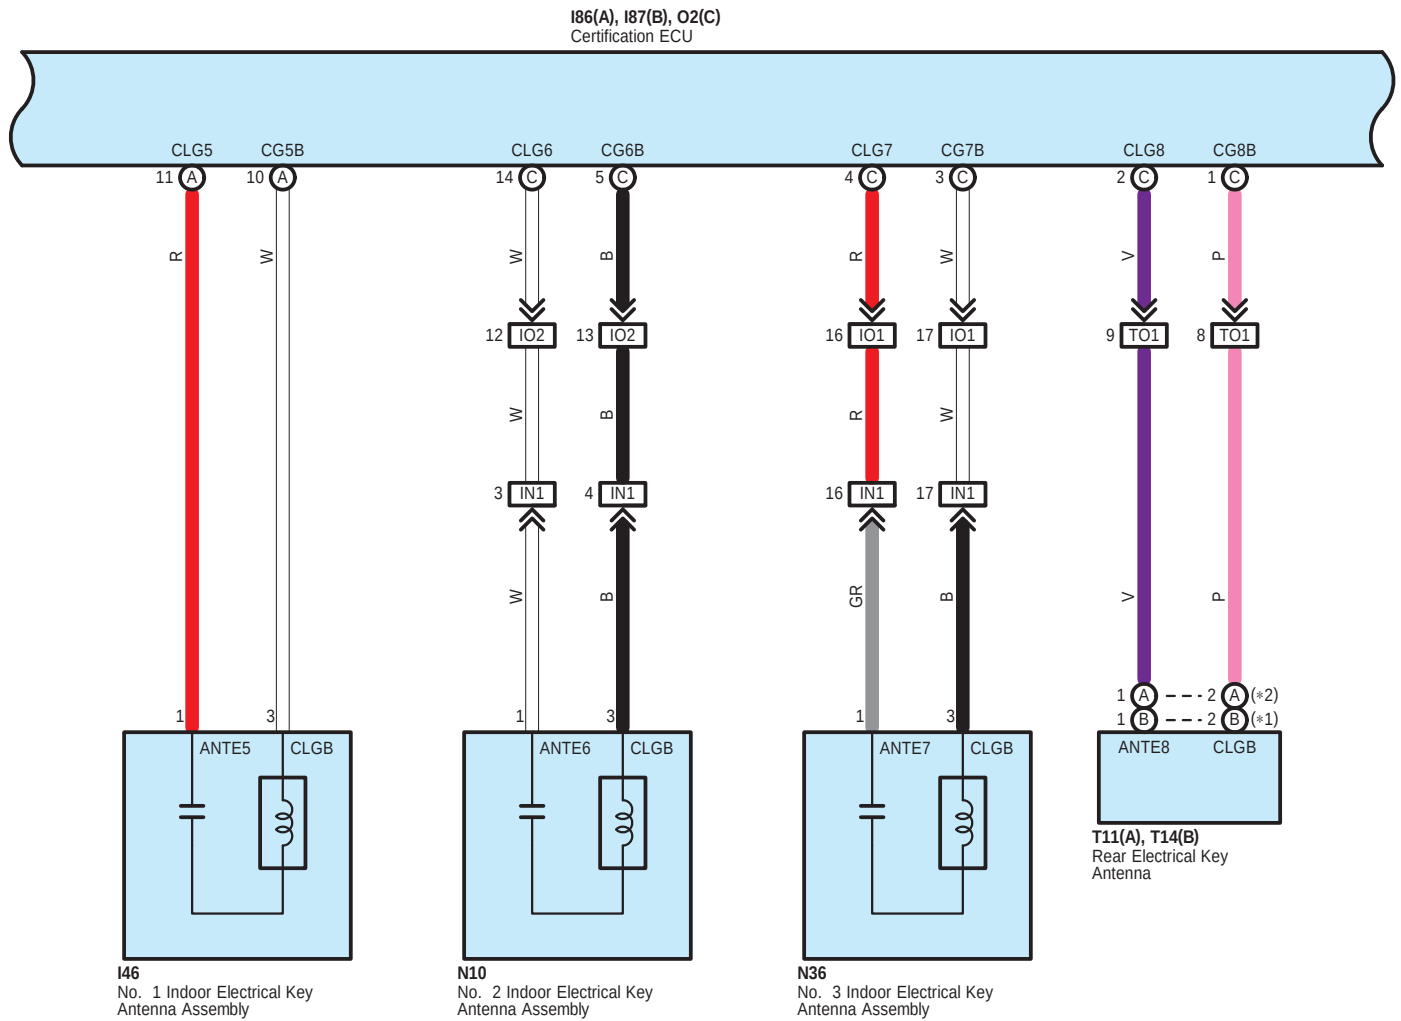
\* 1 : w/ Blind Spot Monitor System  
\* 2 : w/o Blind Spot Monitor System

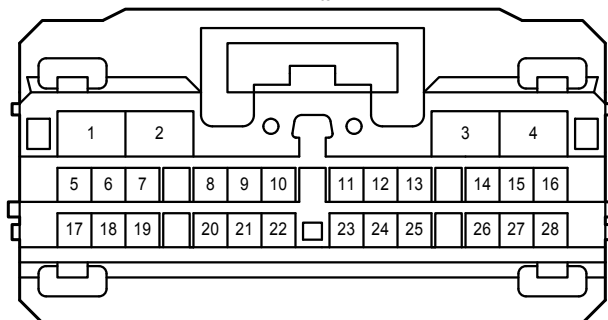
I 12

White

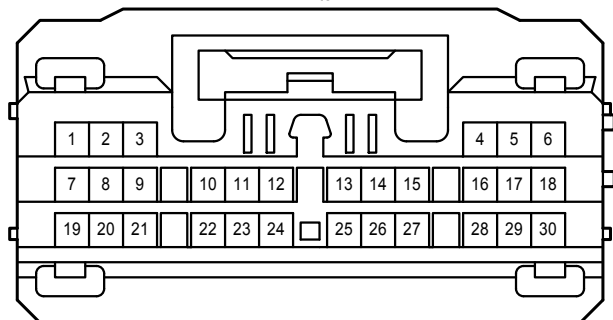
I 13

White
