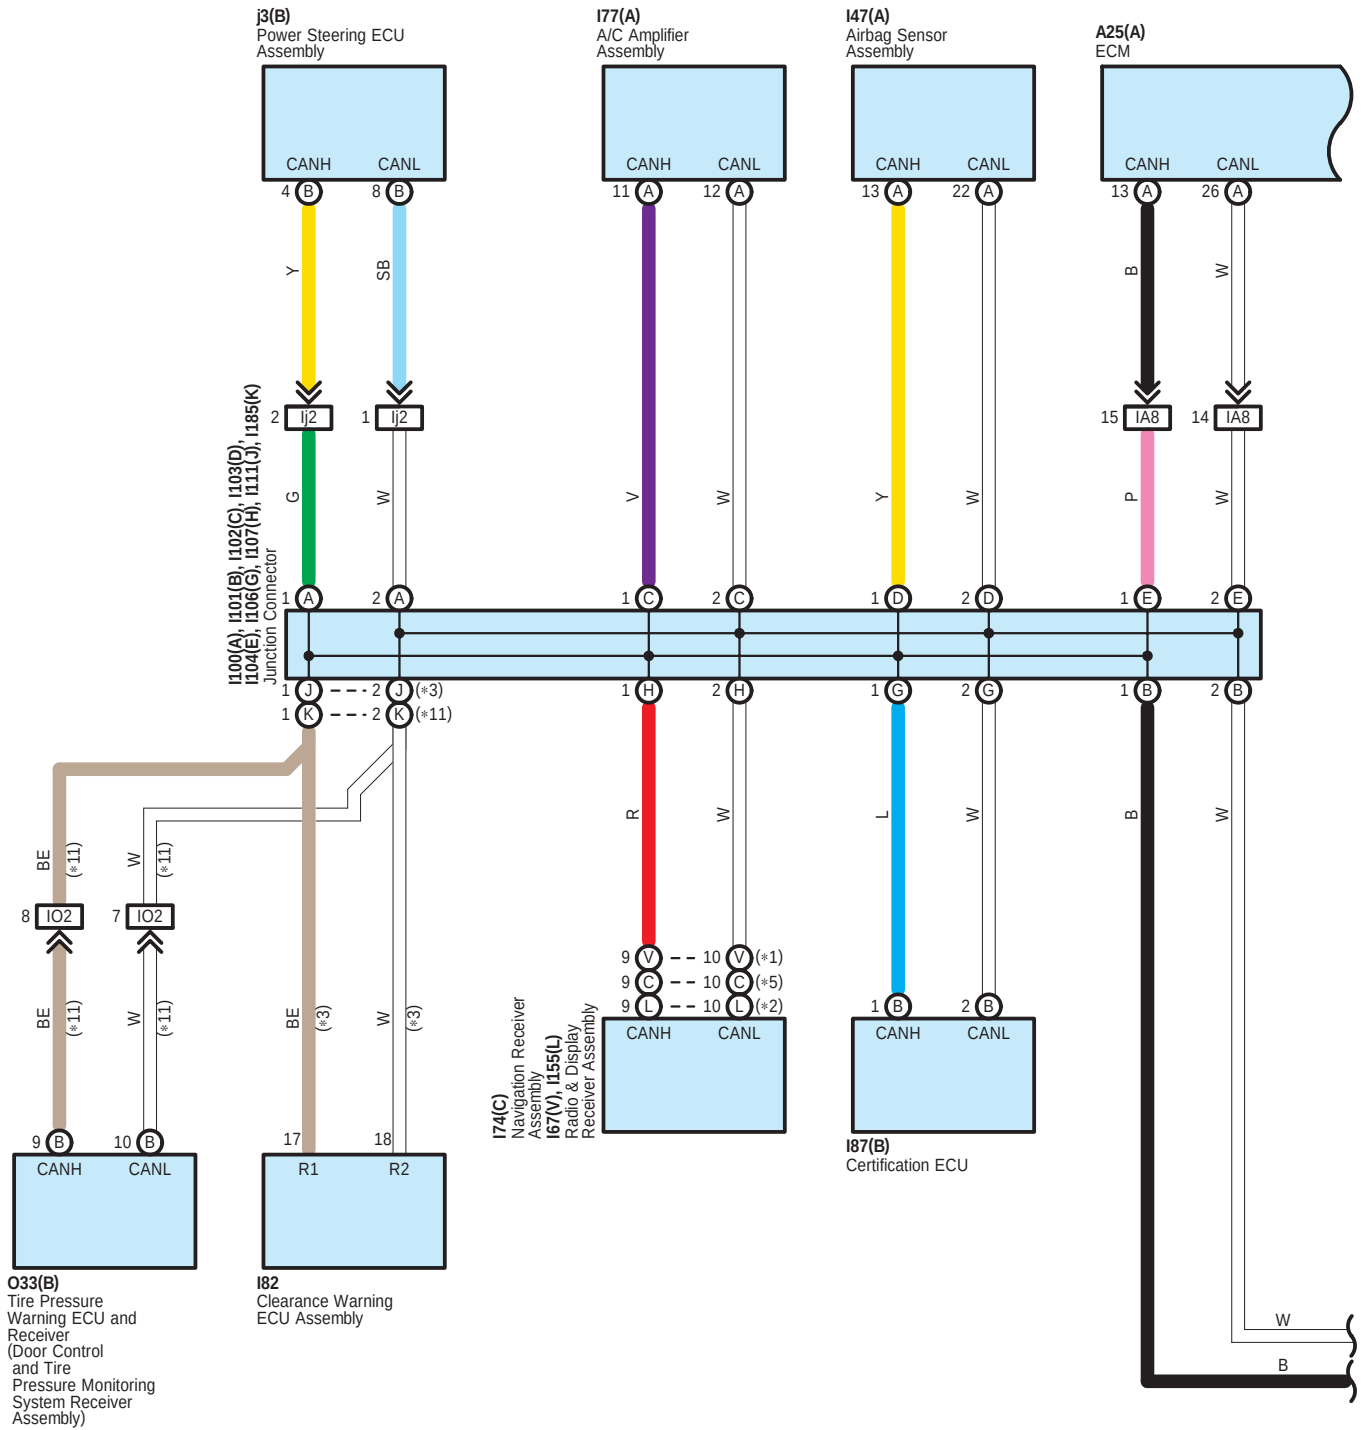
- \* 1 : w/ Radio & Display Receiver Assembly Korea
- \* 2 : w/ Radio & Display Receiver Assembly Except Korea
- \* 3 : w/ Parking Assist (Intuitive Parking Assist)
- \* 4 : w/ Blind Spot Monitor System
- \* 5 : w/ Navigation Receiver Assembly
- \* 8 : w/ Dynamic Radar Cruise Control
- \* 9 : w/o Dynamic Radar Cruise Control
- \* 11 : w/ Tire Pressure Warning System USA

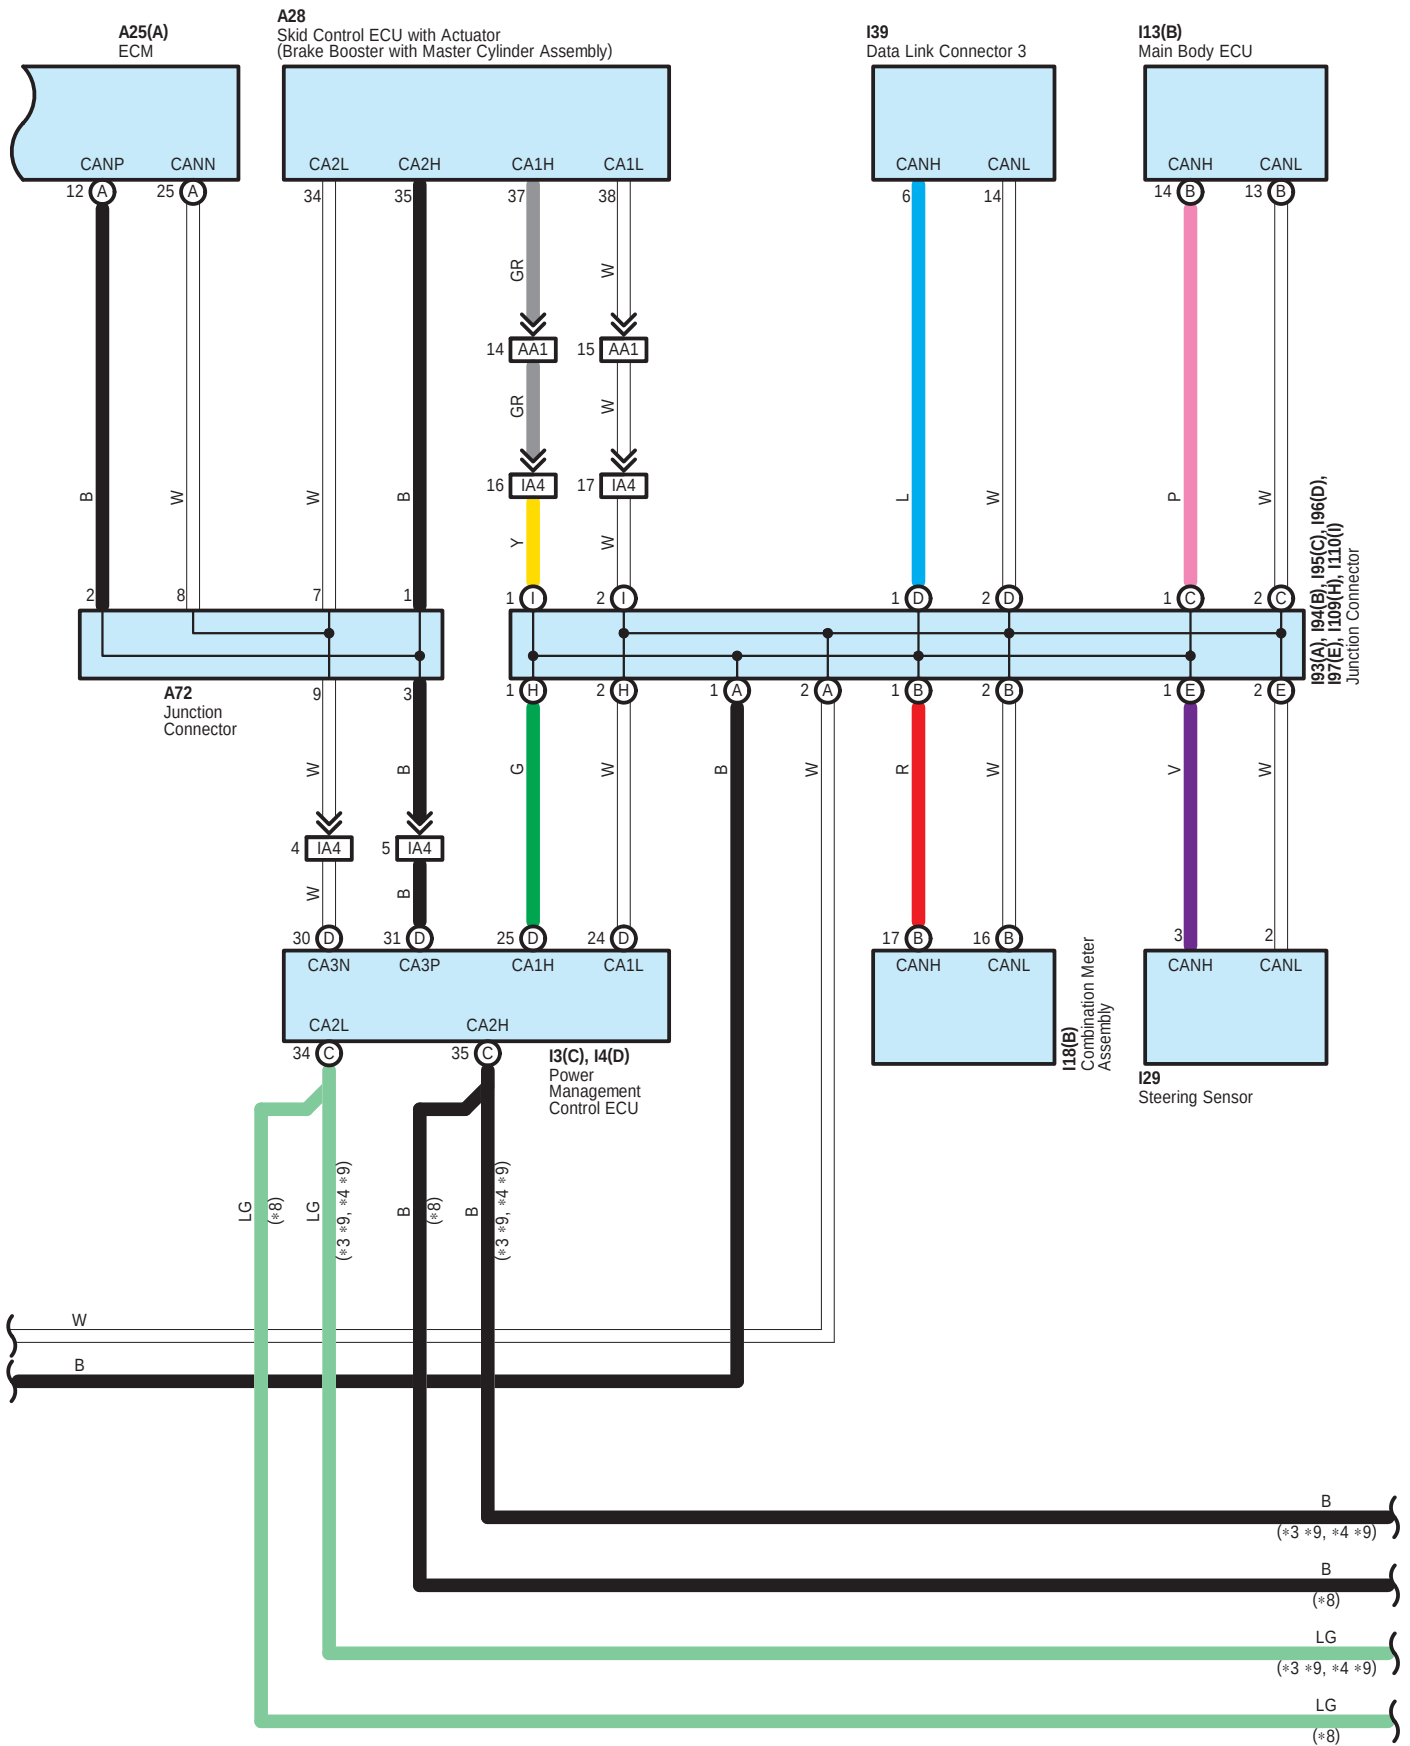
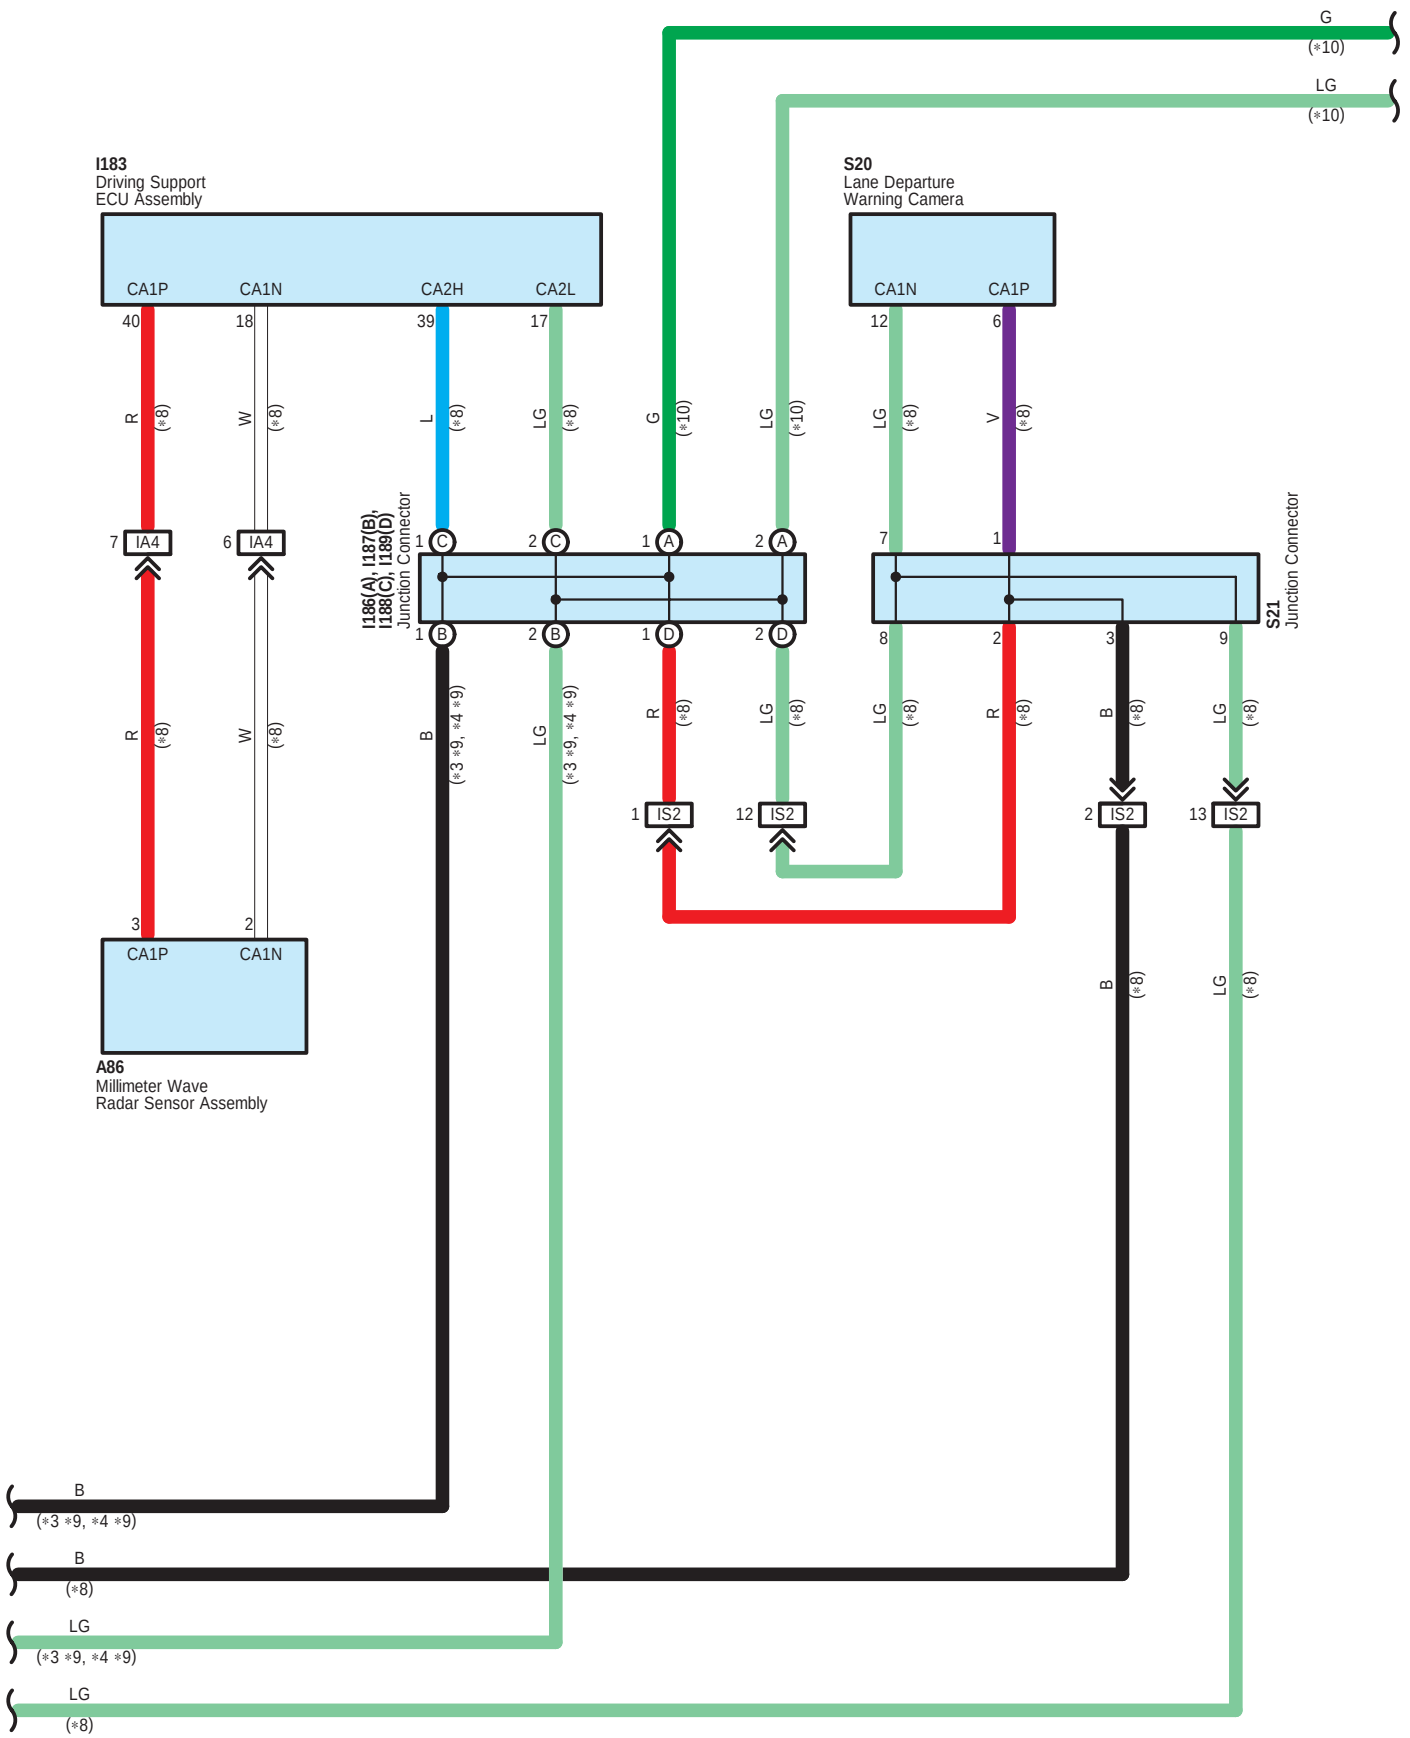
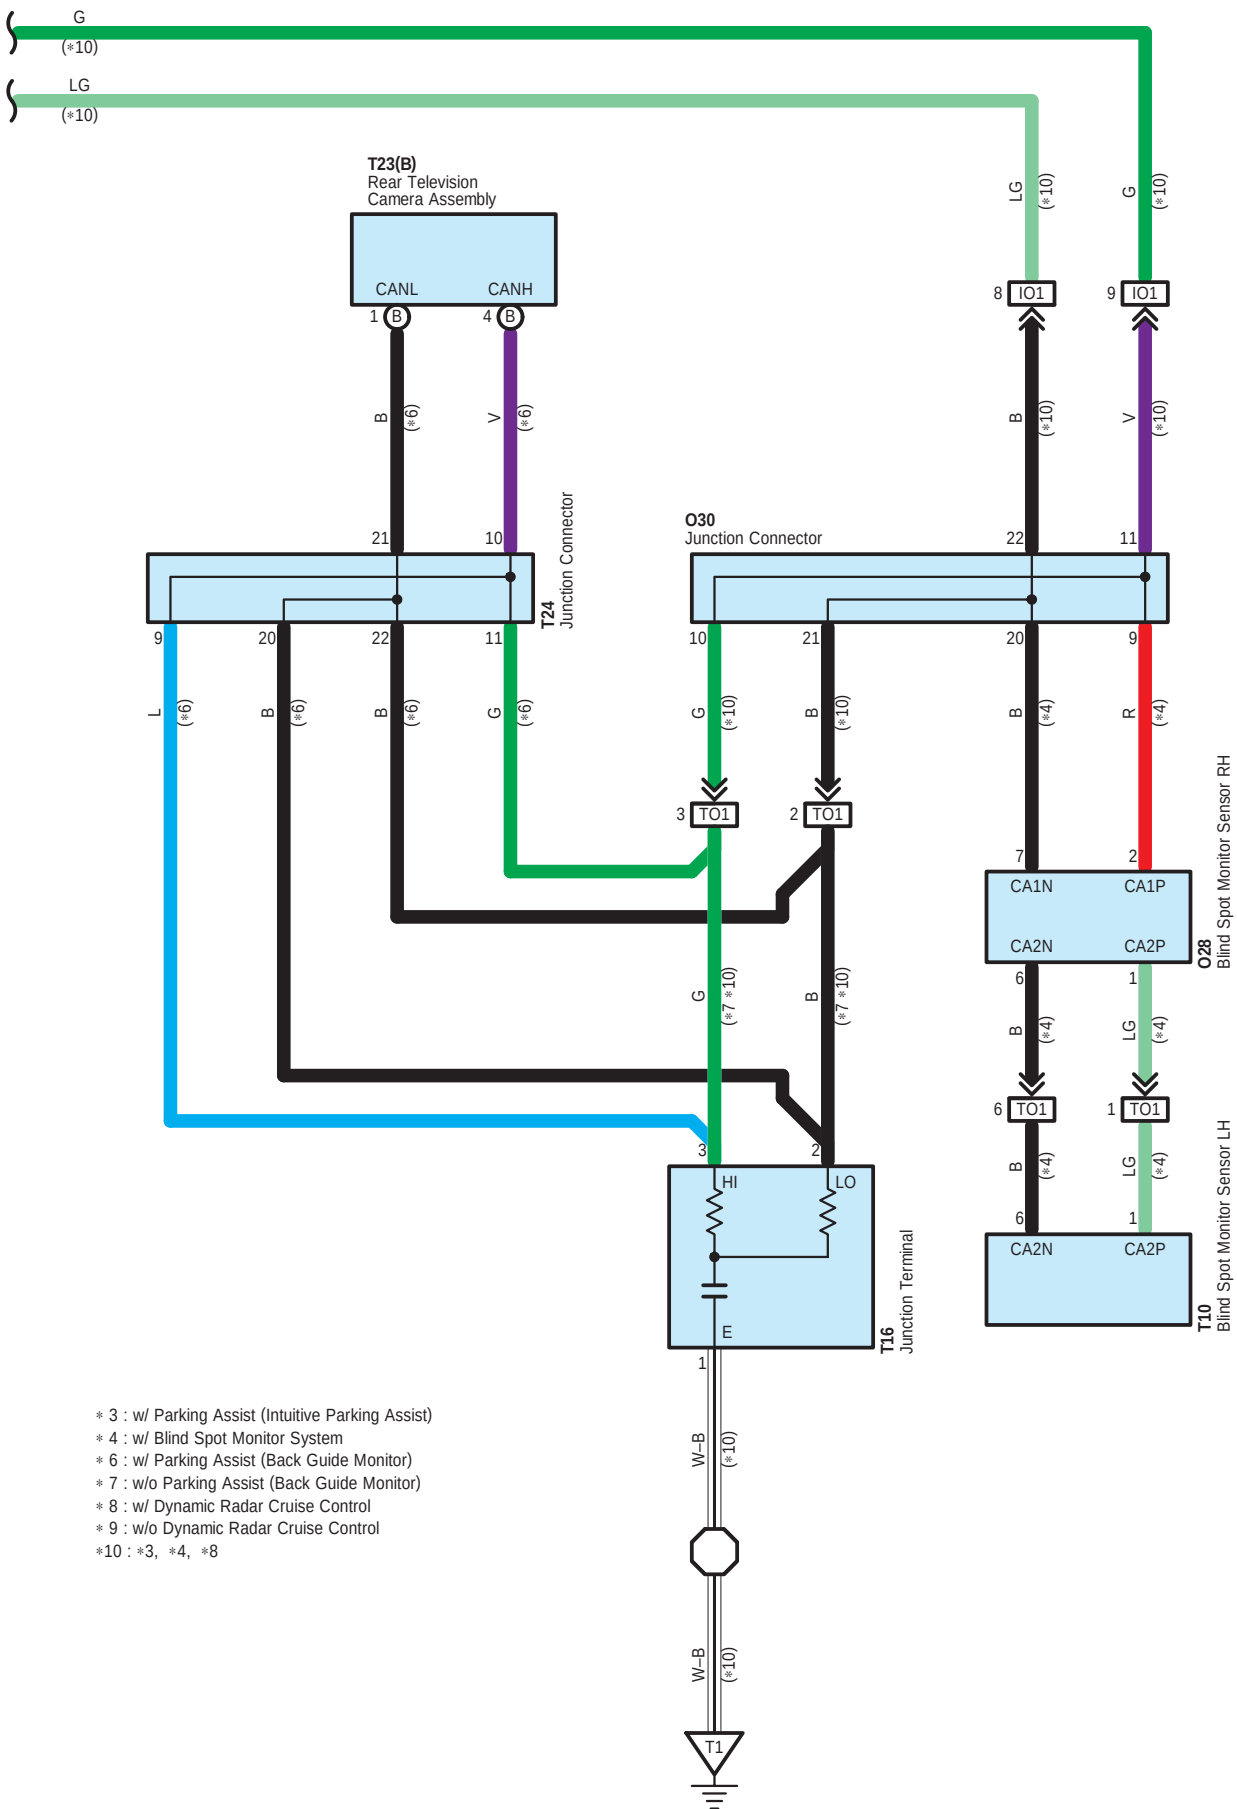
- \* 3 : w/ Parking Assist (Intuitive Parking Assist)
- \* 4 : w/ Blind Spot Monitor System
- \* 6 : w/ Parking Assist (Back Guide Monitor)
- \* 7 : w/o Parking Assist (Back Guide Monitor)
- \* 8 : w/ Dynamic Radar Cruise Control
- \* 9 : w/o Dynamic Radar Cruise Control
- \*10 : \*3, \*4, \*8
