DTC	B0130/63	Short in P/T Squib (RH) Circuit
------------	-----------------	--

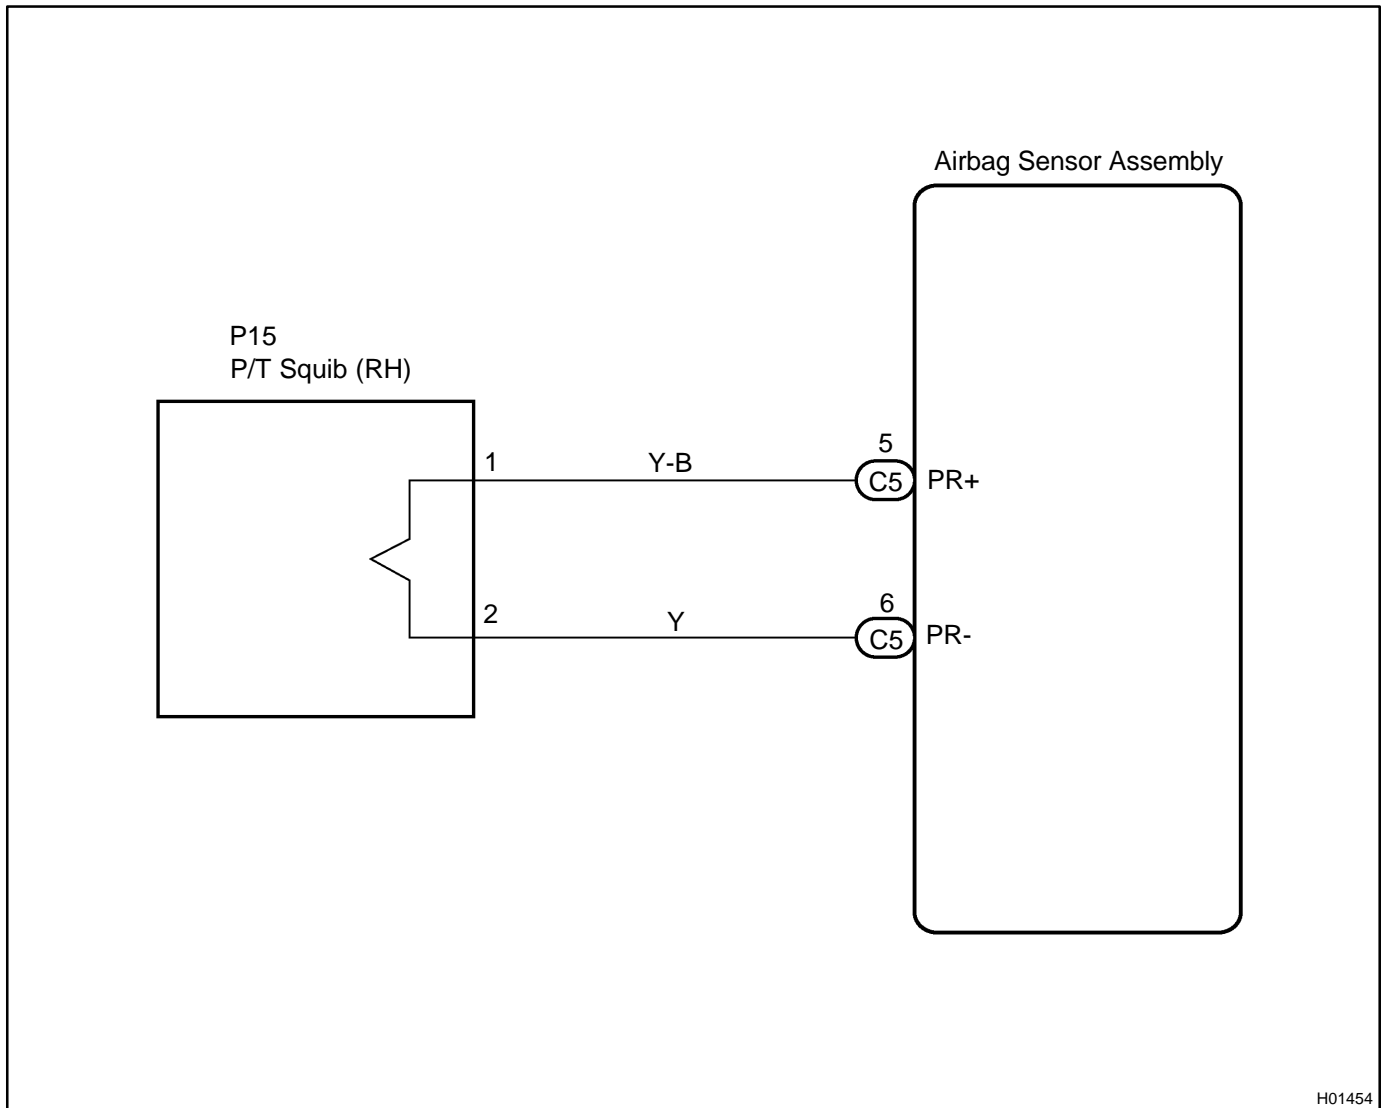
WIRING DIAGRAM

The P/T squib (RH) circuit consists of the airbag sensor assembly and seat belt pretensioner (RH). It causes the SRS to deploy when the SRS deployment conditions are satisfied. For details of the function of each component, see OPERATION on page RS-2 . DTC B0130/63 is recorded when a short is detected in the P/T squib (RH) circuit.

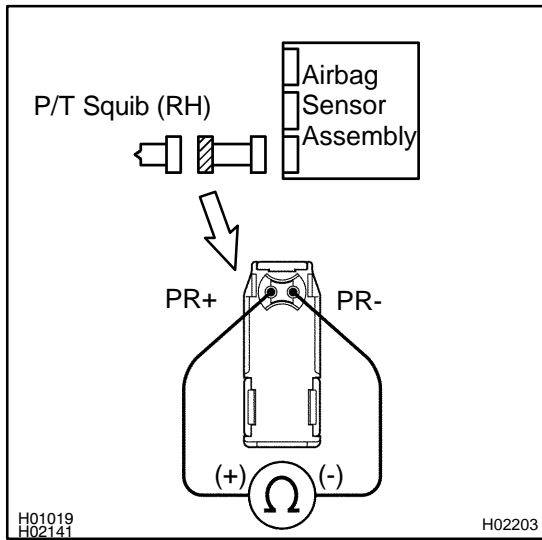
2	Check P/T squib (RH) circuit.
----------	--------------------------------------

Release the airbag activation prevention mechanism of the connector (on the airbag sensor assembly side) between the airbag sensor assembly and the seat belt pretensioner (RH). (See page DI-239)

For the connector (on the seat belt pretensioner side) between the seat belt pretensioner (RH) and the airbag sensor assembly, measure the resistance between PR+ and PR-.

Resistance: 1 MΩ or Higher

NG	Repair or replace harness or connector between seat belt pretensioner (RH) and airbag sensor assembly.
-----------	---

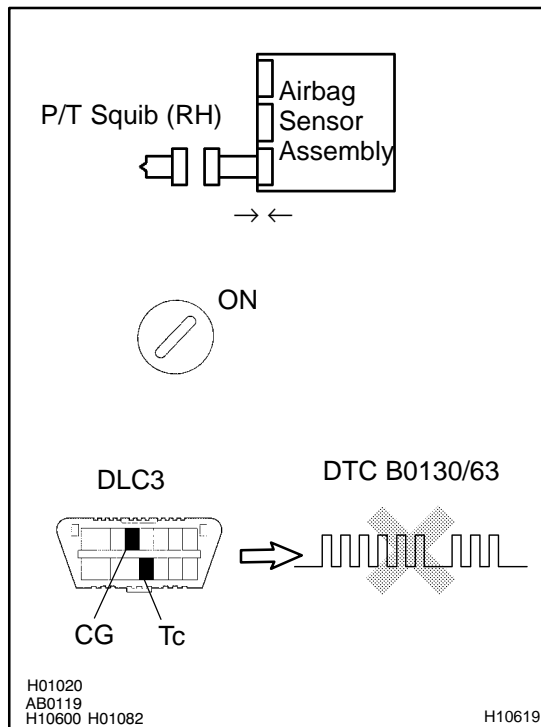
3 Check airbag sensor assembly.

- Connect the connector to the airbag sensor assembly.
- Connect negative (-) terminal cable to the battery, and wait at least for 2 seconds.

- Turn the ignition switch to ON and wait at least for 20 seconds.
- Clear DTC stored in memory. (See page [DI-239](#))
- Turn the ignition switch to LOCK, and wait at least for 20 seconds.
- Turn the ignition switch to ON, and wait at least for 20 seconds.
- Check DTC. (See page [DI-239](#))

DTC B0130/63 is not output.

Replace airbag sensor assembly.

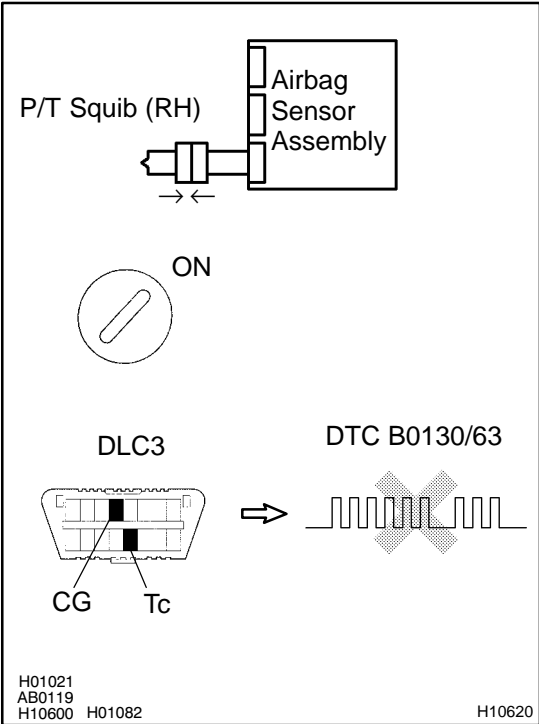
4 Check P/T squib (RH).

- (a) Turn the ignition switch to LOCK.
- (b) Disconnect negative (-) terminal cable from the battery, and wait at least for 90 seconds.
- (c) Connect the seat belt pretensioner (RH) connector.
- (d) Connect negative (-) terminal cable to the battery, and wait at least for 2 seconds.

- (a) Turn the ignition switch to LOCK, and wait at least for 20 second.
- (b) Turn the ignition switch to ON, and wait at least for 20 seconds.
- (c) Clear DTC stored in memory. (See page DI-239)
- (d) Turn the ignition switch to LOCK, and wait at least for 20 seconds.
- (e) Turn the ignition switch to ON, and wait at least for 20 seconds.
- (f) Check DTC. (See page DI-239)

DTC B0130/63 is not output.

NG → **Replace seat belt pretensioner (RH).**
